**Campaign 547**

# Service Campaign 547 Grecale Half-Shafts Check

DATE: OCTOBER 10 2022

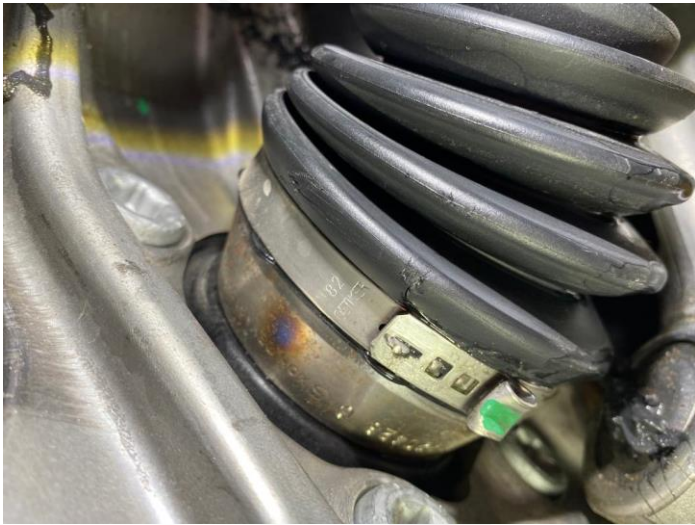
**NOT OK**

This intervention is necessary to verify that the cap of the front half shafts has no signs of damage due to an incorrect assembly in production.

*Example of damaged drive shaft boot  
Always check the entire circumference*

3. If the drive shaft is damaged (**NOT OK**), proceed with the replacement of the component according to the procedure reported in the workshop manual.
4. Although no damage is expected on the right-side half-axis, proceed to check that side as well.
5. The operation can be considered complete.
