**Campaign 549**

# Service Campaign 549 Levante V8 Engine Harness Position Check

DATE: OCTOBER 26 2022

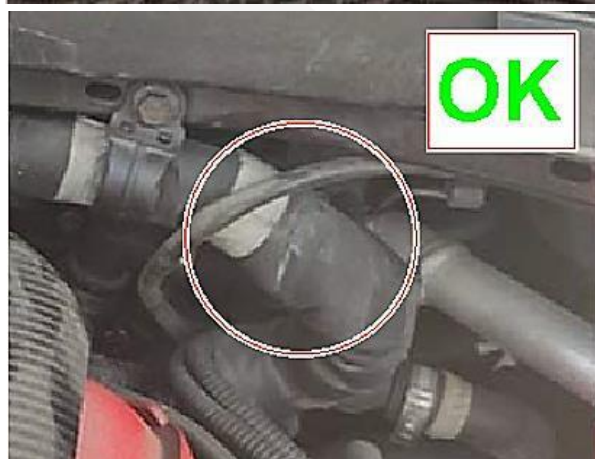
Example of correct routing **IN FRONT** of the plate

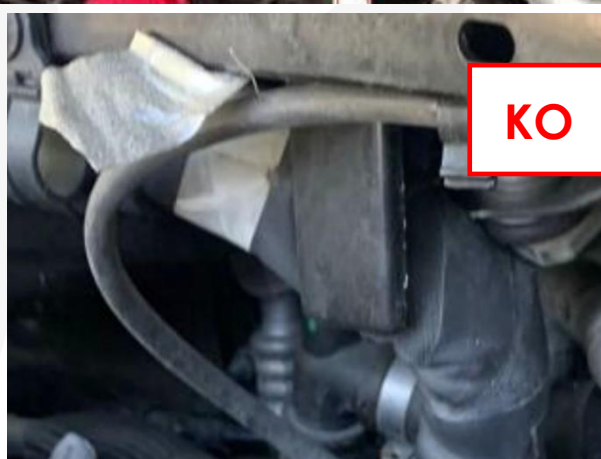
Example of incorrect routing **BEHIND** the plate

3. If the inspection results in:  
Check **OK** → the inspection is completed, and no further action is required.  
Check **KO** → continue with the **rework** procedure indicated in the next step. (**Step 4**)
