MAS003312 MSC 22-42

**Campaign 550**

# Service Campaign 550 Ghibli V6 Engine Harness Position Check

DATE: OCTOBER 26 2022

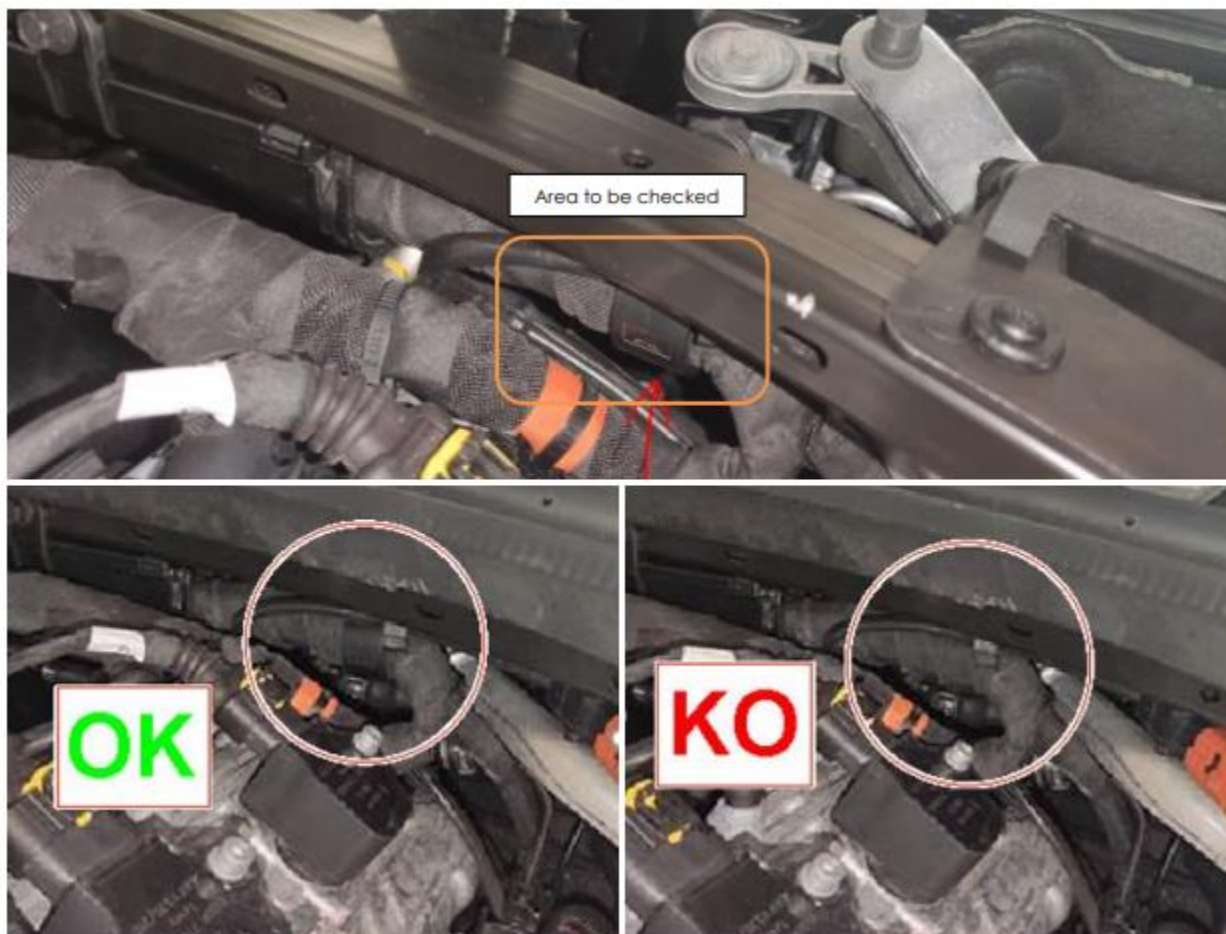
1. Always check in ModisCS+ to see if the vehicle is involved in this campaign and if the The campaign has not been previously performed.
2. Inside the engine compartment, inspect the engine harness and check the presence of the holding clip and that it is correctly fixed to the bar, and that the protective sleeve of the Engine Harness does not have abrasions.

Example of correct routing **with the clip**

Example of incorrect routing **without the clip**

3. If the inspection results in:  
Check **OK** → the inspection is completed, and no further action is required.  
Check **KO** → continue with the **rework** procedure indicated in the next step. **(Step 4)**

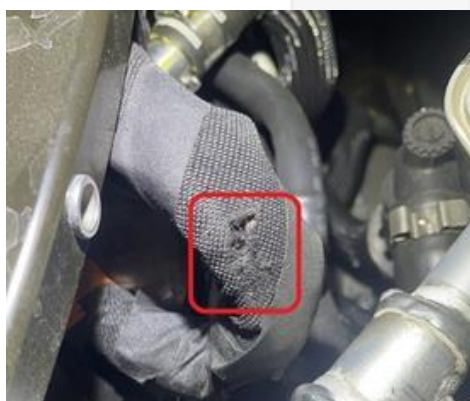
4. During the rework, check the integrity of the harness.
  - If the harness does not present any type of damage proceed to **Step 5**.
  - If there is a sign of abrasion or damage to the sheath, Open a BOL for "SUPPORT REQUEST" attach pictures, and await further instructions
