MAS003315 MSC 22-41

CAMPAIGN 553

Service Campaign 553 MC20 - IPC Software Update

DATE: OCTOBER 21 2022

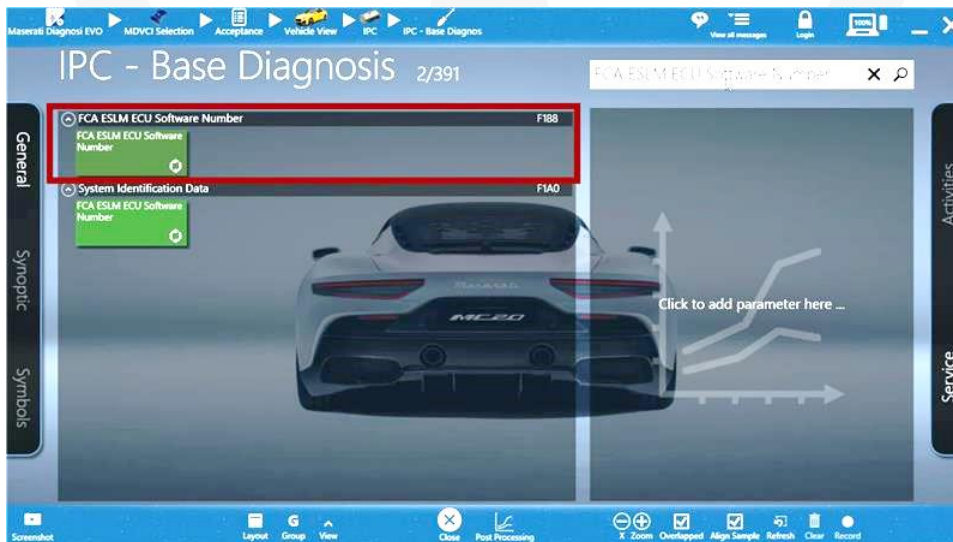
The Sw Below (or newer) must be installed

Note: after the IPC - ECU Programming, please make sure in the IPC - Base Diagnosis - FCA ESLM ECU Software Number that the new software has been installed correctly.

1. Always check in ModisCS+ to see if the vehicle is involved in this campaign and if the The campaign has not been previously performed.
2. Before proceeding, please ensure that the Engine is OFF. Connect the 12V Vehicle Battery to a Battery Maintainer.
3. Connect the MD EVO to the VCI2 using the USB cable.
4. Connect the VCI2 to the vehicle.
5. Key ON Engine OFF (KOE) check battery voltage and ensure it is 12V or above.
6. With the MD EVO select **IPC ► ECU Programming** and follow the prompts.
Note: The programming will take about 1 hour to perform.
