## QUARANTINE NOTICE

| Reference number: | QN-31-1712 | Issued: 29 November, 2022 |
| Subject: | Door Cladding Check and Install | |
| Model(s): | DBX707 | |

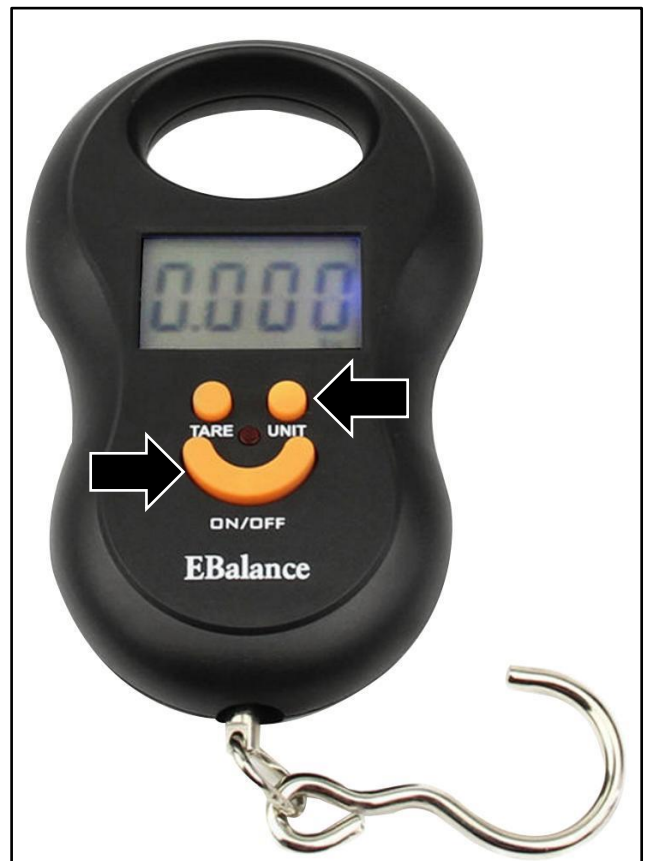
Figure 1

1. Switch the weighing scale on and set to "Kg" with the "UNIT" button (refer to Figure 1).

2. Pull the hook to check the display increases when an increase in force is applied.

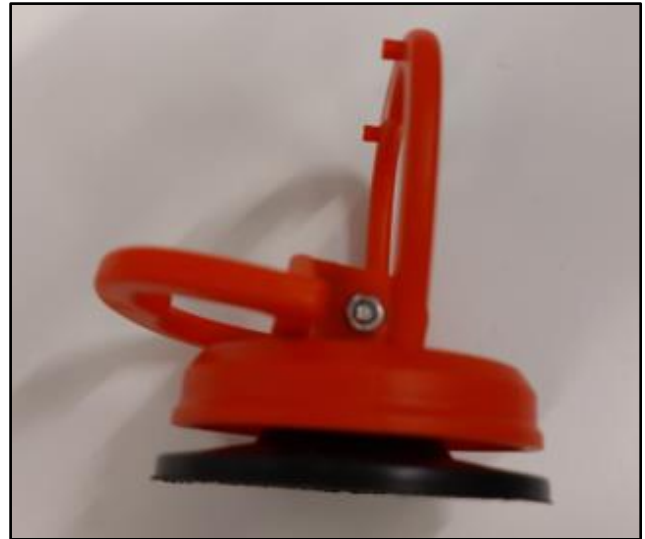
Figure 2

3. Make sure the suction cup is set to the open position as shown (refer to Figure 2).

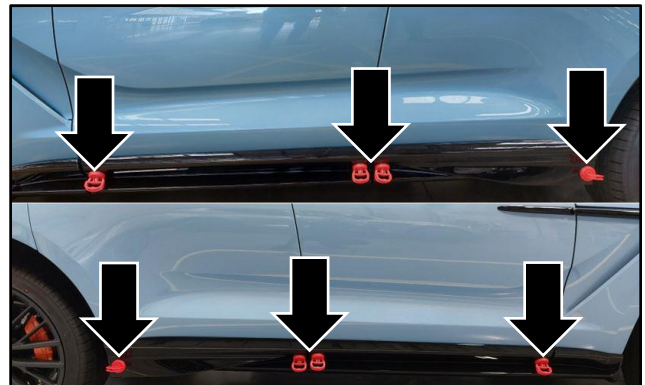
Figure 3

4. Install the suction cup against the flat surface of the door cladding. The image shows all the areas the suction cup must be installed (refer to Figure 3).

**Note: The pull test must be completed on all of the areas shown on both sides of the vehicle.**

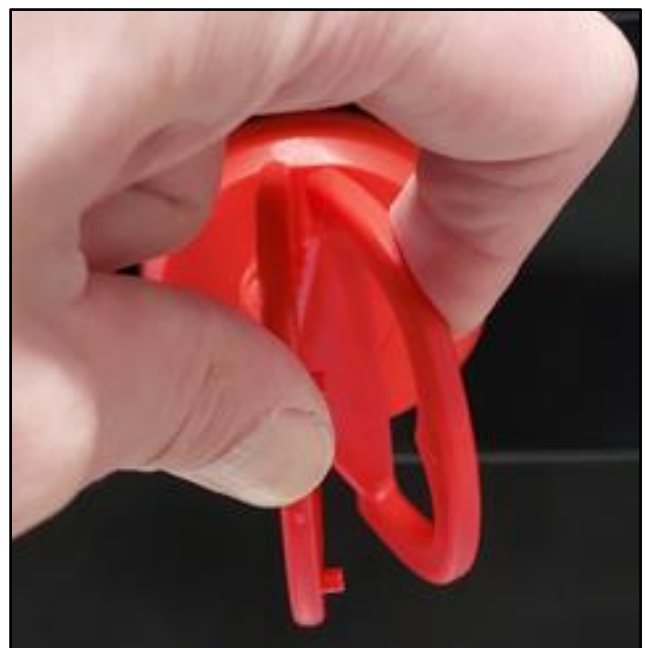
Figure 4

5. Close the levers together to attach the suction cup to the door (refer to Figure 4).

**Note: Make sure that the suction cup is pushed against the cladding when the levers are closed together.**

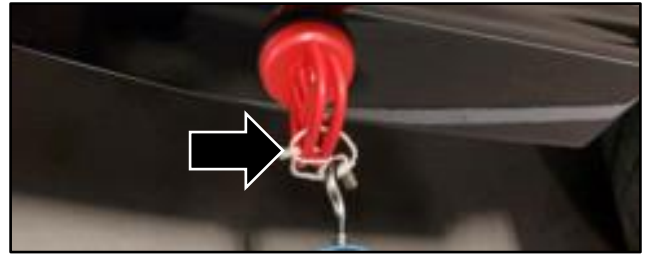
Figure 5

- Use a length of string to attach the weighing scale to the suction cup (refer to Figure 5).

**Note: The string should sit in the centre of the suction cup to correctly spread the load.**

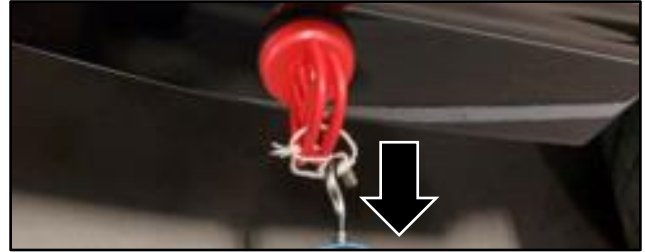
Figure 6

- Pull the weighing scale until a minimum force of 12.75kg or 125N is shown (refer to Figure 6). The door cladding must not detach to pass this test.

**Note: Make sure a minimum force of 12.75kg or 125N is applied. Do not exceed 14.28Kg or 140N of force.**

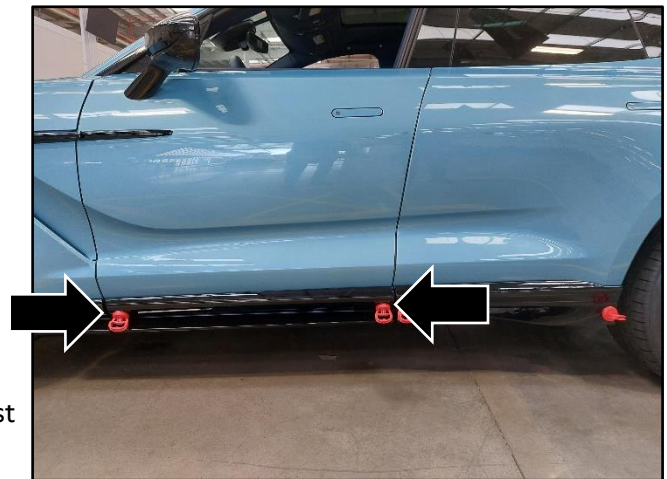
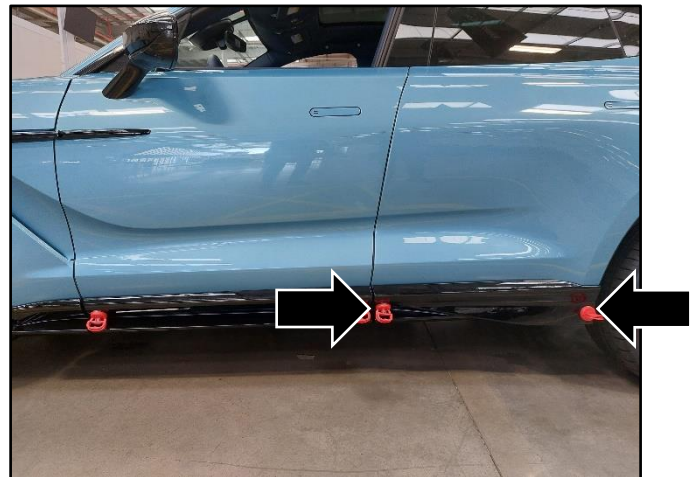
Figure 7

- Note: The door cladding is installed with tape on the upper and lower areas of the door cladding and adhesive on the sides.**

Examine both sides of each door cladding for gaps to the door on the areas shown on both sides of the vehicle (refer to **Error! Reference source not found.**).

Make sure there are no areas where adhesive is not attached to the door and door cladding.

If there are any areas where the adhesive does not attach the door cladding to the door this test is failed, and the door cladding must be replaced.

If more than a combined 100mm of tape becomes detached from the door, the cladding must be replaced.

11. If any cladding must be replaced as part of the test, refer to the applicable Workshop Manual Procedure as follows:
  - 31.04.ES - Left Side Front Door Cladding - Remove and Install New Part
  - 31.04.ET - Right Side Front Door Cladding - Remove and Install New Part
  - 31.04.EU - Left Side Rear Door Cladding - Remove and Install New Part
  - 31.04.EV - Right Side Rear Door Cladding - Remove and Install New Part

12. If there is adhesive remaining on the door it must be removed before new door cladding is installed. Prior authority is necessary before work is started. An image of the adhesive must be provided.
