# **Technical product information**

Topic	HVAC operation issues/HVAC Motor defect DTC's logge			
Market area Bentley: worldwide (2WBE)				
Brand Bentley				
Transaction No. 2051519/11				
Level	EH			
Status	Released for publishing			
Release date	03-Nov-2022

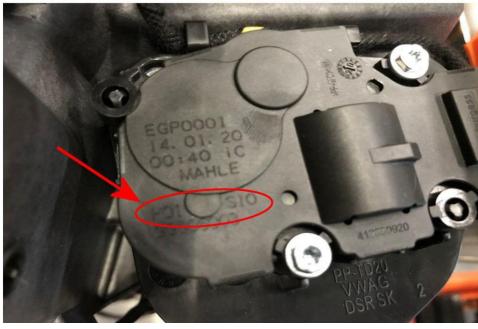
The HVAC motors can become defective causing HVAC operational issues

IMPORTANT NOTE: Referring to Figure 1 (Bentayga) and Figure 2 (New Continental GT/GTC and New Flying Spur) – In the event the Hardware level is H01 and the Software level is S10 these motors do not require replacement unless exhibiting an operational issue as these motors are the latest level

VERY IMPORTANT: To eliminate a repeat repair - The operative MUST replace all HVAC motors which are accessible with the afore listed components removed during the same operation/workshop visit regardless if the motors are faulty or not

$\bullet \ \mathsf{Replace} \ \mathsf{all} \ \mathsf{motors} \ \mathsf{as} \ \mathsf{per} \ \mathsf{the} \ \mathsf{Repair} \ \mathsf{manual} \ \mathsf{and} \ \mathsf{the} \ \mathsf{Technical} \ \mathsf{background} \ \mathsf{section} \ \mathsf{of} \ \mathsf{this} \ \mathsf{TPI}$
