# Technical product information

<b>Topic</b>	Oil leaking from tell tale hole - CDA actuator fixings or Fuel rail fixings or Vacuum assembly fixings - V8 Kovomo
<b>Market area</b>	Russische Föderation (5RU),Australia E04 Bentley rest Asia and Australia (6E04),China 796 VW Import Comp. Ltd (Vico), Beijing (6796),Germany E02 Bentley rest Europe (6E02),Japan E03 Bentley Japan (6E03),Korea, (South) E08 Bentley South Korea (6E08),United Arab Emirates E06 Bentley Middle East and Africa (6E06),United Kingdom E01 Bentley UK (6E01),United States E05 Bentley USA and rest America (6E05)
<b>Brand</b>	Bentley
<b>Transaction No.</b>	2064679/2
<b>Level</b>	EH
<b>Status</b>	Released for publishing
<b>Release date</b>	04-Nov-2022

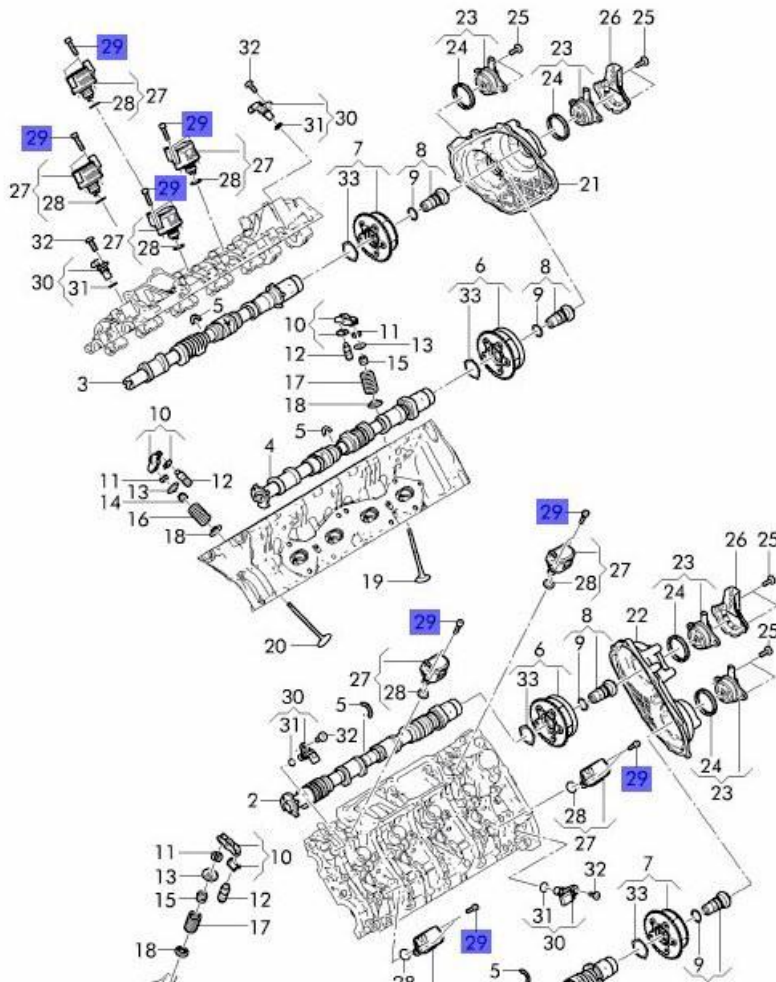
- CDA activation/ deactivation solenoid fixings - Figure 1 (Item 29 - Quantity of 16 in total)

- In the event that x1 (or more) of the CDA solenoid fixing/s are leaking – All 16 CDA solenoid fixings MUST BE REPLACED as a complete set - Refer to Rep.Gr 15 - Ensuring the procedure is followed to enable access to all CDA solenoid fixings

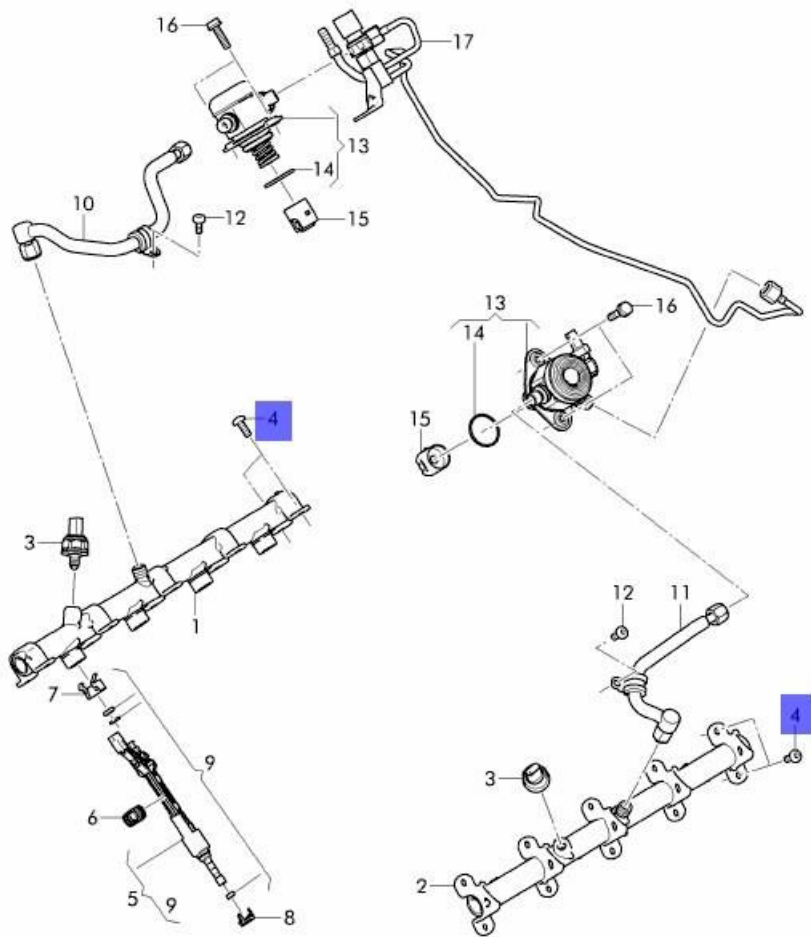
- Fuel rail fixings - Figure 2 (Item 4 - Quantity of 20 in total)

- Refer to Rep.Gr24- Fuel rails to remove and refit- Ensure the procedure is followed to enable access to the fuel rail fixings on both Banks 1 and 2 - Replace all 20 fixings

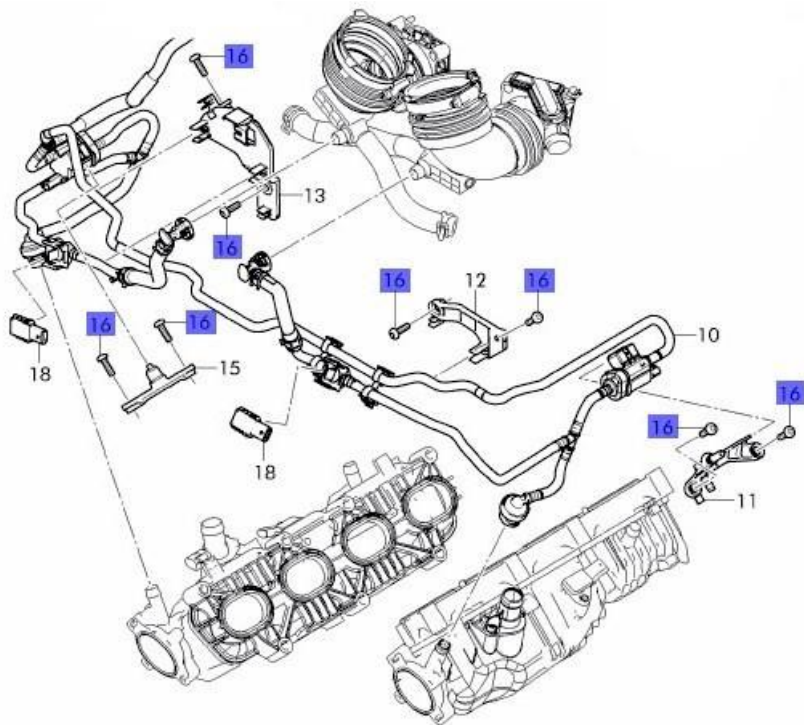
- Fixings for the vacuum system assembly - Figure 3 (Item 16 – Quantity of 8 in total)

1) To gain access to the fixings, the Operative should refer to extracts from the following procedures to replace the fixings:

- Rep.Gr20 - Evaporative Emission Purge Valve and Rep.Gr28 - Ignition coil replacement

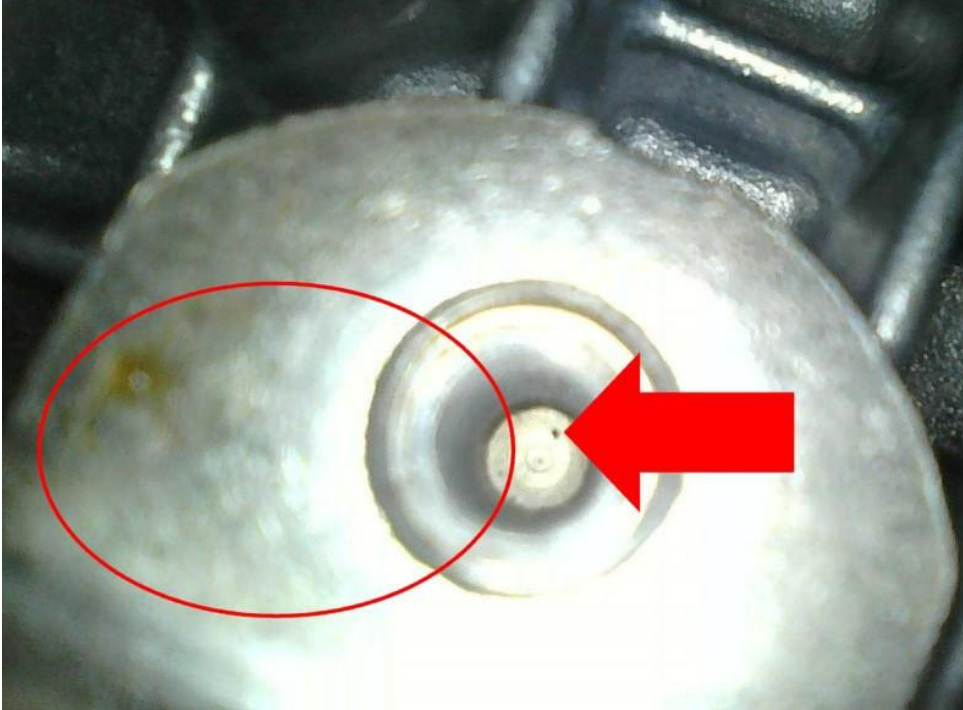
Figure 4 shows oil leaked which had leaked from the tell tale hole at the top of the fixing (Arrow)

- Upgraded fixings prevent oil leaks from the tell hole
