REFERENCE:	Nova Bus Manuals
SECTION:	10: Transmission and Control
RS N°:	MQR 7621-2486
EFFECTIVE IN PROD.:	N/A

SUBJECT:	P-Clamp failure on Transmission cooling pipes.
JUSTIFICATION:	P-Clamp cannot withstand the load of the cooling pipes. Thicker P-clamp as a containment solution.

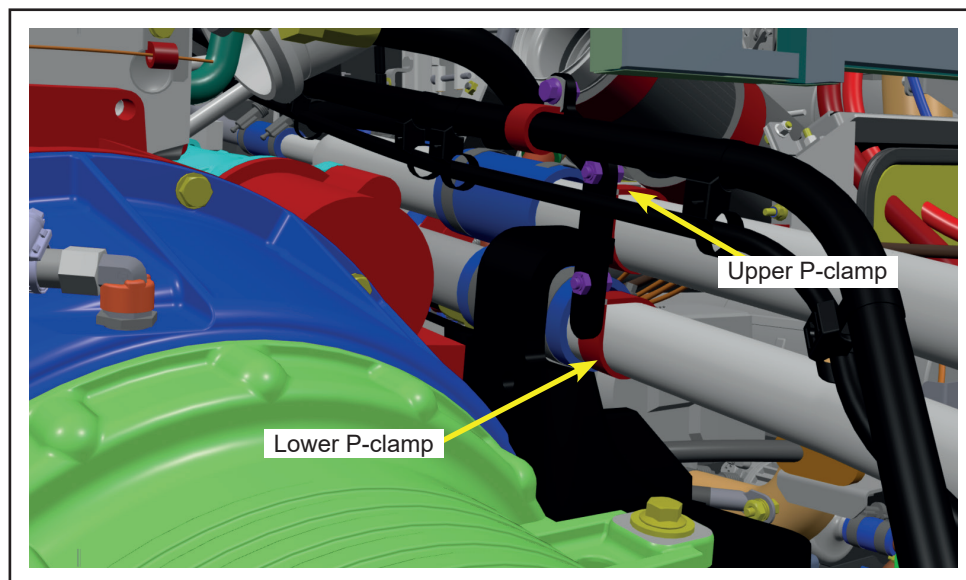
*Figure 1 - Location of P-clamp*

- 1.1. Park the vehicle on an even surface with the transmission on neutral.
- 1.2. Apply the parking brake and set the master control switch to the **stop** position.
- 1.3. Set the battery disconnect switch in the battery compartment to the **off** position
- 1.4. Open the transmission access panel.
- 1.5. Locate the upper and lower P-clamp on Transmission cooling pipes (see figure 1).

- 1.6. Remove the P-clamp using 13mm socket wrench.
- 1.7. Replace new P-clamp P/N N84090-14 on the cooling pipes and Torque to  $23 \pm 2 \text{ N}\bullet\text{m}$ .
- 1.8. Close the transmission access panel.
- 1.9. The vehicle can return in service.❖
