## RYKER 2019-020-021-022 Gearbox improved Parts - 140638

This TST includes solution for the noise that can be heard or felt under deceleration at high speed.

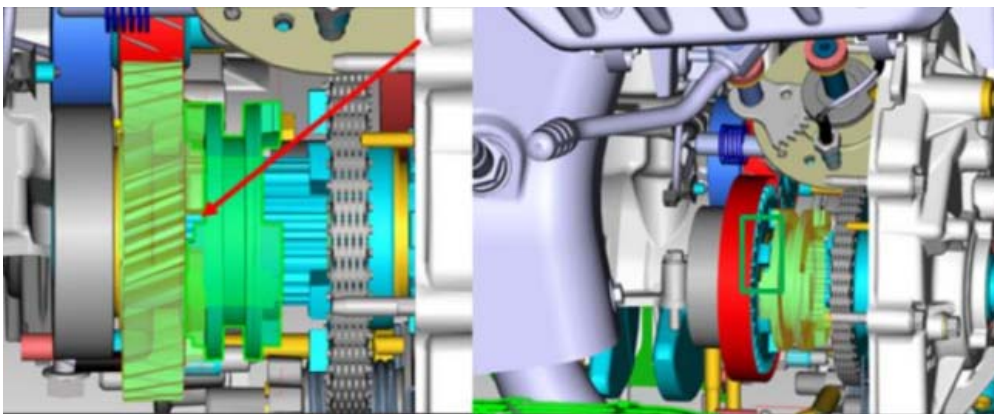
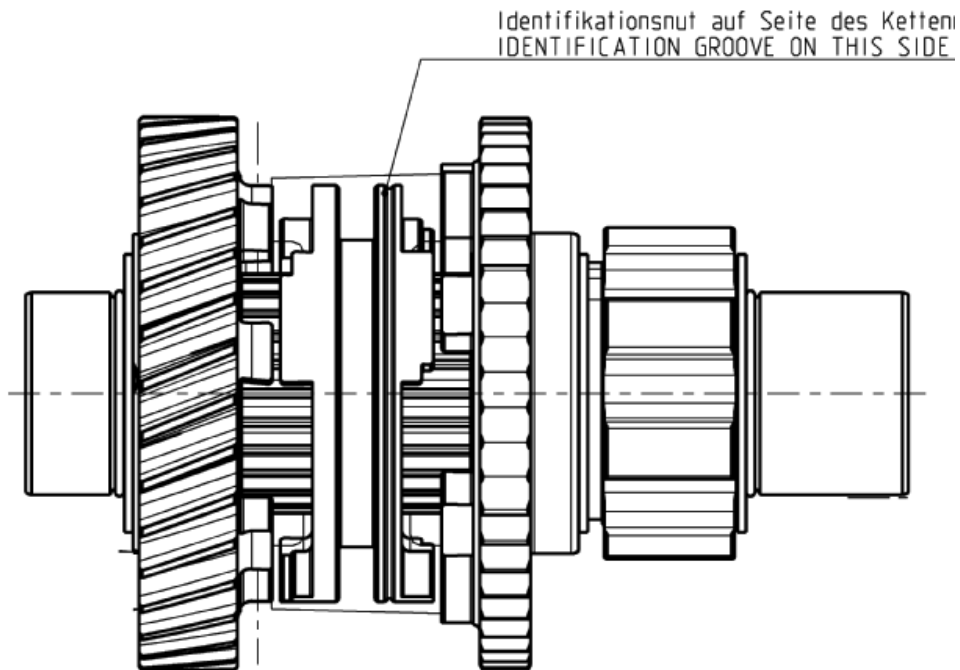
The gearbox is making a loud noise when releasing the throttle at +/- 80 km/h (50 mph). The problem is from the gearbox's internal parts (shifting sleeve & FWD gear).

Addition of a 5 degrees undercut angle to the steps on the shifting sleeve and forward gear. This improvement avoids gear-to-sleeve skipping under deceleration at higher speed. Addition of a 5 degrees undercut angle to the steps on the shifting sleeve and forward gear. This improvement avoids gear-to-sleeve skipping under deceleration at higher speed. MY23 Ryker gearboxes are built with these improvements.

Improved gear set P/N **420637819**. This P/N is blocked and under selective release due to the limited quantity available. A technical case must be opened and it needs to be authorized by a product advisor.
