WARRANTY BULLETIN QUALITY

November 16, 2022 Subject: **Front Fenders Harness Repair - Wear by Tire Rubbing** No. **2023-2**

MODEL YEAR	MODEL	ADMISSIBLE UNITS
2019 to 2021 2022 (Specific serial numbers) 2023 (Specific serial numbers)	Ryker®	In Knowledge Center: - Enter the VIN - Select the <i>DOCUMENTS AND ARTICLES</i> tab - Select filters: • Warranty in <i>ARTICLE TYPE CATEGORIES</i> Warranty Bulletin in <i>ARTICLE TYPES</i>

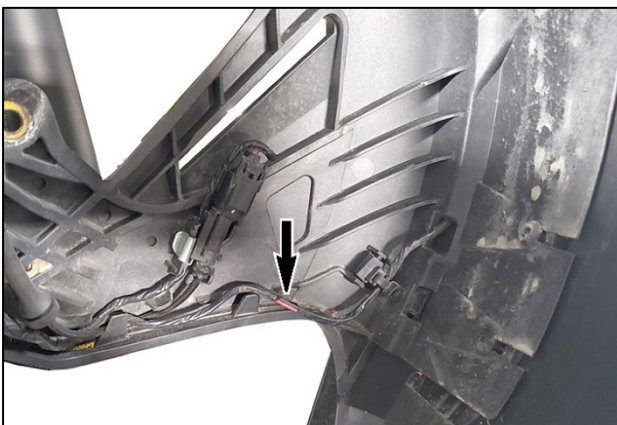
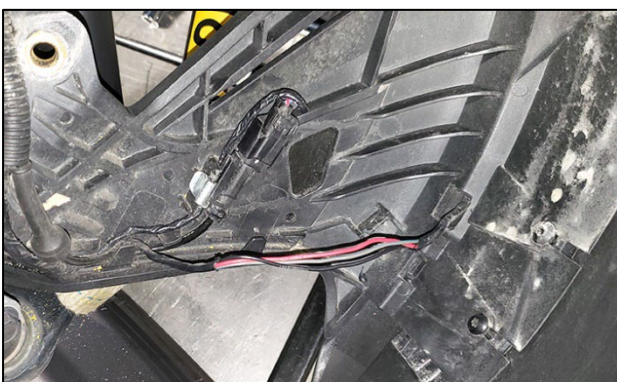
This bulletin is the detailed repair procedure if the position light and flasher electrical harness in the front fenders have rubbed on the tires wearing the insulating sheath.

1. Remove the adhesive tape over a length of about 10 cm centered on the point where insulation wear is visible.
