# Technical Service Bulletin

<b>Subject:</b>  FRONT AND REAR BRAKE NOISE	<b>Bulletin No.:</b> 04-004/22
	<b>Last Issued :</b> 11/29/2022

2013-2023 CX-5

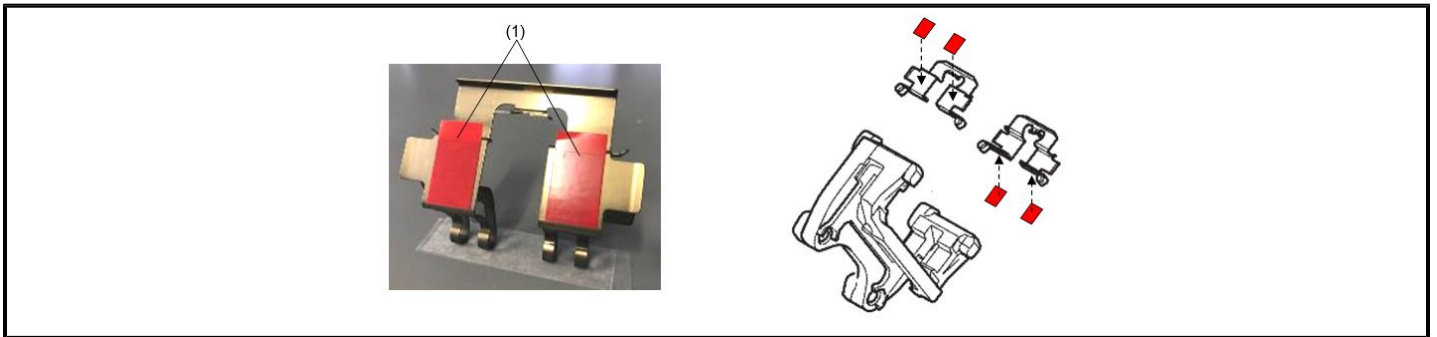
**Rear Brake Noise Symptom 1:** Some vehicles may exhibit a squeak noise from the rear brakes while braking lightly and occurs more frequently when driving at slow speeds. The noise is caused by poor contact between the guide plate and the mounting support. To eliminate this concern, the material of the pads has been changed to copper-free and the specification of the shims has been changed to a coated spring with tape.

- Verify if the tape is installed to both guide plates (some kits do not have the tape installed and is packaged separately).
- If the tape is not applied to the guide plates, peel off the red release film (1) and the dual adhesive tape (2) from the release paper (3) and apply the dual adhesive tape to the contact surfaces of the guide plates as shown below.
