PRODUCT CAMPAIGN BULLETIN

APPLICABILITY: 2009-2013 MY Forester

NUMBER: WRJ-22

SUBJECT: Defective Left Front Seat Belt installed as a replacement part

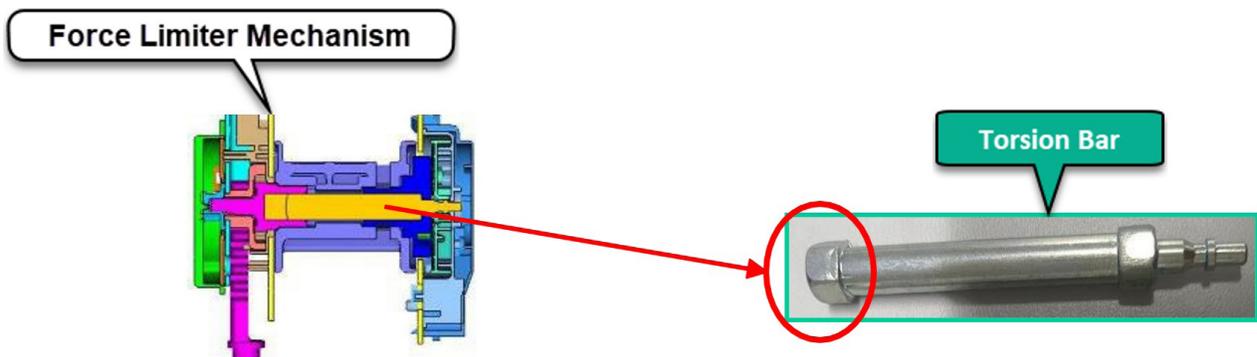
The torsion bar portion of the force limiter mechanism may have a distorted shape due to foreign matter inside the metal mold during production. The production equipment and inspection process has been redelveloped to rectify the seat belt production.

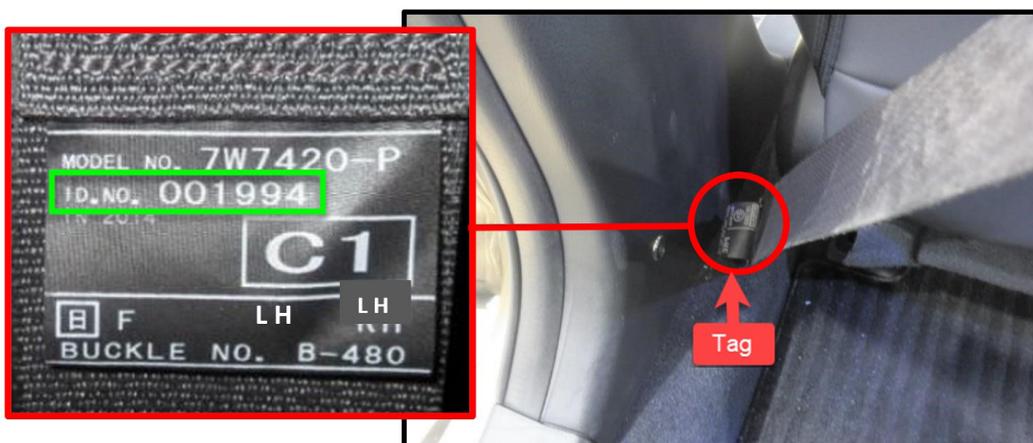
STEP 1: Locate the large tag located on the left front seat belt. Read the 6-digit identification number labeled “ID.NO.” If the number found is **373736**, the seat belt **MUST** be replaced. A non-affected identification number (001994) is shown in the example image below.

Is identification number **373736** found printed on the tag?

YES – Proceed to **STEP 2**.

NO – The seatbelt is not affected. The procedure is finished.
