Technical product information

Topic	Creaking noise from the front suspension when manoeuvring
Market area	Bentley: worldwide (2WBE)
Brand	Bentley
Transaction No.	2048616/10
Level	EH
Status	Approval
Release date

Bentayga series

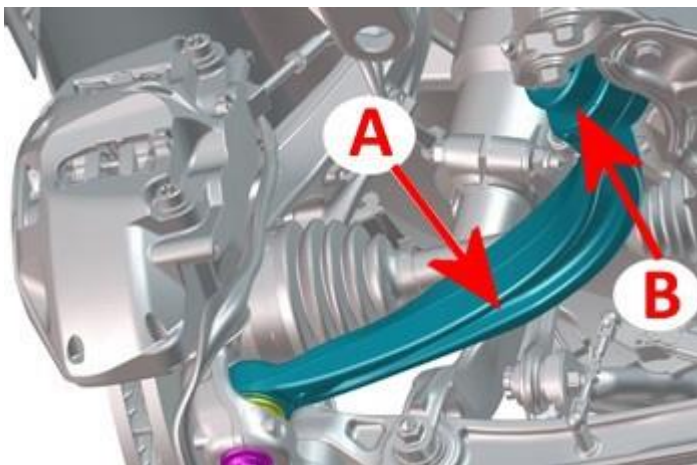
The noise present in the sound file is caused by defective Lower suspension lever - Rear - Hydraulic mounts. In order to reproduce the noise this bush must be twisted, therefore the noise can appear in the following circumstances

Figure 1 shows for example the left hand front rearmost lower suspension lever (A) the hydraulic mount which must be changed is located at (B)

1) Replace the right hand front and left hand front rearmost lower suspension lever inner hydraulic mounts - Refer to Repair manual Rep.Gr.40 front suspension, lower suspension lever bushes – to remove and fit

NOTE: Ensure the right and left hand side hydraulic mounts are replaced
