Technical Service Bulletin

DOOR OUTER HANDLE TOUCH SENSOR DOES NOT WORK (LOCK AND/OR UNLOCK)

Bulletin No.: 09-019/22

2019-2022 Mazda3 (Japan built) with VINS lower than JM1BP*****500020 (produced before November 3, 2021) 2019-2022 Mazda3 (Mexico built)

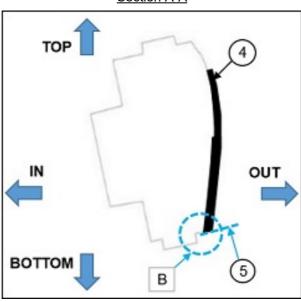
Section A-A

- (2) 2 inches (55mm)
- (3) 0.63inch (16mm)
- (4) Butyl tape: 1/16inch (1.5mm) thickness

3. If rubber sheet is installed, remove the rubber sheet (1) from the sensor and then apply the butyl tape (4), aligning the bottom edge (5) of the butyl tape (4) to the edge of the sensor.

- · Location and size of the applying area are as follows.
- Peel off the release paper on the butyl tape just before assembling to the front outer handle.
- DO NOT let the butyl tape stick out beyond the edge (6).
- DO NOT leave a gap (7).

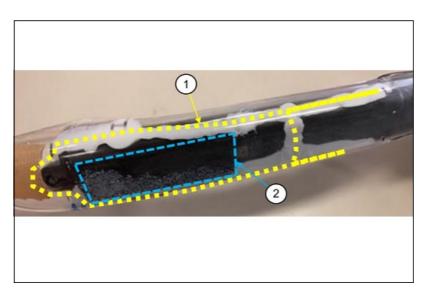
- (1) Image of the adhesive application location
- (2) Butyl tape
- 10. Verify repair.

- (1) Verify the wires are not outside the grooves
- 8. Fill the adhesive from the back of the outer cover.
- 9. Let the adhesive dry for 2 hours, keeping the position of the outer cover so that the adhesive on the back of it does not drip.
