Technical product information

Topic	EPB Warning light in DIP - Front door/s power latch system intermittent - DTC U112300 within Address 03 and Address 46
Market area	Bentley: worldwide (2WBE)
Brand	Bentley
Transaction No.	2055883/2
Level	EH
Status	Released for publishing
Release date	02-Nov-2022

Bentayga

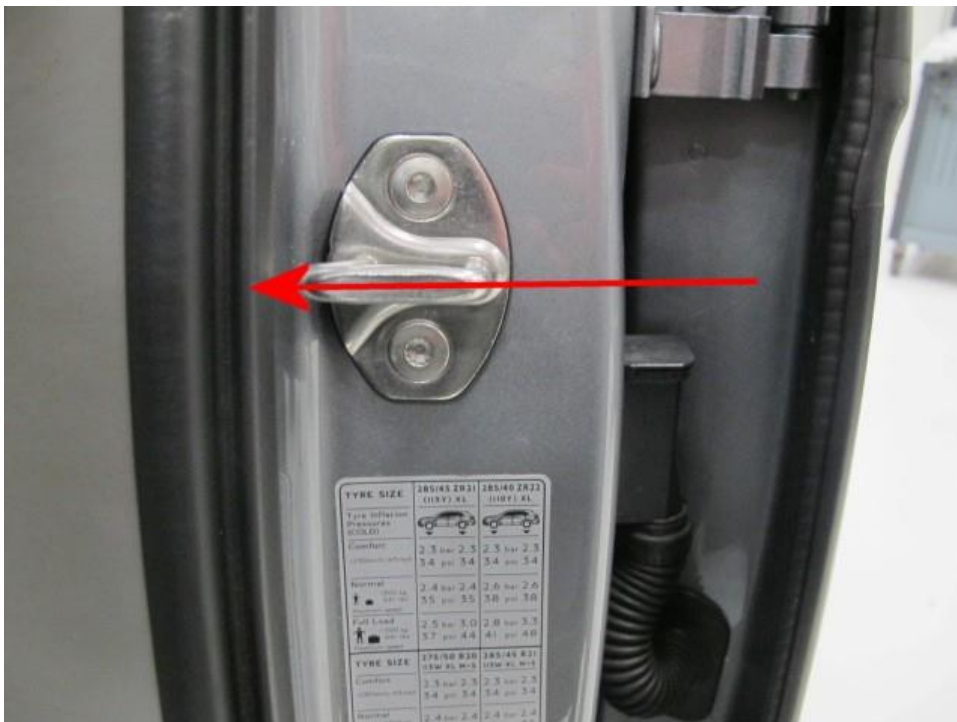
Figure 1

The micro switch signal of the door lock is not recognised or too briefly

A counter-pressure of the door is required to clearly recognise the signal

- 1) Check whether the striker runs into the centre of the rotary latch of the door lock and correct it if necessary - Refer to Rep.Gr 57 - Door striker - To remove and fit

In addition, adjust the striker as far as possible (at least 0.5 mm) further inwards (Figure 1)
