**SERVICE BULLETIN**

**APPLICABILITY:** 2019-**23**MY Impreza  
 2019-**23**MY Crosstrek (Including Hybrid Model)  
 2019-**23**MY Forester  
 2019MY Legacy/ Outback  
 2019-21MY WRX  
 2019-21MY WRX STI  
 2019-21MY BRZ- Navigation -equipped ONLY  
 2019-22MY Ascent

**NUMBER:** 15-236-18R

**SUBJECT:** Reprogramming File Availability for Optimization of Harman Gen 3.1 and Gen 3.1α Audio and Navigation Head Units

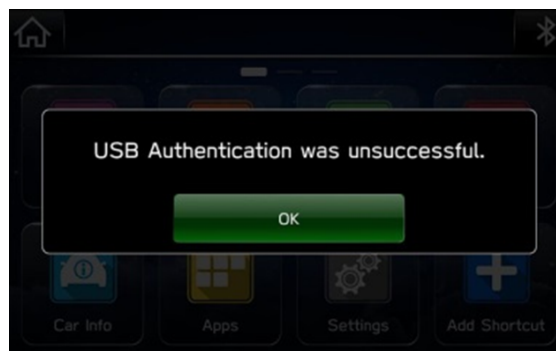
**NOTE:** If an attempt is made to install the wrong “grade” file into the wrong grade head unit (EXAMPLE: “Base” update file into a “Base Plus or Mid” or “High” head unit), the USB Authentication error screen below will be displayed:

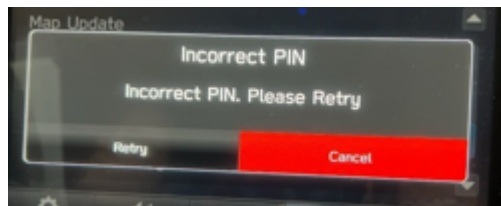
- 8) Repair Facility POI icons are now shown on the NAVI map display. See **NOTE 4** below.
- 9) **Activation Code Not Accepted by Navigation System when updating Map Data**

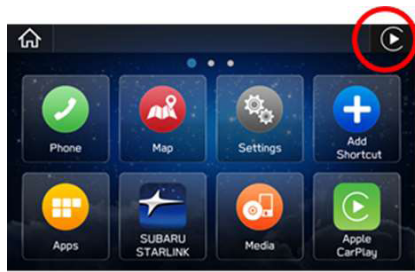
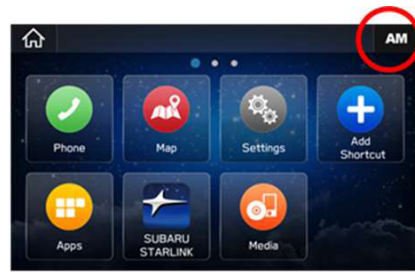
**On Ver. 6.0 and before:**

Music playing via iPhone in CarPlay.

After disconnecting, the music source changes to Radio automatically.

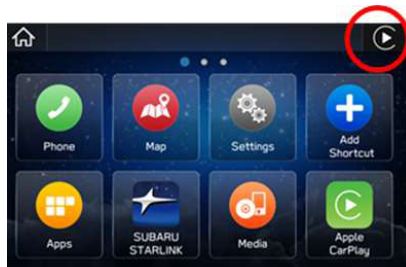
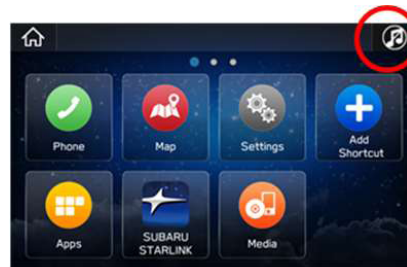
Music playing via iPhone in CarPlay.

After disconnecting, no music source is selected automatically.

If a source of music other than CarPlay has been playing when the iPhone is disconnected, the music source remains same (it is not turned off.)

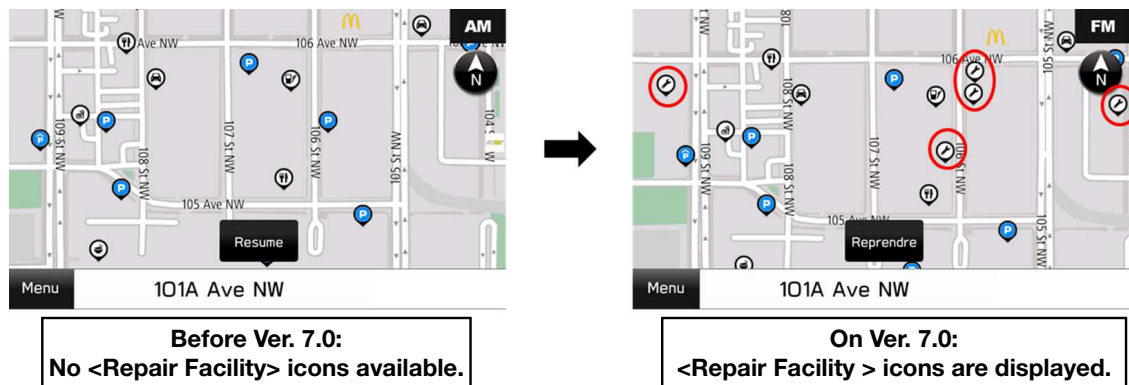
## NOTE 4: Displaying Repair Facility POI icons:

<Repair Facility> Icons can be displayed in the NAVI Map.

<Repair Facility> Icons can be turned On or OFF by going to: Settings > Navigation > POI Icons.

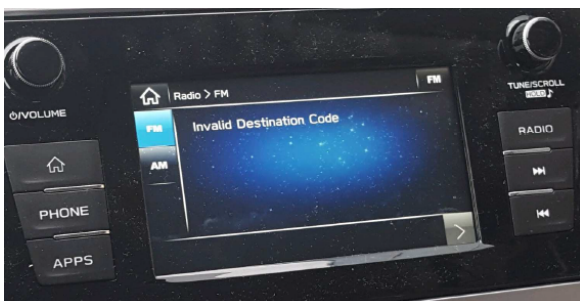
- 3) US State names corrected when using voice guidance.
- 4) Correction made for Pop / Crackling-type sound when using AM radio.
- 5) Navigation system freezes during loading / start-up.
- 6) Music skips/cuts out while using Apple CarPlay.
- 7) Hands-free feature freezes intermittently while loading.
- 8) Navigation system freezes after entering a particular address using Voice Recognition.  
**NOTE:** All other functions are not affected.
- 9) The voice guidance volume no longer changes After Ignition Off/On. Once the Voice Guidance has been muted, the system retains that setting even after switching the ignition Off/On.
- 10) Invalid Destination Code message appears on the display while listening to the radio.

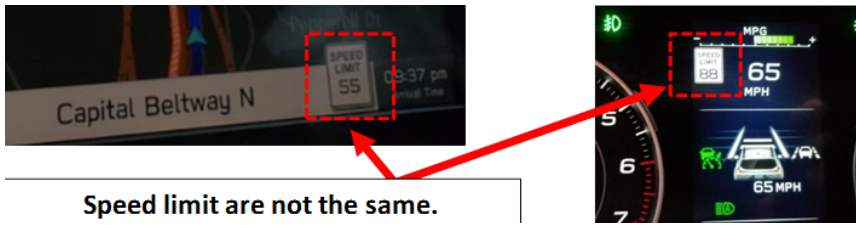
12) Mismatch of Speed Limit between Navigation display and the Speed Limit displayed in the Combination Meter Multi-Function Display (MFD).
