SERVICE BULLETIN

APPLICABILITY: 2019-21MY Forester

NUMBER: 03-89-22R

SUBJECT: DTC B280B VDC Brake Fluid Pressure

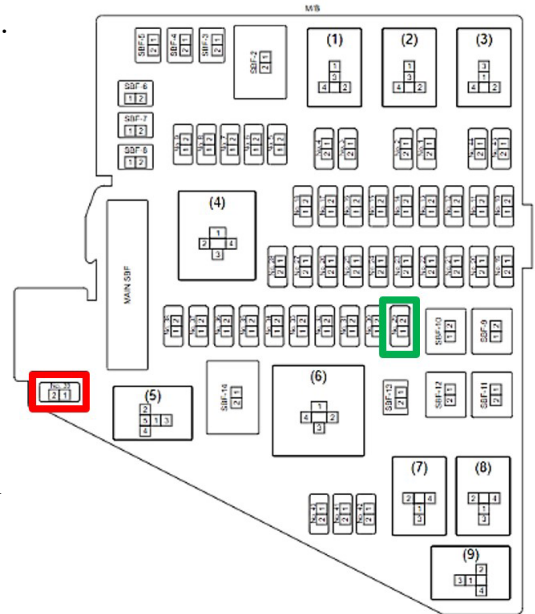
After reprogramming the VDC system, the Auto Headlight Leveler Control will be in the fail-safe status. Follow the procedure outlined below for proper initialization. If this procedure is not followed, the steering responsive headlights and headlamp leveling features may become temporarily unavailable.

- A. Confirm the vehicle is parked on a flat and level surface.
- B. Turn the ignition switch to the “OFF” position.
- C. Remove the 30 Amp transport fuse from the #29 (GREEN) position of the main fuse box located under the hood.
- D. Insert the removed fuse into the #39 (RED) position and switch the ignition switch to the “ON” position.
- E. Wait at least three seconds, then turn the ignition switch to the “OFF” position.
- F. Return the fuse to the original position (#29).
- G. Start the engine and run for at least three seconds. Using the Subaru Select Monitor (SSM), clear any fault codes that might have been set during the procedures listed above.
- H. Perform a function test of ALL the operations of the headlight system.
