**SERVICE BULLETIN**

**APPLICABILITY:** 23MY Outback/Legacy Models **NUMBER:** 15-305-22  
**SUBJECT:** Reprogramming File Availability for Optimization of Gen 4 Denso CP1.5 Infotainment Systems **DATE:** 11/30/22

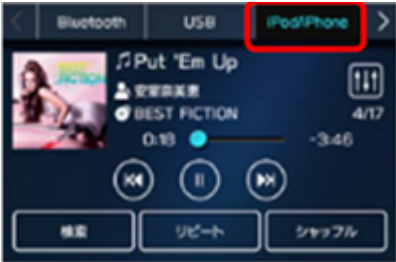
Number	Symptoms to be Improved:
1	<p>iPod/iPhone tab in Media screen cannot be selected, when connected by USB.</p> <p>The symptom occurs when the iPhone is connected to CP1.5 via Bluetooth in parallel to USB connection by error. (It is supposed to be connected either via Bluetooth or by USB.)</p>

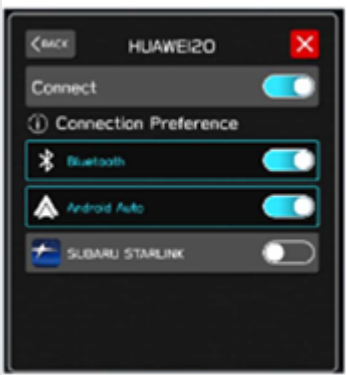
2	<p>On the “Manage Devices” screen Bluetooth cannot be selected as connection preference.</p>

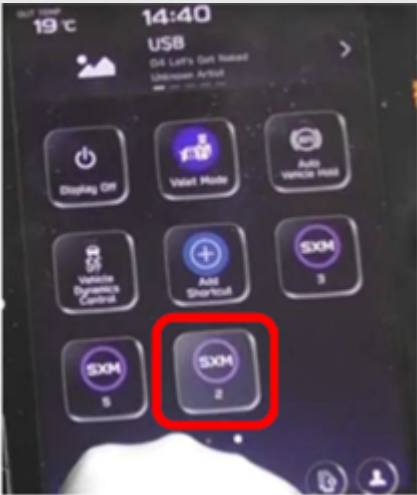
Number	Symptoms to be Improved:
5	Cannot pair Bluetooth device, when Bluetooth device has long name including symbols.
6	<p>SXM station shortcut created by the customer does not work when the SXM has not been used as audio source after the Ignition Switch was turned on in the ignition cycle.</p>

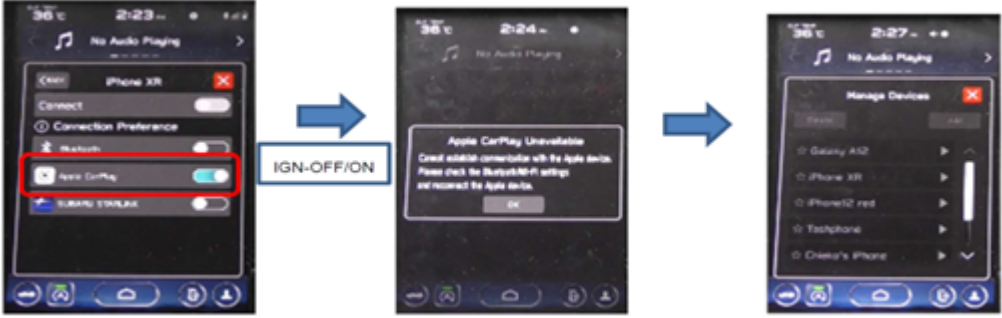
7	<p>Manage Device Screen becomes dark and inoperative when Ignition Switch is turned Off and On while starting CarPlay by CID operation.</p>

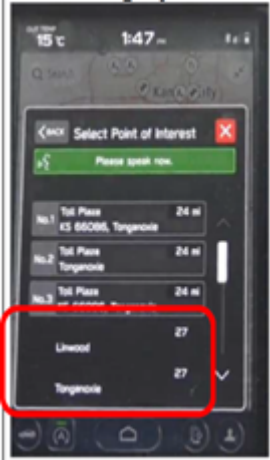
Number	Symptoms to be Improved:
9	<p>POI Search Result shows only city names and distances (without unit) when voice recognition POI search with Category name like “Find toll gate” is used.</p>

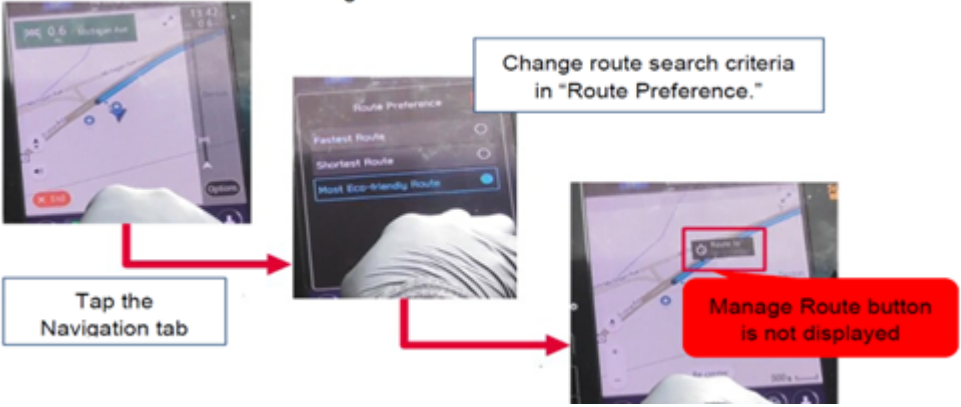
10	<p>Navigation restarts itself, when the letters are rashly entered or deleted using keyboard function to search destination.</p>
11	<p>“Manage Route” button is not displayed when touching the route line on Navigation system, when the route search criteria got changed in the Route Preference Screen after a route had been searched.</p>

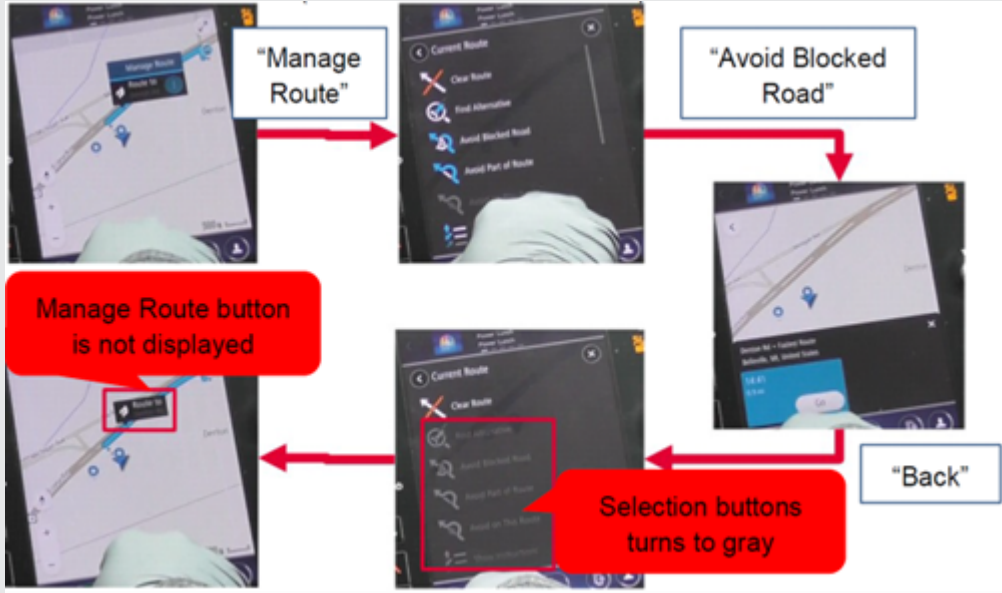
Number	Symptoms to be Improved:
12	<p>“Manage Route” button is not displayed and buttons on the Current Route Screen become unselectable (turns to grayish fill) when the Navigation system is operated in the sequence of “Manage Route” &gt; “Avoid Blocked Road” (in the Current Route Screen) &gt; “Back.”</p>
