Technical product information

Topic	Bentayga Hybrid - Emission control system warning lamp illuminated within the DIP - Open circuit DTC's evident
Market area	Russische Föderation (5RU),Australia E04 Bentley rest Asia and Australia (6E04),China 796 VW Import Comp. Ltd (Vico), Beijing (6796),Germany E02 Bentley rest Europe (6E02),Japan E03 Bentley Japan (6E03),Korea, (South) E08 Bentley South Korea (6E08),United Arab Emirates E06 Bentley Middle East and Africa (6E06),United Kingdom E01 Bentley UK (6E01),United States E05 Bentley USA and rest America (6E05)
Brand	Bentley
Transaction No.	2065697/2
Level	EH
Status	Released for publishing
Release date	03-Nov-2022

Bentayga - Hybrid

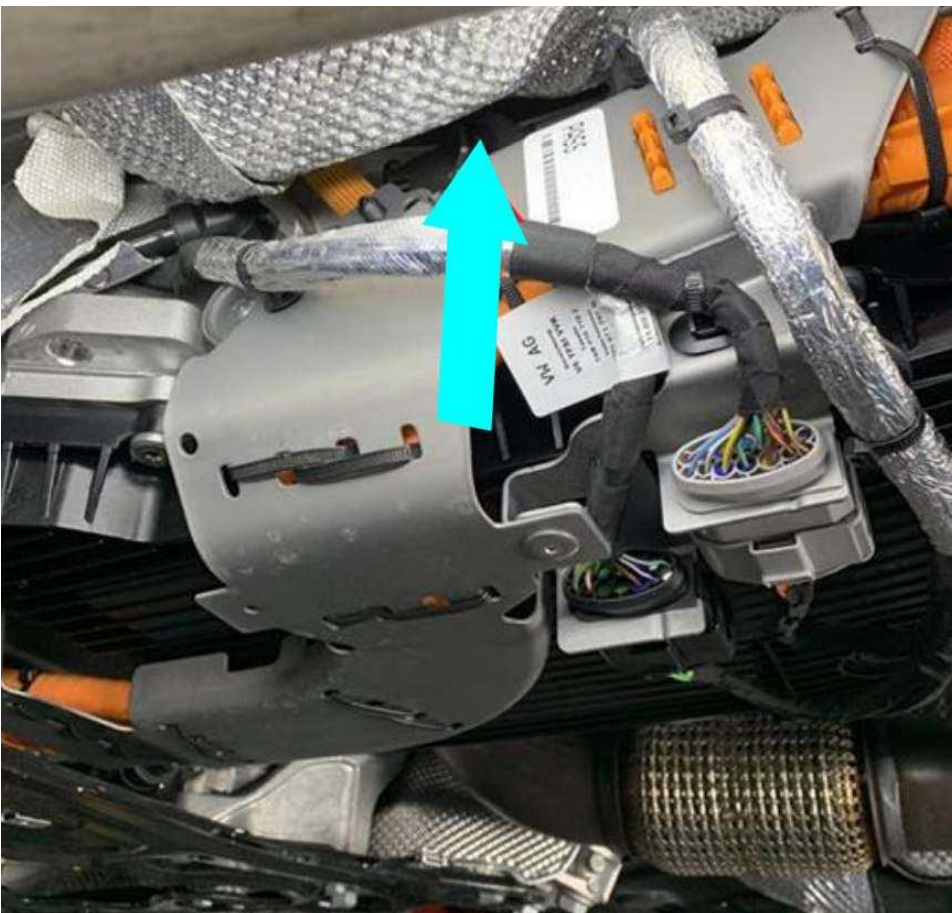
- The operative should identify the location shown in Figure 2 (Left hand side of Transmission)

- Referring back to the fitting location in Figure 2 - Reposition/secure the wiring harness ensuring the wiring harness cannot chaff/contact any of the surrounding components

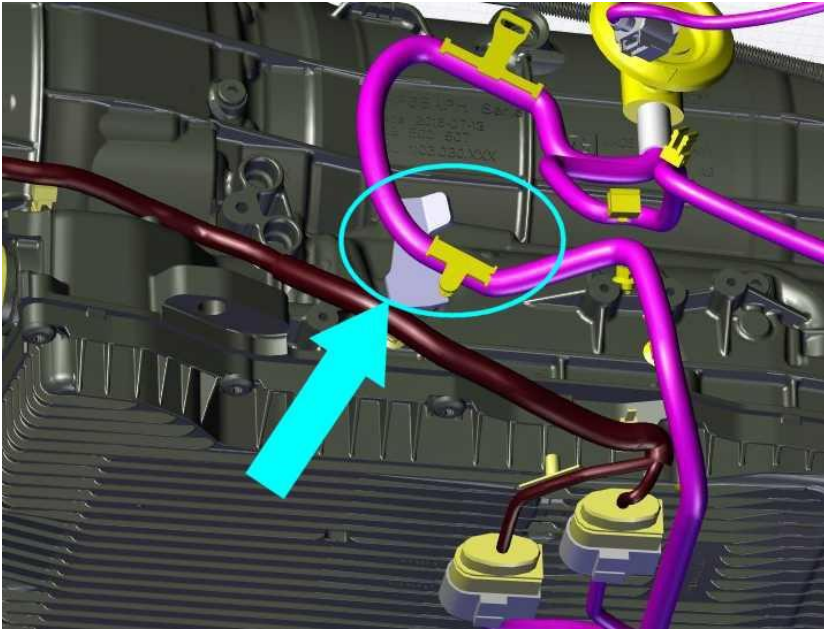
Figure 3

TIP: Referring to Figures 3 and 4 - Consider contact/chaffing between the main body harness and the following components:

- Transmission outer casing webbing
- Floorpanel
- Transmission park lock mechanism

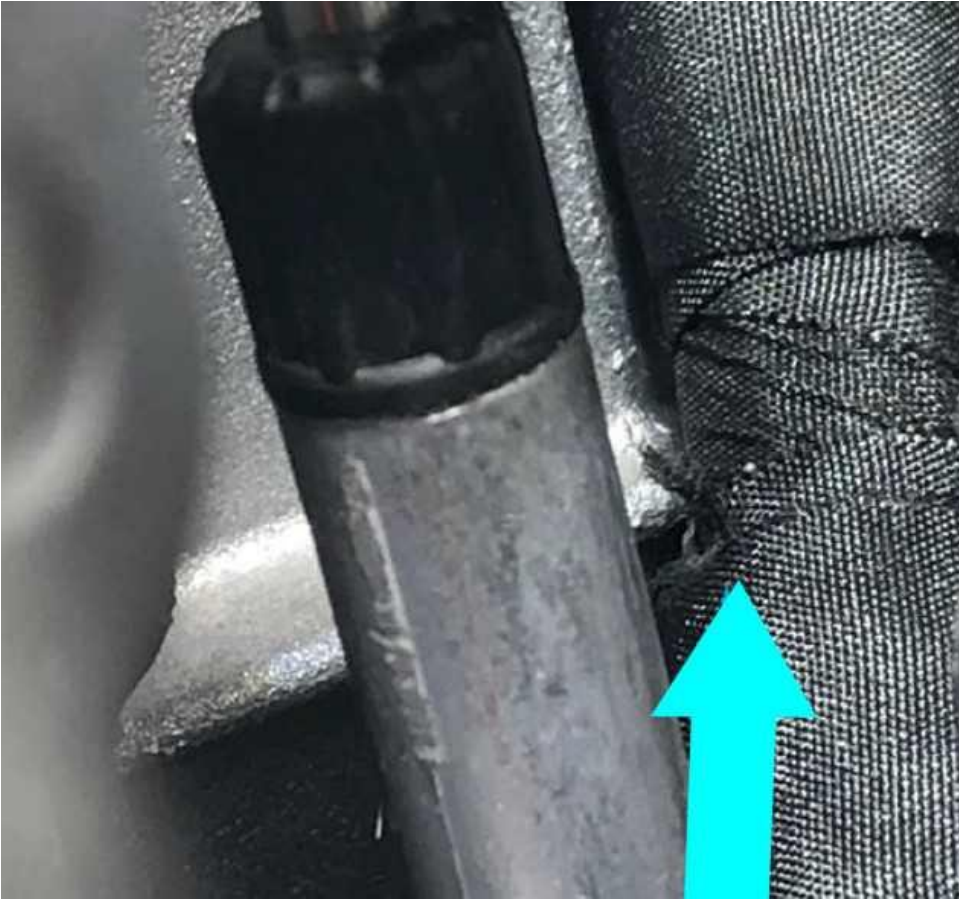
Figure 5

- The actual symptom(s) may be different than described depending on the wire(s) which are damaged/chaffed - Refer to the examples as shown in Figures 5,6 and 7

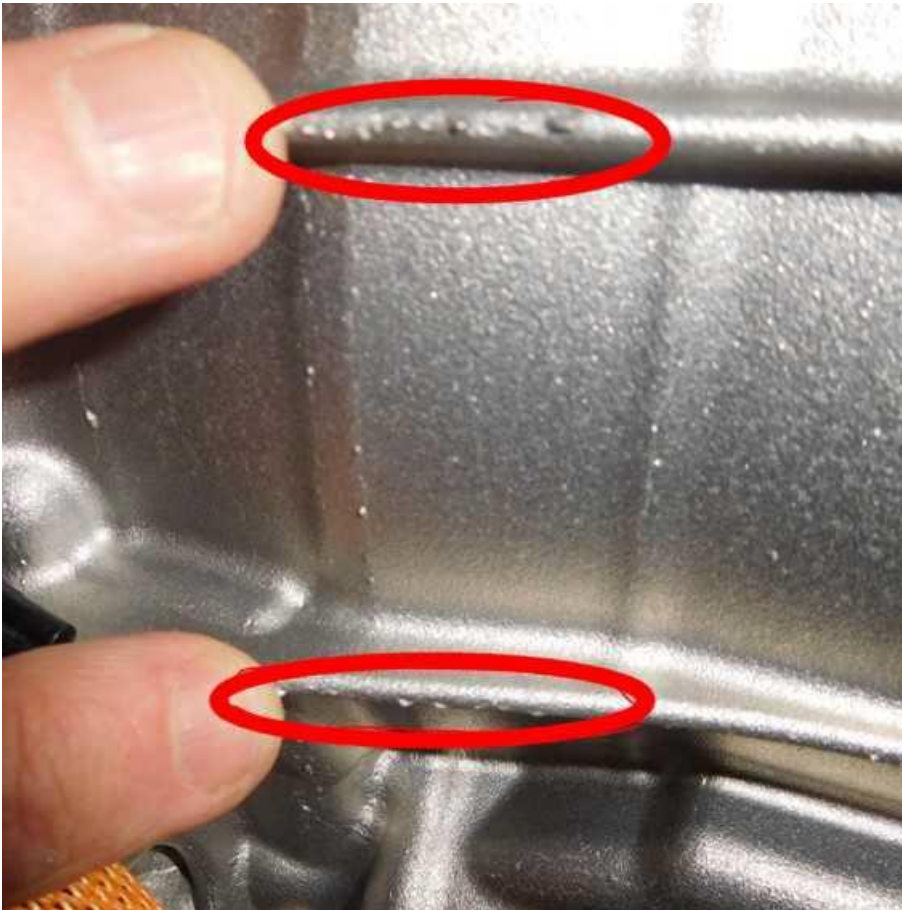
Figure 8

IMPORTANT: Check to confirm the actual point of contact for example: The transmission outer casing webbing (Figure 8)

- In the event that any sharp edges or excess casting spots are evident, the operative should carefully remove any sharp edges with low grade sandpaper for example
