Technical product information

Topic	Fuel pressure regulator - DTC P242200 with symptom code 14536 evident within address 0001
Market area	Russische Föderation (5RU),Australia E04 Bentley rest Asia and Australia (6E04),China 796 VW Import Comp. Ltd (Vico), Beijing (6796),Germany E02 Bentley rest Europe (6E02),Japan E03 Bentley Japan (6E03),Korea, (South) E08 Bentley South Korea (6E08),United Arab Emirates E06 Bentley Middle East and Africa (6E06),United Kingdom E01 Bentley UK (6E01),United States E05 Bentley USA and rest America (6E05)
Brand	Bentley
Transaction No.	2065926/2
Level	EH
Status	Released for publishing
Release date	03-Nov-2022

Bentayga Hybrid

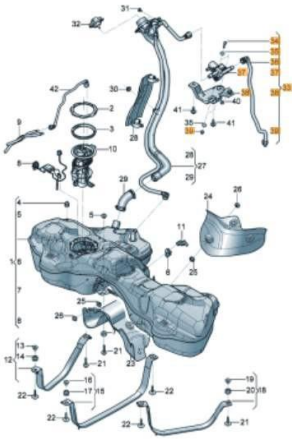
4M0 201 549A - Pressure regulator assembly and associated parts as shown below

▶ 33	4M0 201 549 A	pressure regulator	
34		Oval hexagon socket head bolt	M6X30 Included in position: 33
35		Washer	M6 Included in position: 33
36		Breather line	Included in position: 33
37		pressure regulator	Included in position: 33
38		Bracket	Included in position: 33
39		Hexagon collar nut self-locking	M6 Included in position: 33

- 1) Referring to Rep.Gr20 - Replace the Pressure regulator assembly and associated components
- 2) Conduct a road test in EV Mode and/or Hybrid drive mode where possible
- 3) On return from road test - Check to confirm the issue is resolved and DTC P242200 is not evident within address 0001
