# Technical product information

<b>Topic</b>	DTC P04F000 EVAP system high pressure purge line performance DTC logged
<b>Market area</b>	China 796 VW Import Comp. Ltd (Vico), Beijing (6796),Korea, (South) E08 Bentley South Korea (6E08),United States E05 Bentley USA and rest America (6E05)
<b>Brand</b>	Bentley
<b>Transaction No.</b>	2058573/2
<b>Level</b>	EH
<b>Status</b>	Released for publishing
<b>Release date</b>	02-Nov-2022

## Bentayga Kovomo 4.0 TSI

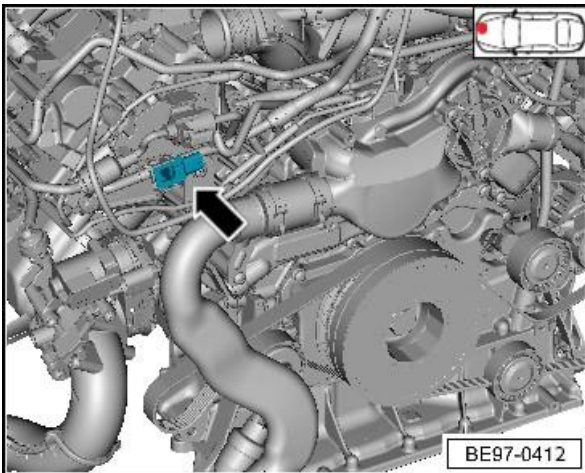
Figure 2

The DTC is related to mismatched terminal locations of the Pressure sensor for the activated charcoal filter system – G804 (Figure 2)

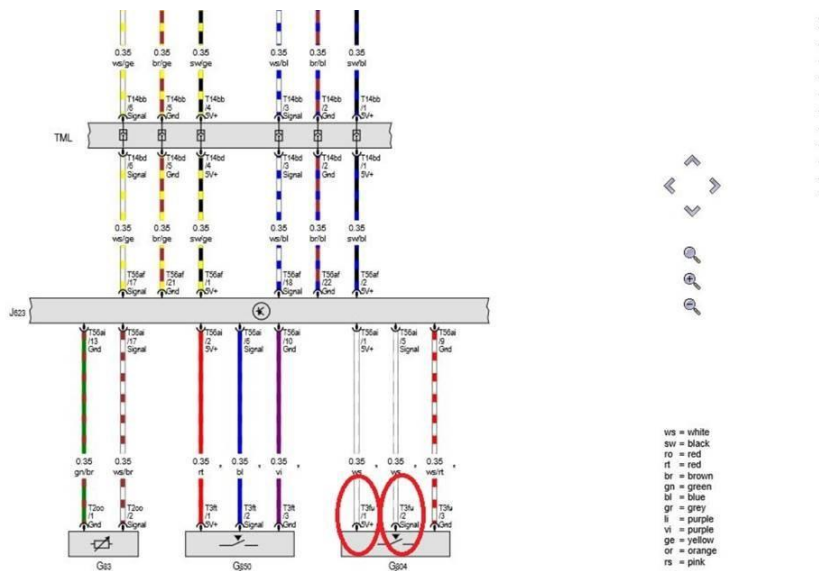
Figure 3

1) Refer to Wiring diagram 106/18 within Elsa pro (Figure 3)

2) Should the terminal locations NOT be as shown in Figure 3, the terminals should be reallocated within plug as per the wiring diagram

- Refer to Repair manual Rep.Gr 20 - Tank ventilation pressure sensors - To remove and fit to gain access to the sensor connection
- Reallocate the sensor terminals as per Elsa pro wiring diagram instruction
