# Technical Service Bulletin

## 68 Noises from the center console when in contact with the knee

68 22 40 2068592/1 November 17, 2022.

Model(s)	Year	VIN Range	Vehicle-Specific Equipment
e-tron quattro	2019 – 2023	All	Not Applicable
e-tron Sportback quattro	2021 – 2023		
e-tron S	2022 - 2023

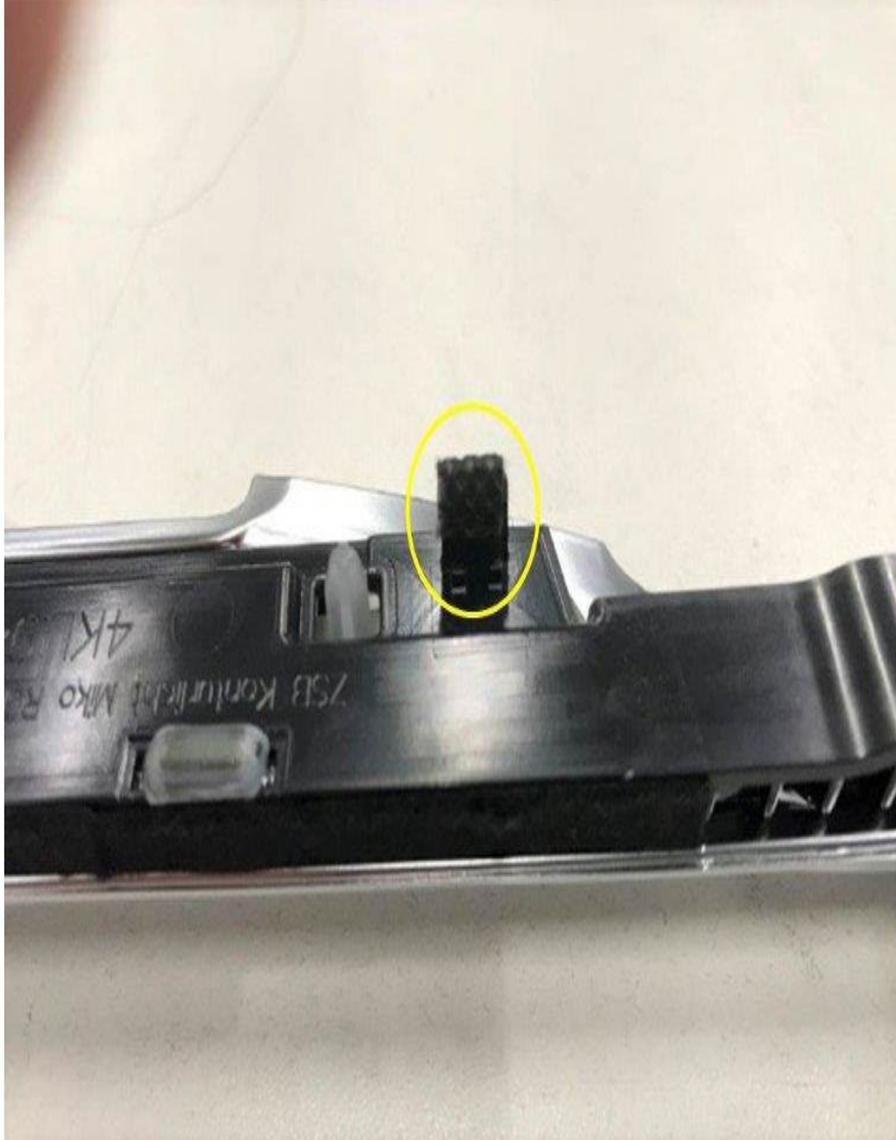
- Relative movement between trim/light bar and center console results in noises.

Relative movement between trim/light bar and center console results in noises.

**Figure 1.** Apply fleece adhesive tape (approx. 3/8" long, folded over).

1. Remove the center console decorative trim according to:  
*Elsa >> Repair manual >> Body >> Body Interior >> 68 Interior Equipment >> Center Console >> Center console Decorative Trim, Removing and Installing.*
2. Apply fleece adhesive tape to the trim/light bar as shown (figures 1, and 2).

3. Reinstall the center console decorative trim.
4. Verify the repair by applying pressure to the center console trim.

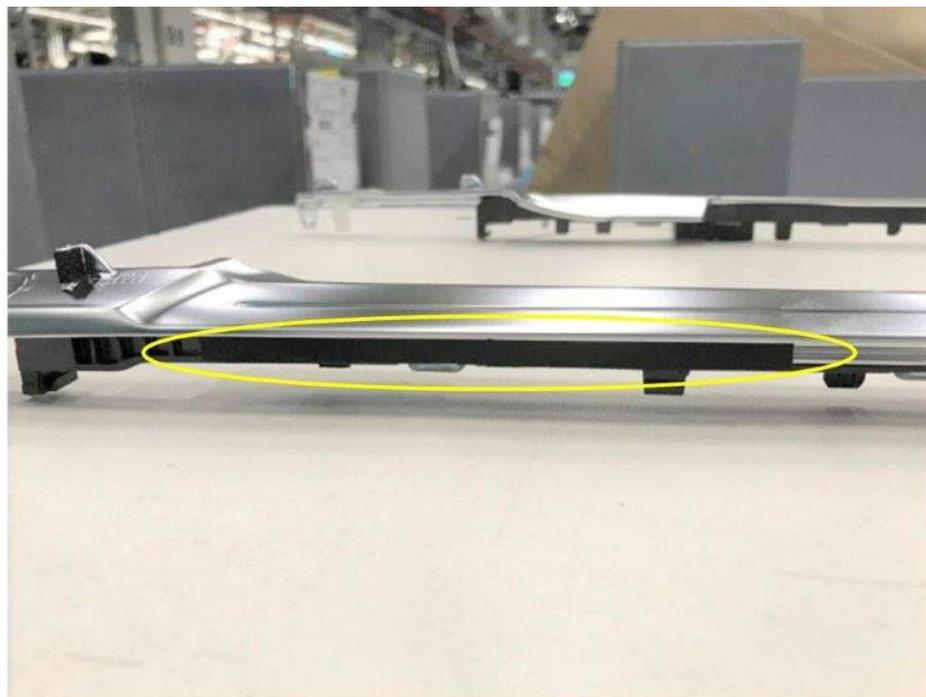
**Figure 2.** Apply a double layer of fleece adhesive tape (approx. 2 ½" long) to increase thickness.
