## SERVICE BULLETIN

**APPLICABILITY:** 2018-**23**MY Legacy and Outback  
 2017-**23**MY Impreza  
 2018-**23**MY Crosstrek  
 2019-**23**MY Forester  
 2019-**23**MY Ascent

**NUMBER:** 16-132-20R

**SUBJECT:** Diagnostic Information for Alleged Chain Slip Condition on TR580 / TR690 Transmissions

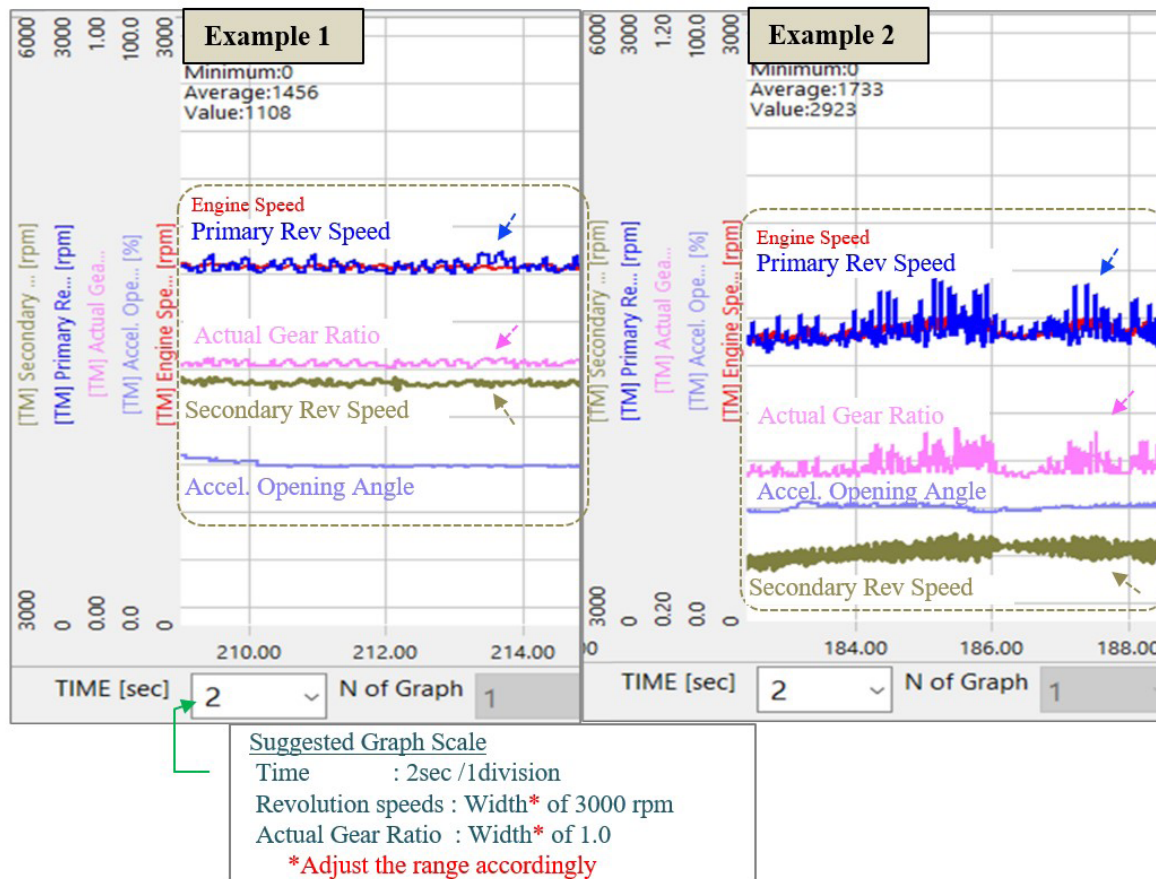
#### 1. Continuous Micro-Slip:

During a continuous micro-slip, while the Accelerator Opening Angle monitor displays a stable value for more than one second, there are fluctuations in the Actual Gear Ratio monitor:

**Peak to Peak > 0.02**

**Frequency > 3 cycles per 1 second**

There are fluctuations in the Primary Rev Speed and/or Secondary Rev Speed monitor:

**Peak to Peak > 50 rpm**

Below are two examples of the data monitoring during Continuous Micro-Slip

Using Subaru Select Monitor (SSM), check and record data monitors and compare to the three examples listed below. If the recorded data from the vehicle matches the examples below, the CVT will require replacement. The SSM data will be required for claim submission. A QMR containing the same information will also be required.

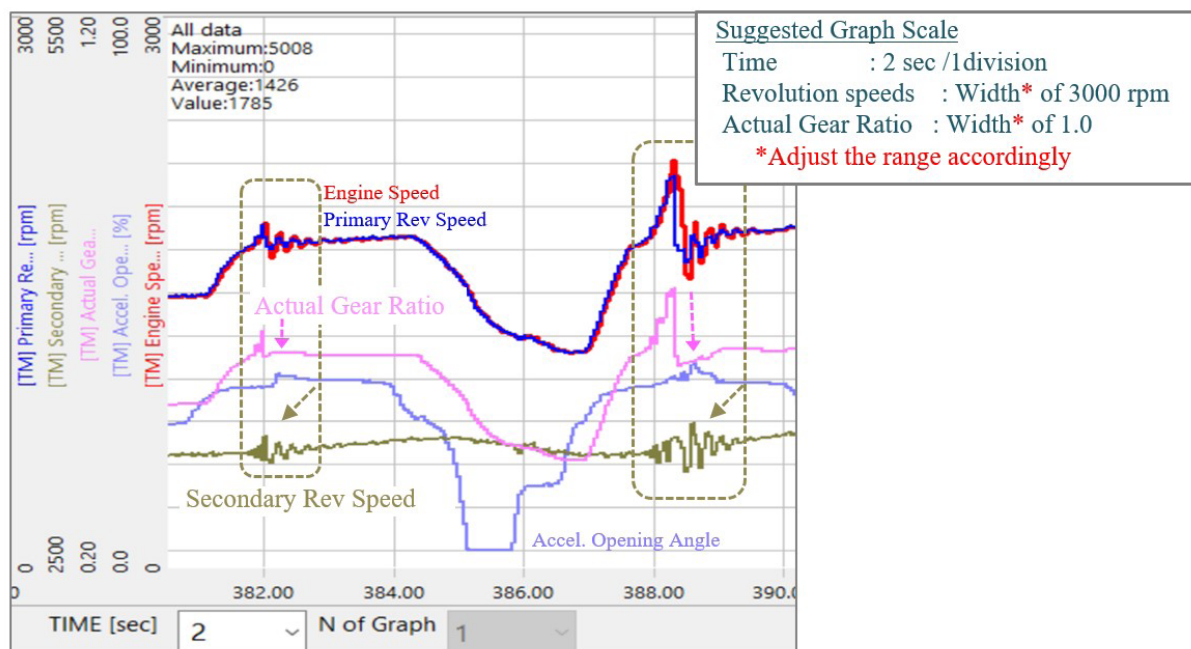
## 2. Short-Time Slip:

When a short-time slip occurs, the changes in the Actual Gear Ratio monitor will be larger than 0.1 per 0.1 second. After the Actual Gear Ratio monitor resumes to stable conditions, distinct fluctuations in revolution speed continues.

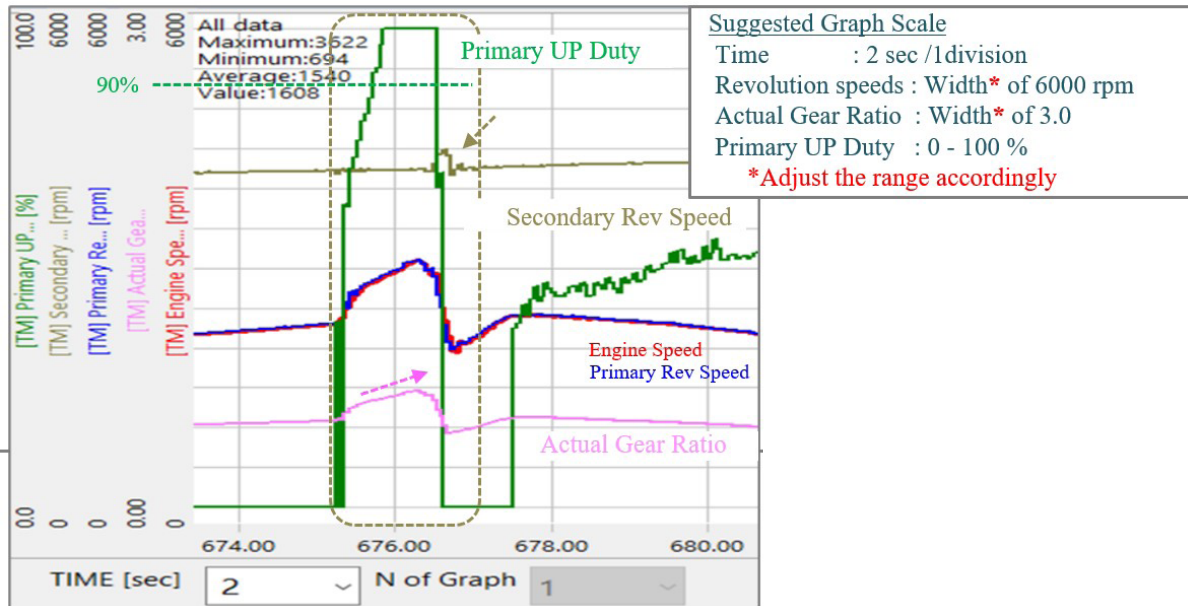
### 3. Long-Time Slip:

When a long-time slip occurs, the Primary UP Duty monitor will be larger than 90% and the Actual Pulley Ratio monitor lowers for a duration of 0.5 seconds or more. Even after the Actual Gear Ratio monitor resumes to stable conditions, distinct fluctuations in revolution speed continues.

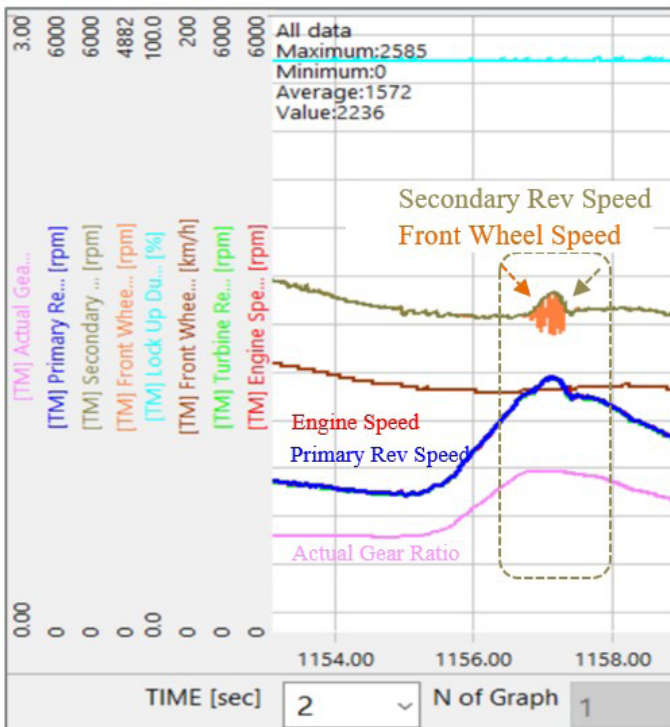
Example for  
2.4L Turbo or 3.6L NA **equipped** vehicles

#### 1. Forward Clutch Slip Shock:

The rotation speeds for the upstream and downstream sides of the forward clutch do not synchronize when driving.

Upstream side of the forward clutch-  
Secondary Rev Speed

Downstream side of the forward clutch-  
Front Wheel Speed

This shock can occur when the forward clutch slips. If this situation is reported, reprogram the TCM with new software if it is available. If there is no new software available or the reprogramming does not remedy the issue, report the situation to Techline.

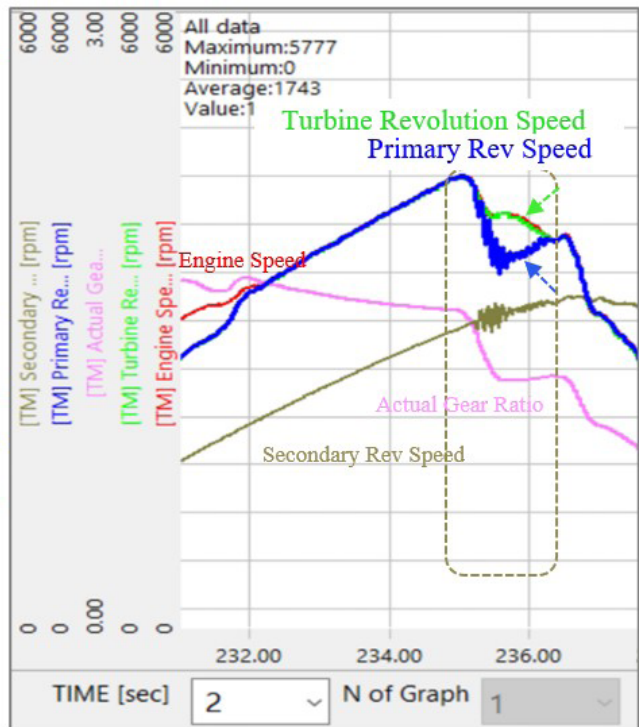
Example for **vehicles WITHOUT**  
2.4L Turbo or 3.6L NA

Upstream side of the forward clutch-  
Turbine Revolution Speed

Downstream side of the forward clutch-  
Primary Rev Speed

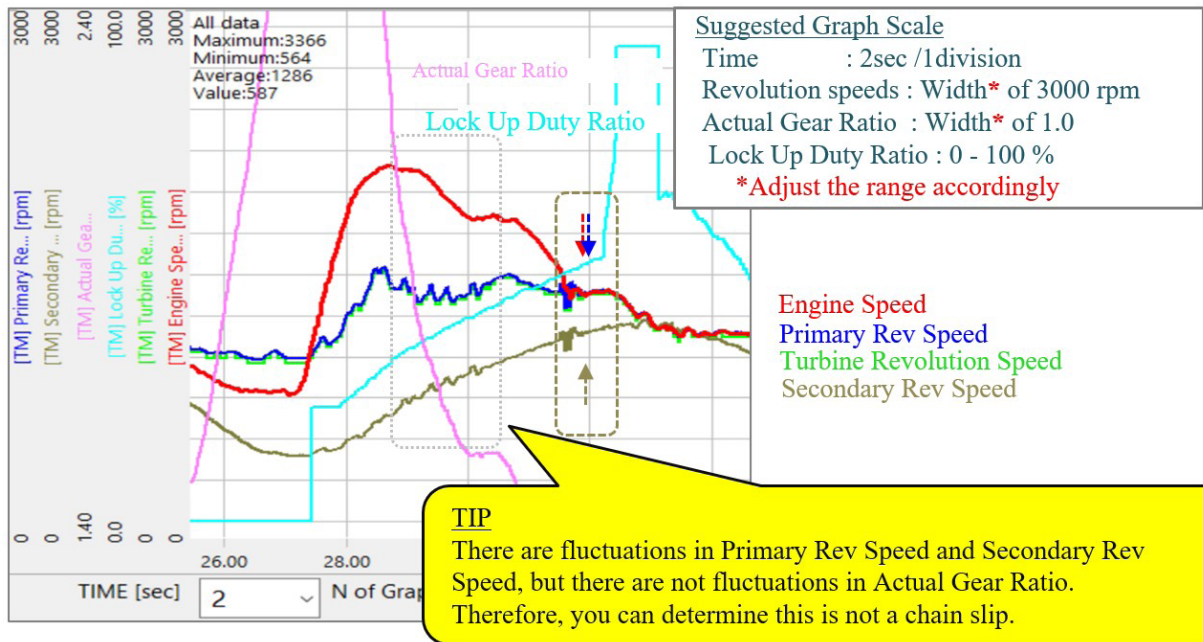
## 2. Lock Up Clutch Engagement Shock:

This shock can occur when the lock up clutch engages rapidly. If this situation is reported, reprogram the TCM with new software if it is available. If there is no new software available or the reprogramming does not remedy the issue, report the situation to Techline.

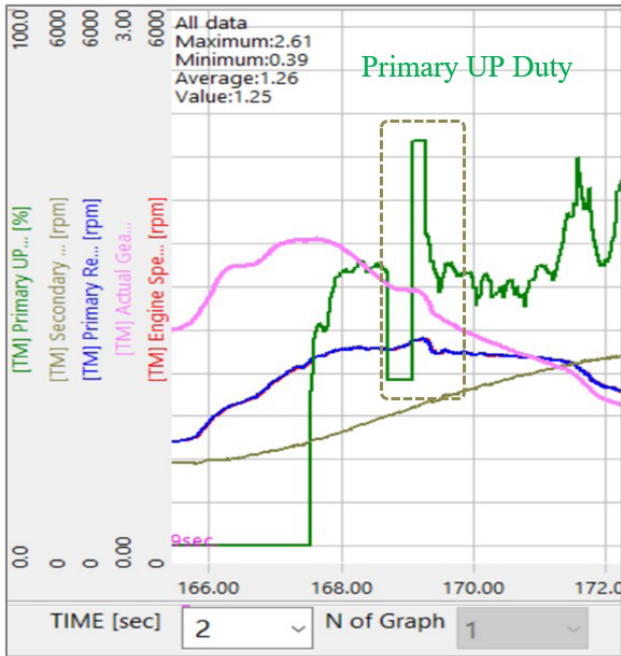
#### 4. Primary Up Duty Square Control (Ascent Models up to 2021MY):

A harsh shift can be felt while driving. If this situation is reported, reprogram the TCM with new software if it is available. If there is no new software available or the reprogramming does not remedy the issue, report the situation to Techline.
