Technical Service Bulletin

Topic	Bentayga V8 Kovomo - DTC P310B00 with Symptom Code 2638 - Check Engine Lamp - Fuel Pressure Regulation
Market area	Bentley: worldwide (2WBE)
Brand	Bentley
Transaction No.	2058484/10
Level	EH
Status	Released for publishing
Release date	Nov 22, 2022

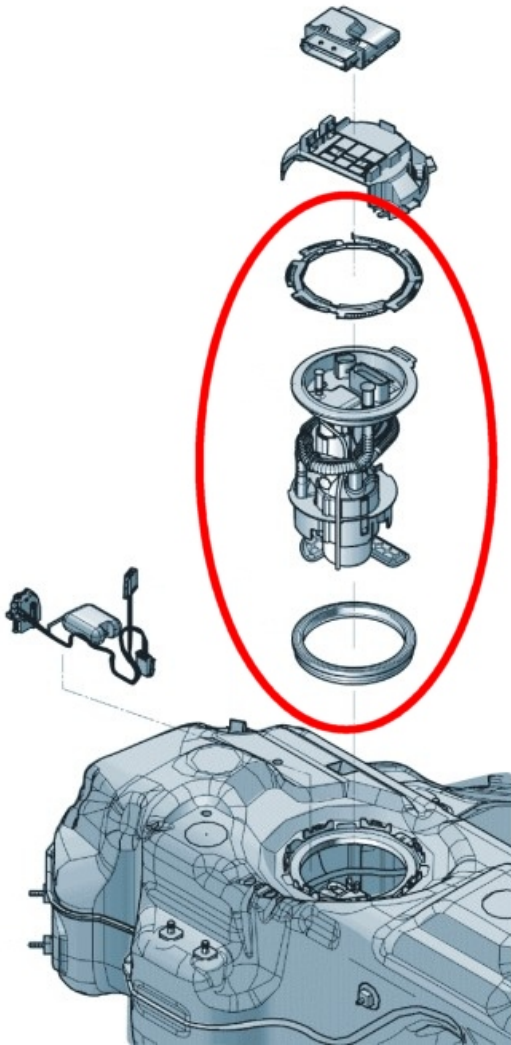
Figure 5

Engine warning lamp is illuminated within the Driver Instrument Panel (DIP) in conjunction with the DTC as detailed below:

- ***"P310B00 with symptom code 2638 - Low Fuel Pressure Regulation"***

11) In the event the value is between minus 100 to 200 kPa - the Fuel Delivery Module within the fuel tank (Figure 5) should be replaced - Refer

to Repair Group 20 Fuel supply, gas operation / 4.0L V8 TSI / Fuel pump, fuel level sensors, and jet pump (RH) - To remove and fit.
