Technical product information

Topic	V8 Kovomo - Engine MIL light on - DTC 'P04F000: EVAP system high pressure purge line performance' evident
Market area	Russische Föderation (5RU),Australia E04 Bentley rest Asia and Australia (6E04),China 796 VW Import Comp. Ltd (Vico), Beijing (6796),Germany E02 Bentley rest Europe (6E02),Japan E03 Bentley Japan (6E03),Korea, (South) E08 Bentley South Korea (6E08),United Arab Emirates E06 Bentley Middle East and Africa (6E06),United Kingdom E01 Bentley UK (6E01),United States E05 Bentley USA and rest America (6E05)
Brand	Bentley
Transaction No.	2065148/2
Level	EH
Status	Released for publishing
Release date	03-Nov-2022

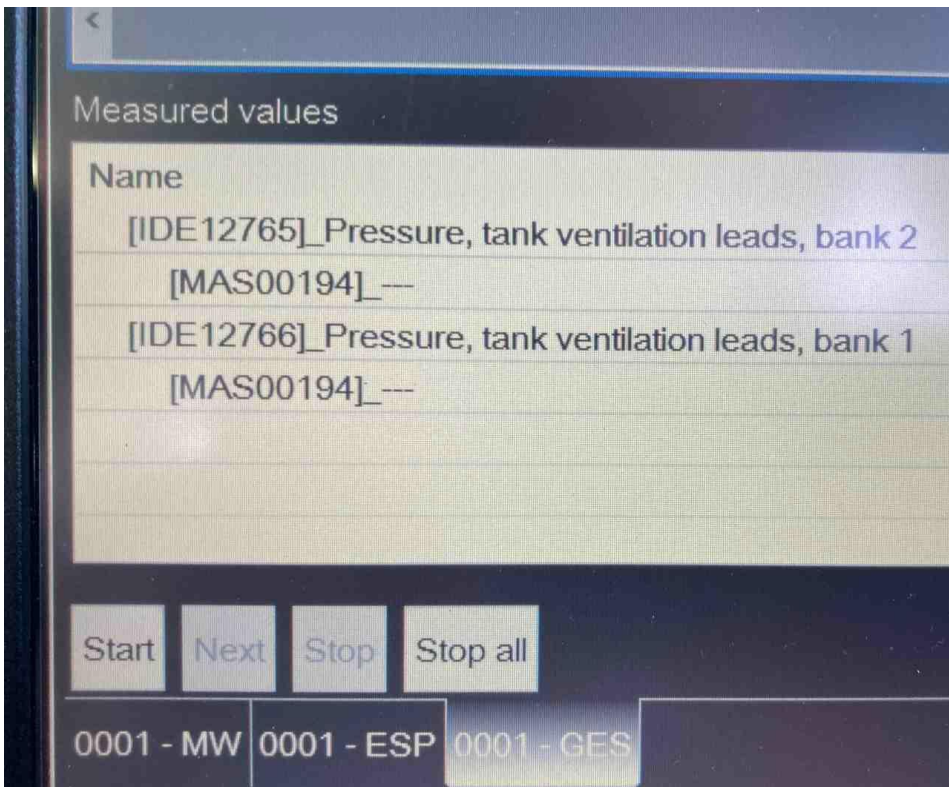
Figure 1

Observations when monitoring IDE12765 and IDE12766

IDE12765 (When monitored) fluctuates from the static value found (Ignition on/Engine Off) Or

With/without purge activation

However

IDE12766 (When monitored) DOES NOT fluctuate from the static value found (Ignition on/Engine Off) Or

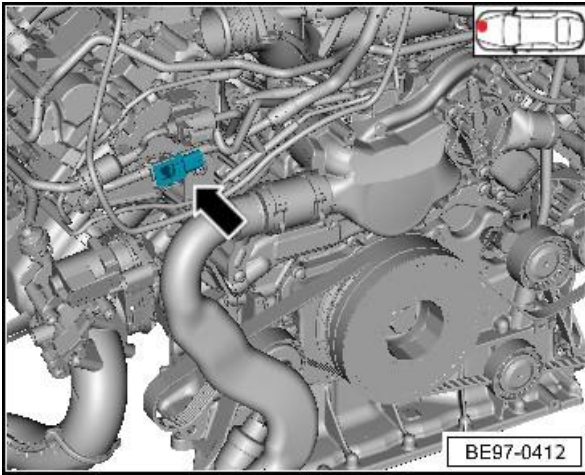
- Referring to Figure 2 - Locate the Pressure sensor connector (T3dd) for the activated charcoal filter system (G804)

- Disconnect T3dd
- Disconnect T56aj from the Engine control unit (J623)
- Referring to the applicable wiring diagram within in Elsa pro - Conduct a wiring integrity check

From T3dd (PIN's 1 and 2) - To Connector T56aj (PIN's 1 and 5)

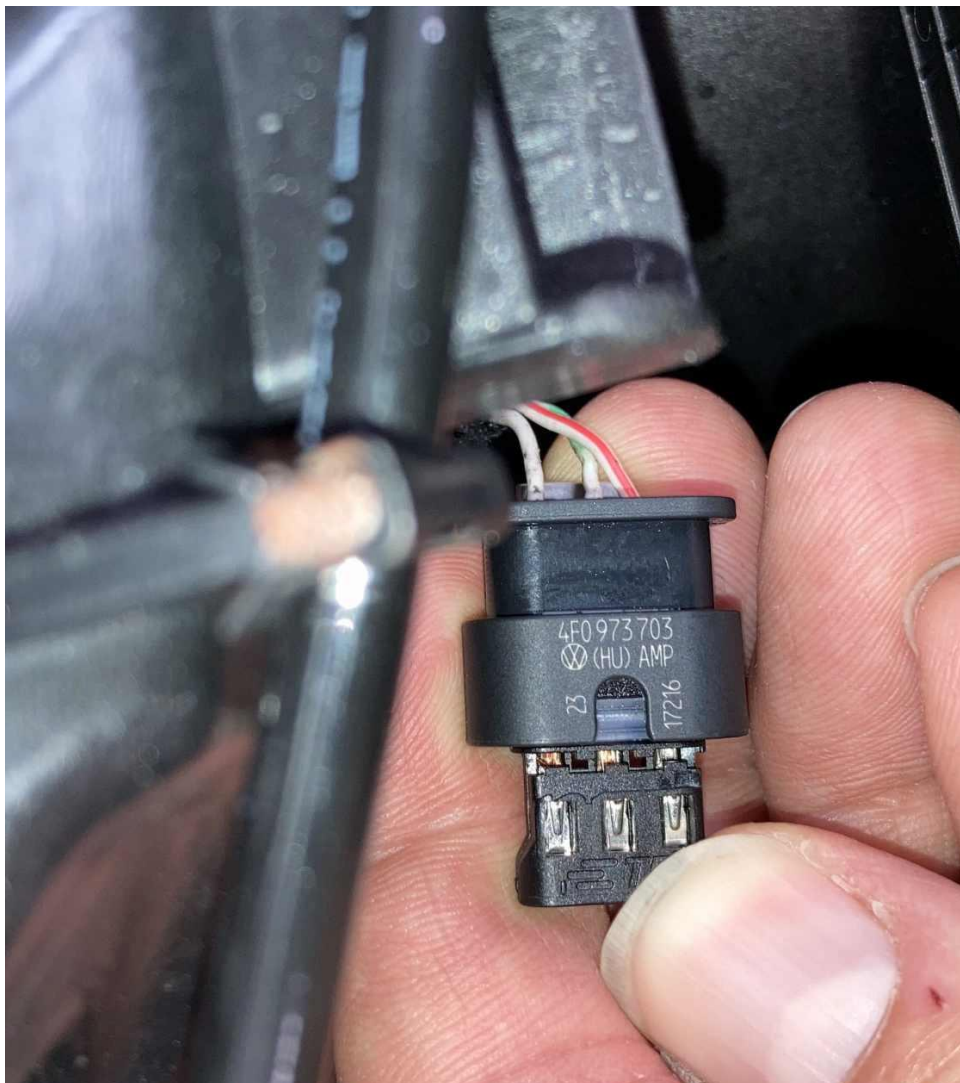
TIP: As both wires are white, the green line which can be seen on the central white wire was applied to aid the operative when swapping the PIN's to the correct locations

2) Referring to Figure 3 and the attached PDF instructions - De-pin/Remove PIN's 1 and 2 from connector T3dd

3) Install PIN2 into PIN 1

4) Install PIN 1 into PIN 2

5) Conduct a wiring integrity check from T3dd (PIN's 1 and 2) - To Connector T56aj (PIN's 1 and 5)
