Technical product information

Topic	Bentayga V8 Kovomo - Engine MIL light on - DTC "O2 Sensor Signals Swapped Bank 1 Sensor 2/ Bank 2 Sensor 2
Market area	China 796 VW Import Comp. Ltd (Vico), Beijing (6796),Korea, (South) E08 Bentley South Korea (6E08),United States E05 Bentley USA and rest America (6E05)
Brand	Bentley
Transaction No.	2065664/2
Level	EH
Status	Released for publishing
Release date	03-Nov-2022

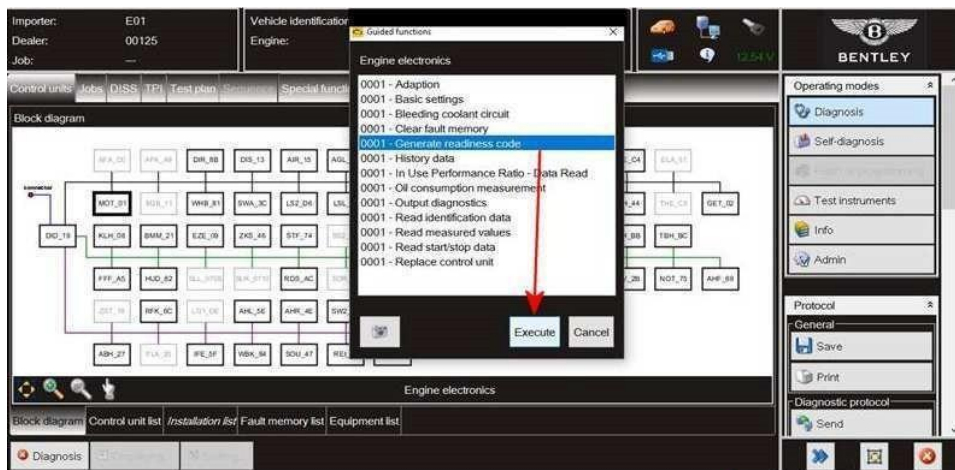
DTC P004100: "O2 Sensor Signals Swapped Bank 1 Sensor 2/ Bank 2 Sensor 2 is evident within address 0001 (Engine control unit) and MIL light active after attempting to conduct a readiness test

1) Run the engine basic setting routine - Select option 3.7 - Test for oxygen sensor interchange after catalytic converter

2) Immediately run the Readiness test as per the following instructions:

- Referring to Figure 1 - Select Guided functions from 01 - Engine Control Module 1
- Select Generate readiness code
- Select Execute and follow the readiness code procedure to completion as per all on screen prompts
