Technical product information

Topic	Bentayga V8 Kovomo - DTC P304300 with symptom code (10061) - Fuel Pump Mechanical Malfunction - MIL lamp
Market area	Russische Föderation (5RU),Australia E04 Bentley rest Asia and Australia (6E04),China 796 VW Import Comp. Ltd (Vico), Beijing (6796),Germany E02 Bentley rest Europe (6E02),Japan E03 Bentley Japan (6E03),Korea, (South) E08 Bentley South Korea (6E08),United Arab Emirates E06 Bentley Middle East and Africa (6E06),United Kingdom E01 Bentley UK (6E01),United States E05 Bentley USA and rest America (6E05)
Brand	Bentley
Transaction No.	2062092/2
Level	EH
Status	Released for publishing
Release date	02-Nov-2022

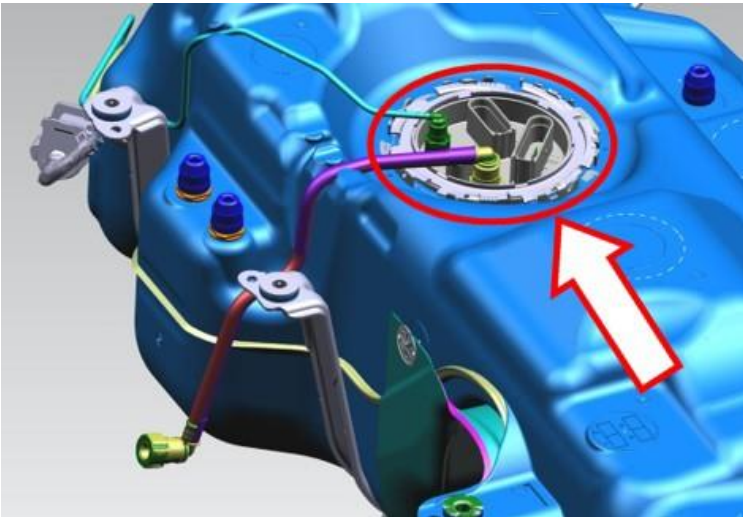
Figure 1

4) Conduct a visual inspection of the fuel pump delivery module (Top) for any obvious signs of damage (Figure 1)
