Subject: ELECTRICAL CONCERN AND/OR MULTIPLE DTC'S DUE TO AFTERMARKET DEVICE	Service Alert No.: SA-075/22
	Last Issued : 11/14/2022

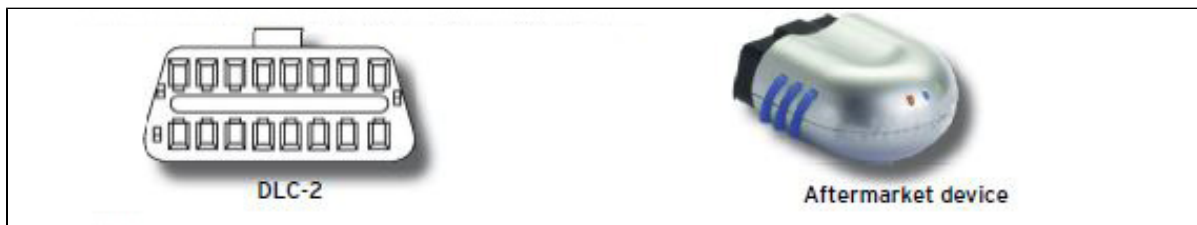
Example 1

Some electrical devices connected to the DLC-2 connector by insurance or mobile phone companies may cause:

- Battery discharge. The device may disrupt the CAN system battery saver mode.
- IDS/MMDS will not communicate with the vehicle due to poor DLC-2 connection. The aftermarket device may cause DLC-2 female terminals to spread open.
- DTCs
 - B1041:54 - ADAPTIVE FRONT LIGHTING SYSTEM (AFS) CONTROL MODULE
 - B108E:04 - CENTER DISPLAY INTERNAL MALFUNCTION
 - C0061:54 - DSC HU/CM
 - C1001:92 - FORWARD SENSING CAMERA (FSC)
 - C1001:97 - FORWARD SENSING CAMERA (FSC)
 - U300A:62 - ELECTRIC PARKING BRAKE (EPB)
 - U3004:17 - ACC RELAY CIRCUIT MALFUNCTION
 - U0415:00 - MAZDA RADAR CRUISE CONTROL (MRCC)/SMART BRAKE SUPPORT (SBS)
 - U0420:00 - MAZDA RADAR CRUISE CONTROL (MRCC)/SMART BRAKE SUPPORT (SBS)
 - Multiple DTC's (U0XXX:00 COMMUNICATION ERROR)

- If an aftermarket device is found connected to DLC-2, take a photo and attach it to the RO. Advise the customer to remove it.
- If you determine that no aftermarket devices have been installed, continue with normal MGSS diagnosis.

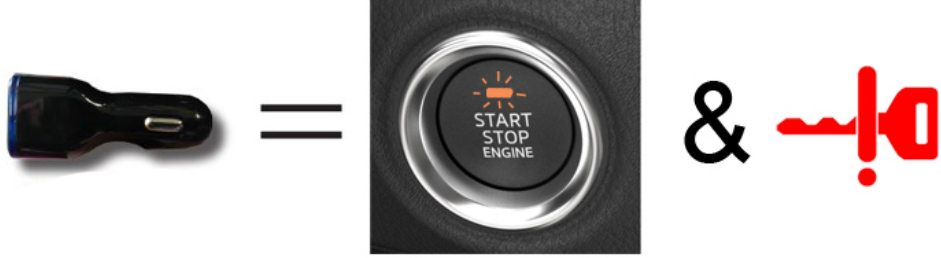
Some aftermarket cell phone chargers or accessories connected to the 12V outlet may cause issues with the START/STOP button

When you receive a customer complaint that vehicle power supply cannot be controlled adequately, such as an engine no start condition or the ignition cannot be turned off from the engine-running or the ignition-on, explain to the customer as follows. Due to the reverse power supply from electronic devices with internal batteries to the vehicle through the accessory socket, the vehicle system may not be able to determine the vehicle electronic status. As a result, the vehicle power supply control fails.

Aftermarket Cell Phone Charger/Accessory connected to 12V outlet	Engine Start/Stop Button Amber Indicator Light Flashing	Key Warning Light (red)

To overcome this situation, remove the electronic device with internal batteries from the accessory socket.

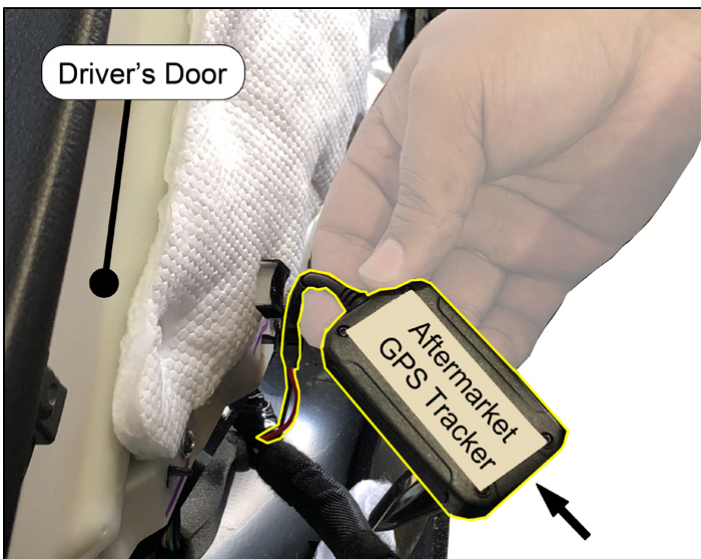
Below are examples of concerns due to an aftermarket GPS tracking device wired to the power window main switch:

- Engine no start
- Battery discharge
- Main relay buzzing

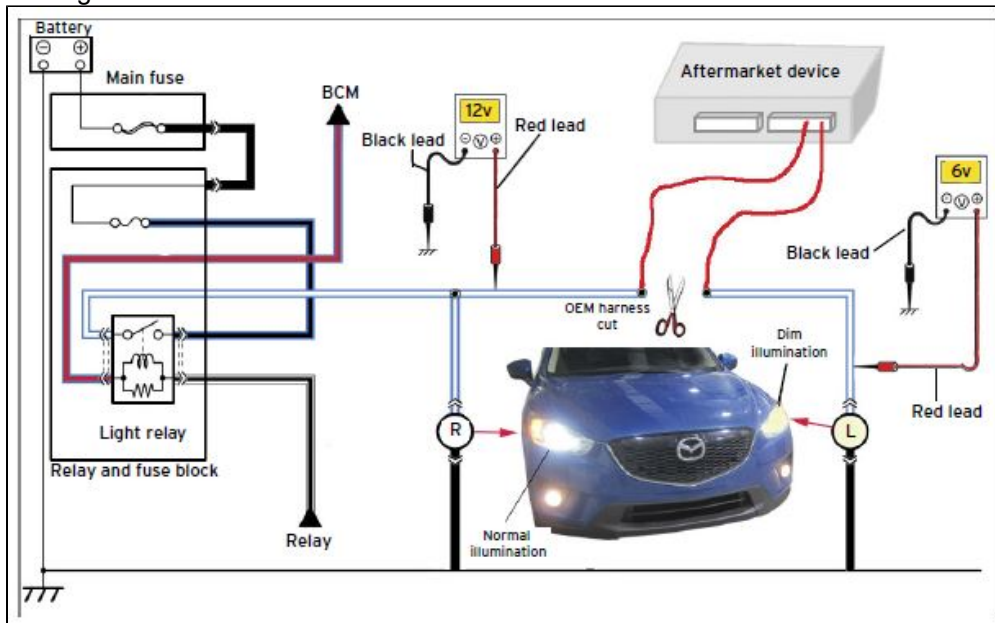
Below is an example of a dim headlight. The aftermarket device changed the headlight circuit resistance, causing a dim headlight.

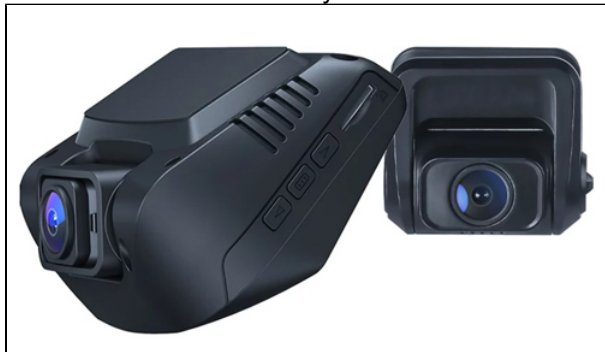
Example 4

DTC B119F:01 (TEL antenna No.1 malfunction) stored. This may be caused by an aftermarket dash cam. The aftermarket device may cause electrical noise disturbing the reception of GPS signals.

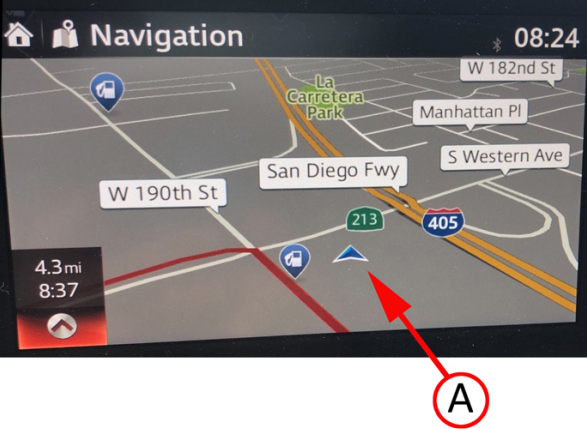
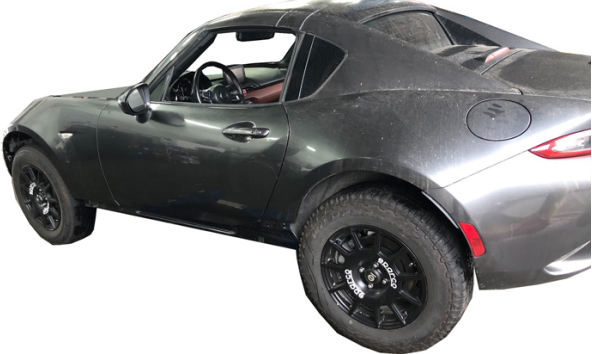
Navigation display map shows incorrect GPS location (A). This may be caused by over-sized wheels/tires. Confirm correct wheel/tire size according to the tire label.

Navi Map Shows Incorrect GPS position (A)	Possible oversized wheels/tires
