# TECHNICAL SERVICE BULLETIN

## Ting, Pop Or Clicking Noise From The Front Or Rear Wheel Hub When Accelerating Or Applying Brakes (Torque Reversals)

**22-2395**

<b>Ford</b> 2022-2023 F-150 Lightning
--

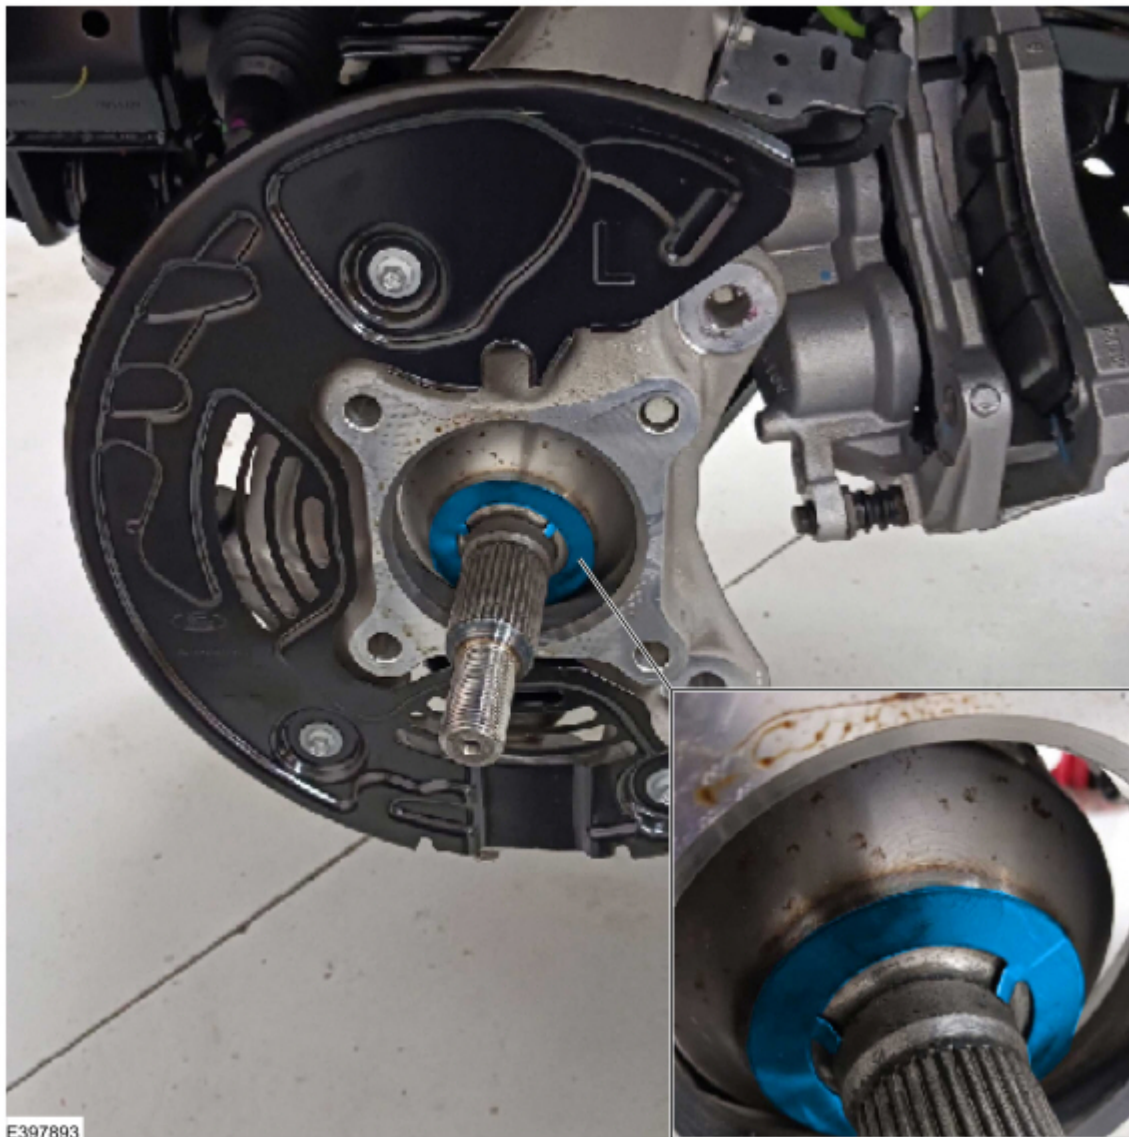
Figure 1

**Issue:** Some 2022-2023 F-150 Lightning vehicles may exhibit a ting, pop or clicking noise from the front or rear wheel hub when accelerating or applying brakes or when shifting between drive/reverse (torque reversals). This condition may be caused by stick/slip between the hub and halfshaft interface, during the torque reversals creating the ting/pop or clicking noise. To correct the condition, follow the Service Procedure to install the new anti-ting washer between the wheel hub and axle shaft.

1. Drive the vehicle to verify the concern, accelerate/apply brakes or shift from forward to reverse (torque reversals).
2. Does the vehicle exhibit ting, pop or clicking noise from the front or rear?
  - (1). Yes - add the anti-ting washer to both left and right halfshaft to hub interface for front and/or rear of the vehicle that exhibits the noise. (Figure 1) Refer to the Workshop Manual (WSM) 204-02 Rear Suspension - Wheel Bearing and Wheel Hub > Electric Procedure or WSM 204-01B Front Wheel Bearing and Wheel Hub. Install the anti-ting washer between the wheel hub and axle shaft interface and reassemble.
