TECHNICAL SERVICE BULLETIN

Lumbar Settings Not Populating In the Center Display Screen And/Or Inoperative Seat Adjustment - Built On 19-Apr-2022 And Through 11-Jul-2022

22-2418

Lincoln 2022 Aviator	Built on 19-Apr-2022 and through 11-Jul-2022
-------------------------	--

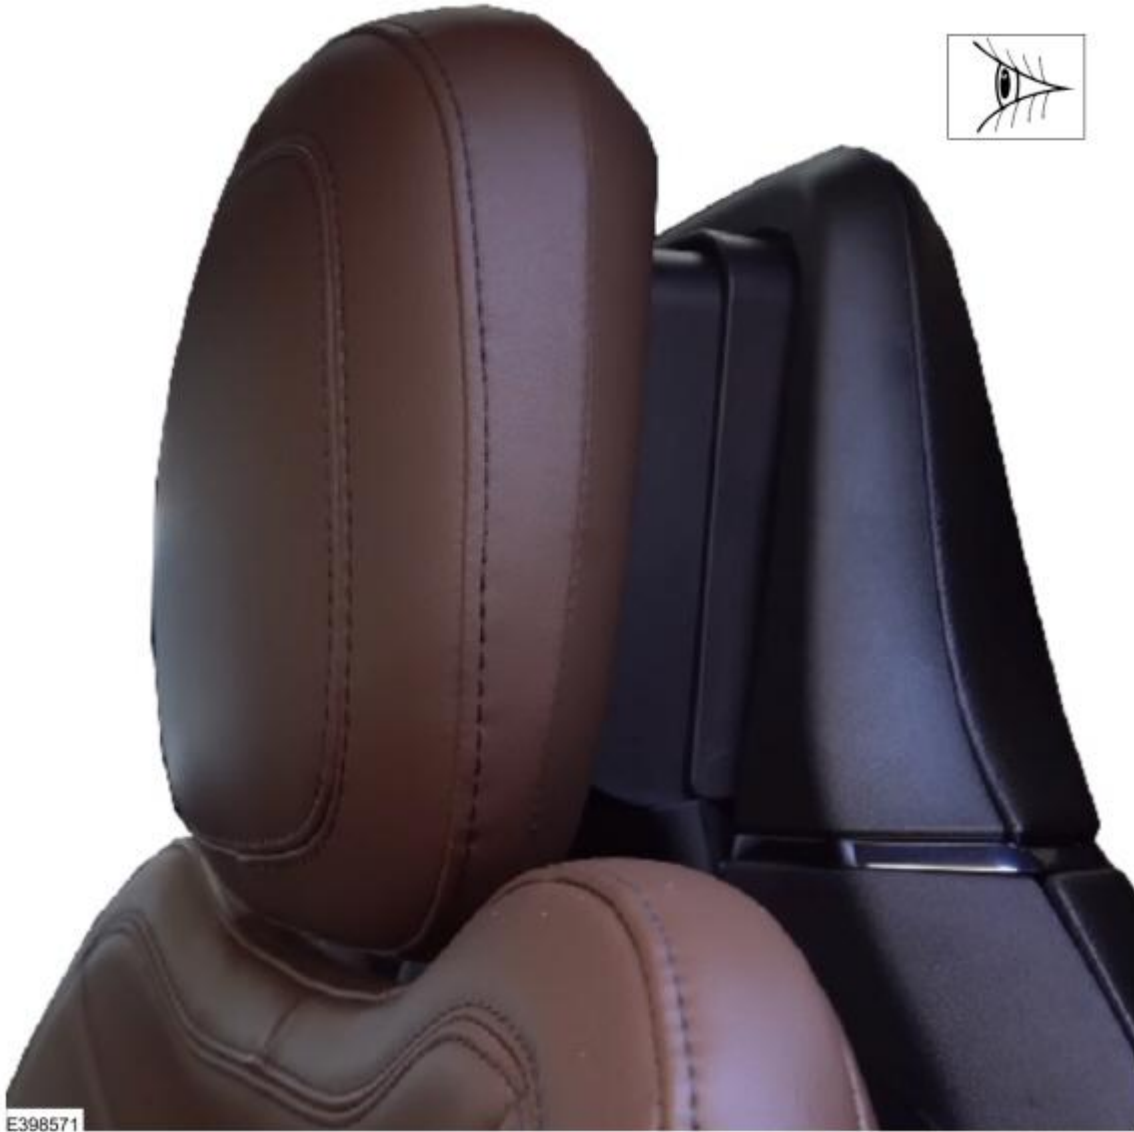
Figure 1 - First generation head restraint

1. Visually inspect the front head restraint. Is the vehicle equipped with a first generation head restraint (Figure 1) or a second generation head restraint (Figure 2)?

- (1). Equipped with a first generation head restraint - proceed to Step 2.
 - (2). Equipped with a second generation head restraint - this article does not apply. Refer to Workshop Manual (WSM), Section 501-10A for normal diagnostics.
2. Remove the affected front seat control switch. Refer to WSM, Section 501-10.
 3. Check the front seat control switch part number. Refer to Table 1. Is the correct part number installed?
 - (1). Yes - reinstall the front seat control switch. Proceed to Step 4.
 - (2). No - replace the affected front seat control switch. Refer to WSM, Section 501-10. Proceed to Step 4.
