TECHNICAL SERVICE BULLETIN

Hard Top Roof - Headliner Loose And/Or Sagging

22-2436

Ford 2021-2022 Bronco

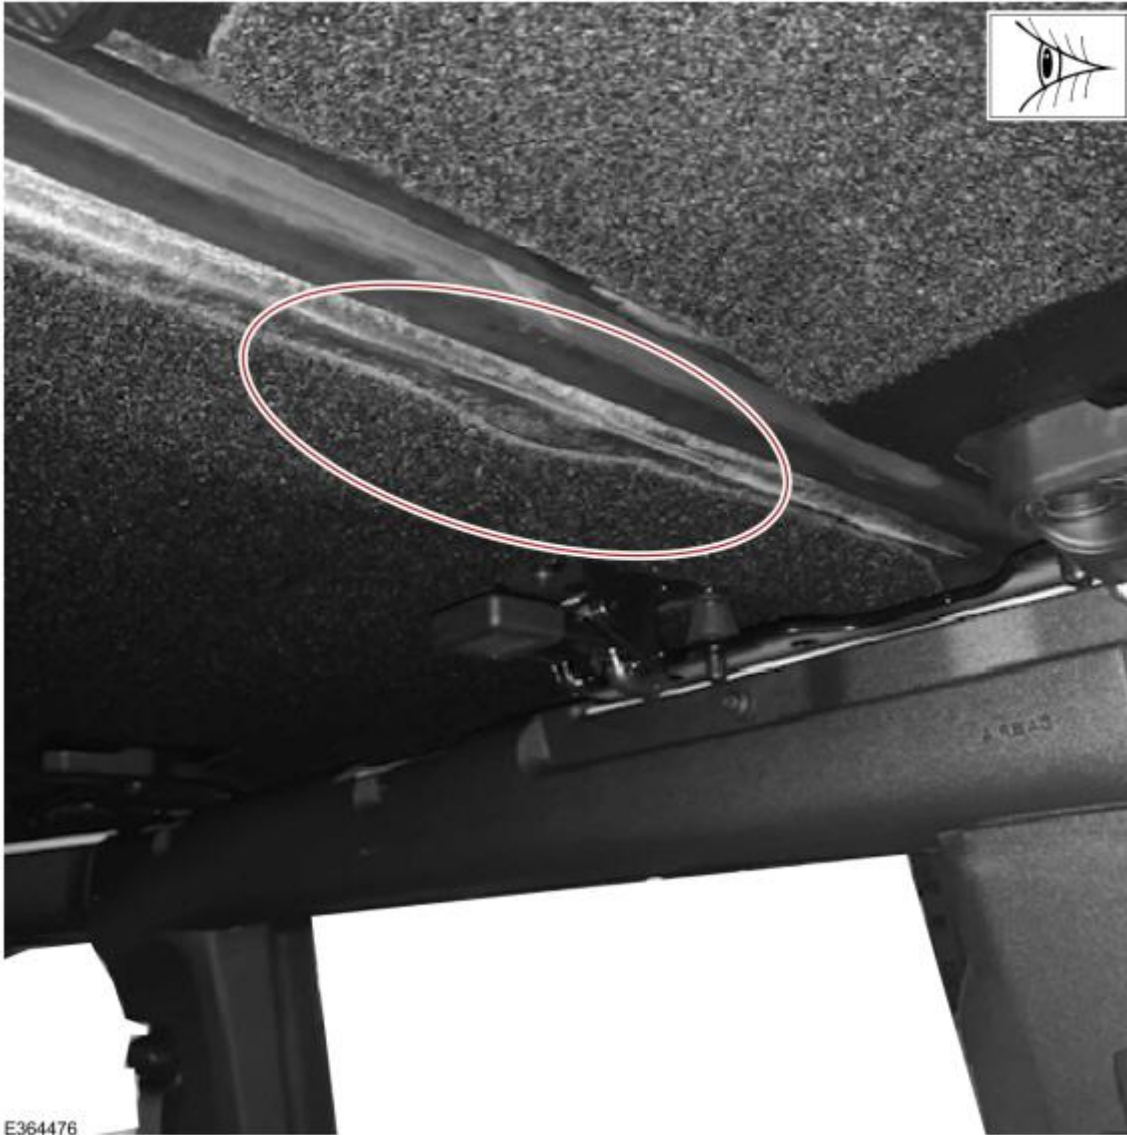
Figure 1

1. Inspect the interior headliner. Is the headliner loose and/or sagging? (Figure 1)

- (1). Yes - proceed to Step 2.
- (2). No - this article does not apply.

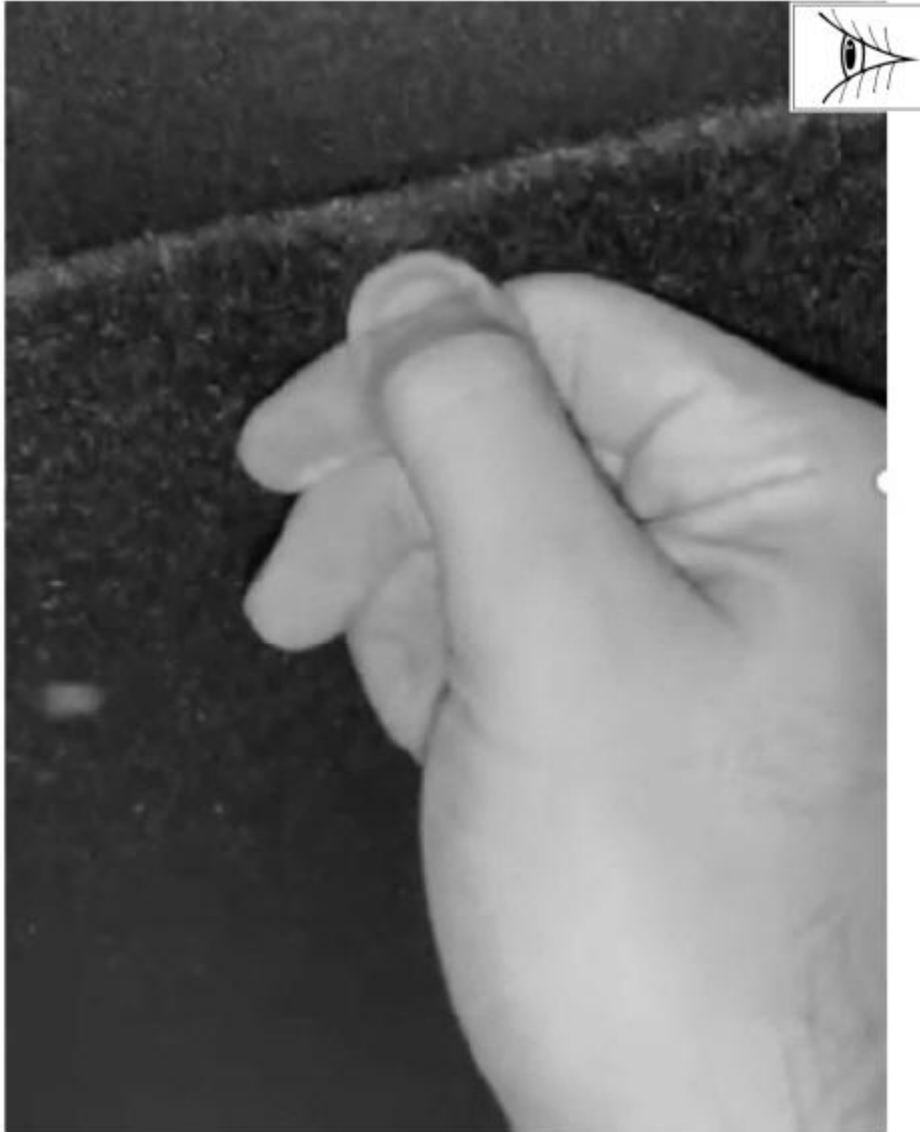
Figure 4

4. Does the headliner properly adhere to the roof with no visible gaps? (Figure 4)

- (1). Yes - repair is complete.
- (2). No - replace the affected headliner.
