Technical product information

Topic	Air suspension warning light within the DIP - DTC's P089200 - C104707 - C103B13 - Evident within Address 74
Market area	Russische Föderation (5RU),Australia E04 Bentley rest Asia and Australia (6E04),China 796 VW Import Comp. Ltd (Vico), Beijing (6796),Germany E02 Bentley rest Europe (6E02),Japan E03 Bentley Japan (6E03),Korea, (South) E08 Bentley South Korea (6E08),United Arab Emirates E06 Bentley Middle East and Africa (6E06),United Kingdom E01 Bentley UK (6E01),United States E05 Bentley USA and rest America (6E05)
Brand	Bentley
Transaction No.	2062259/5
Level	EH
Status	Released for publishing
Release date	04-Nov-2022

New Continental GT /GTC (Including Speed) & New Flying Spur

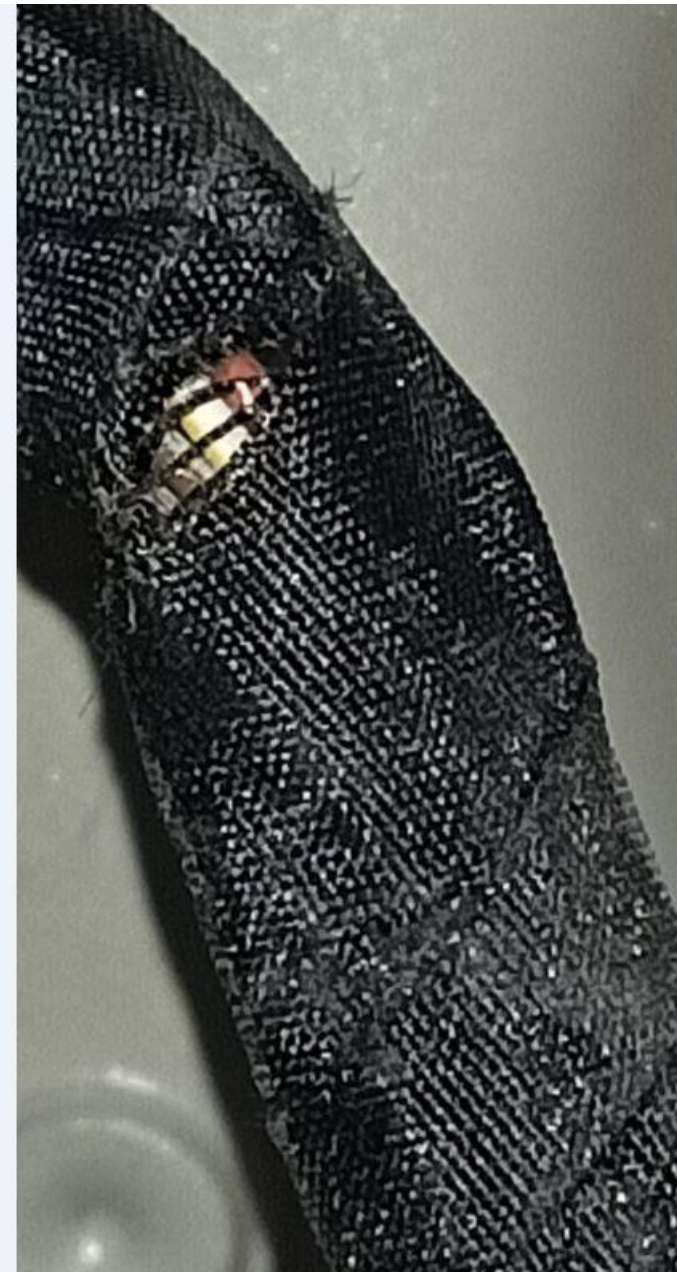
- Broken wires
- Kinked wiring
- Pin/s missing
- Pin/s broken
- Pin/s loose

NOTE: Refer to the example shown in Figure 1 of a damaged wiring harness

2) Repair any broken or damaged wires as per Rep.Gr 97
