4700
4800
4900
5700

6900
> 47X
> 49X

**Western Star
Service Bulletin**

Description of Revisions: *This bulletin replaces the version dated 08/17/2022. Information about the protective boot has been updated.*

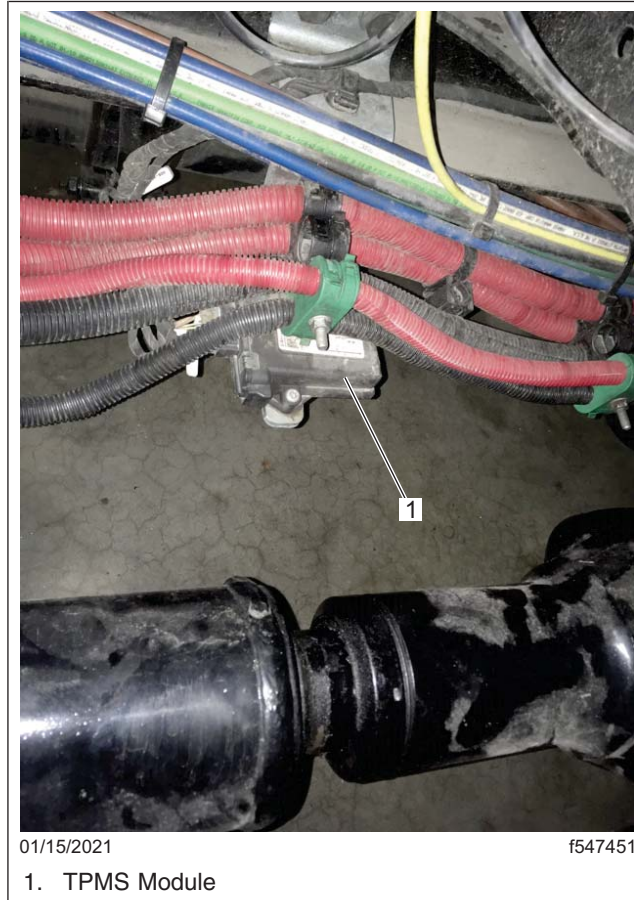
Fig. 1, Location of the TPMS Module

1. Park the vehicle on a level surface, shut down the engine, and set the parking brakes. Chock the tires.
2. Locate the TPMS module mounted below the left frame rail as shown in [Fig. 1](#).

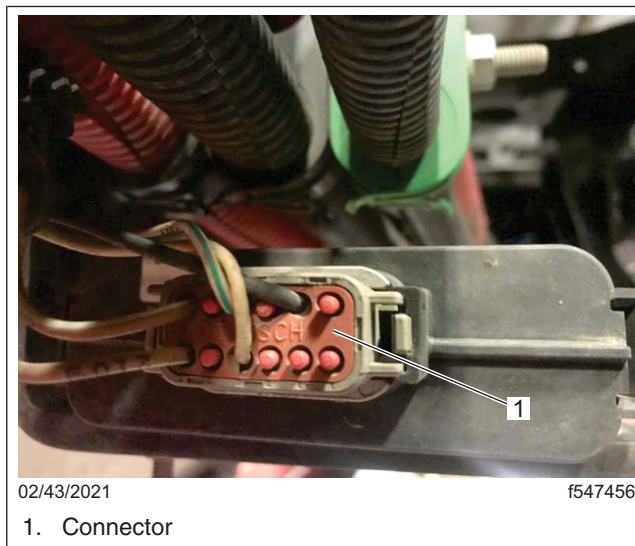
Fig. 2, TPMS Module Connector

IMPORTANT: **Figure 2** is intended for visual orientation purposes only. The wire routing should NOT be such that the wire connections are stressed, as is seen here. Proper procedure for wiring with this module is outlined below in Step 7.

3. Disconnect the wiring harness connector from the TPMS module. See **Fig. 2**.

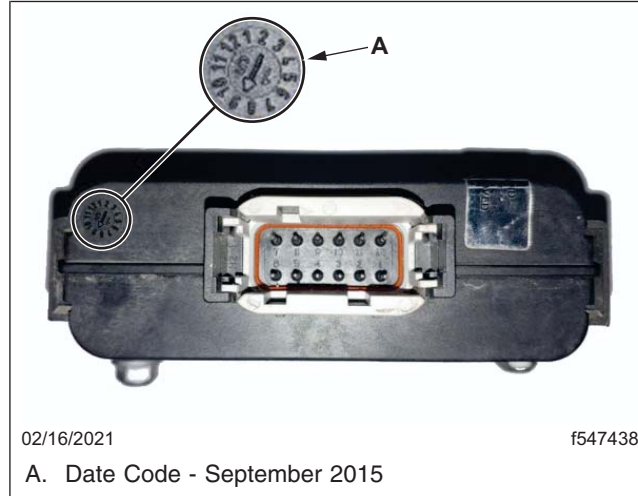
Fig. 4, TPMS Housing Date Code

5. Inspect the TPMS housing date code. If the date is between February 2019 and June 2020, replace the TPMS module. See [Fig. 4](#) for the location of the date code.
