Technical product information

Topic	Infotainment screen turns red sporadically
Market area	Bentley: worldwide (2WBE)
Brand	Bentley
Transaction No.	2055846/7
Level	EH
Status	Released for publishing
Release date	02-Nov-2022

New Continental GT and New Continental GTC

New Flying Spur

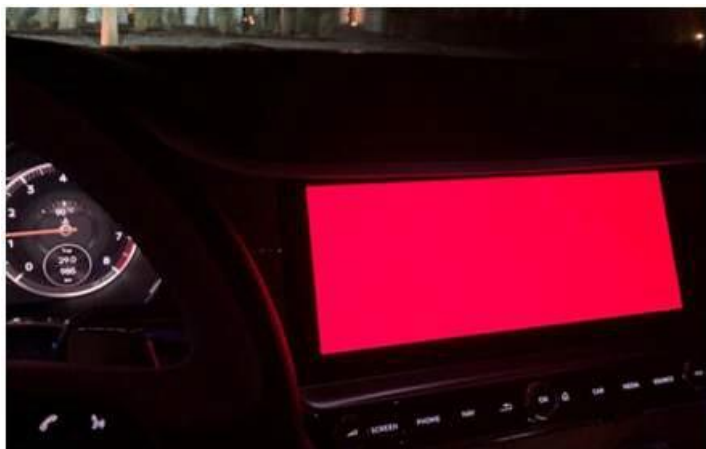
Figure 1

Infotainment screen 'Goes Red Fully or partially' within the MMI Screen (Figure 1)

The operative should complete the questionnaire within the Measure section of this TPI, once completed the questionnaire should be attached to an existing or already open DISS query the operative should await feedback before conducting any further work
