## Technical product information

<b>Topic</b>	Knock/clunk noise from the rear of the vehicle (Rear axle)
<b>Market area</b>	Russische Föderation (5RU),Australia E04 Bentley rest Asia and Australia (6E04),China 796 VW Import Comp. Ltd (Vico), Beijing (6796),Germany E02 Bentley rest Europe (6E02),Japan E03 Bentley Japan (6E03),Korea, (South) E08 Bentley South Korea (6E08),United Arab Emirates E06 Bentley Middle East and Africa (6E06),United Kingdom E01 Bentley UK (6E01),United States E05 Bentley USA and rest America (6E05)
<b>Brand</b>	Bentley
<b>Transaction No.</b>	2064477/4
<b>Level</b>	EH
<b>Status</b>	Released for publishing
<b>Release date</b>	04-Nov-2022

Knock/clunking noise heard from the rear of the vehicle when changing direction at low speed

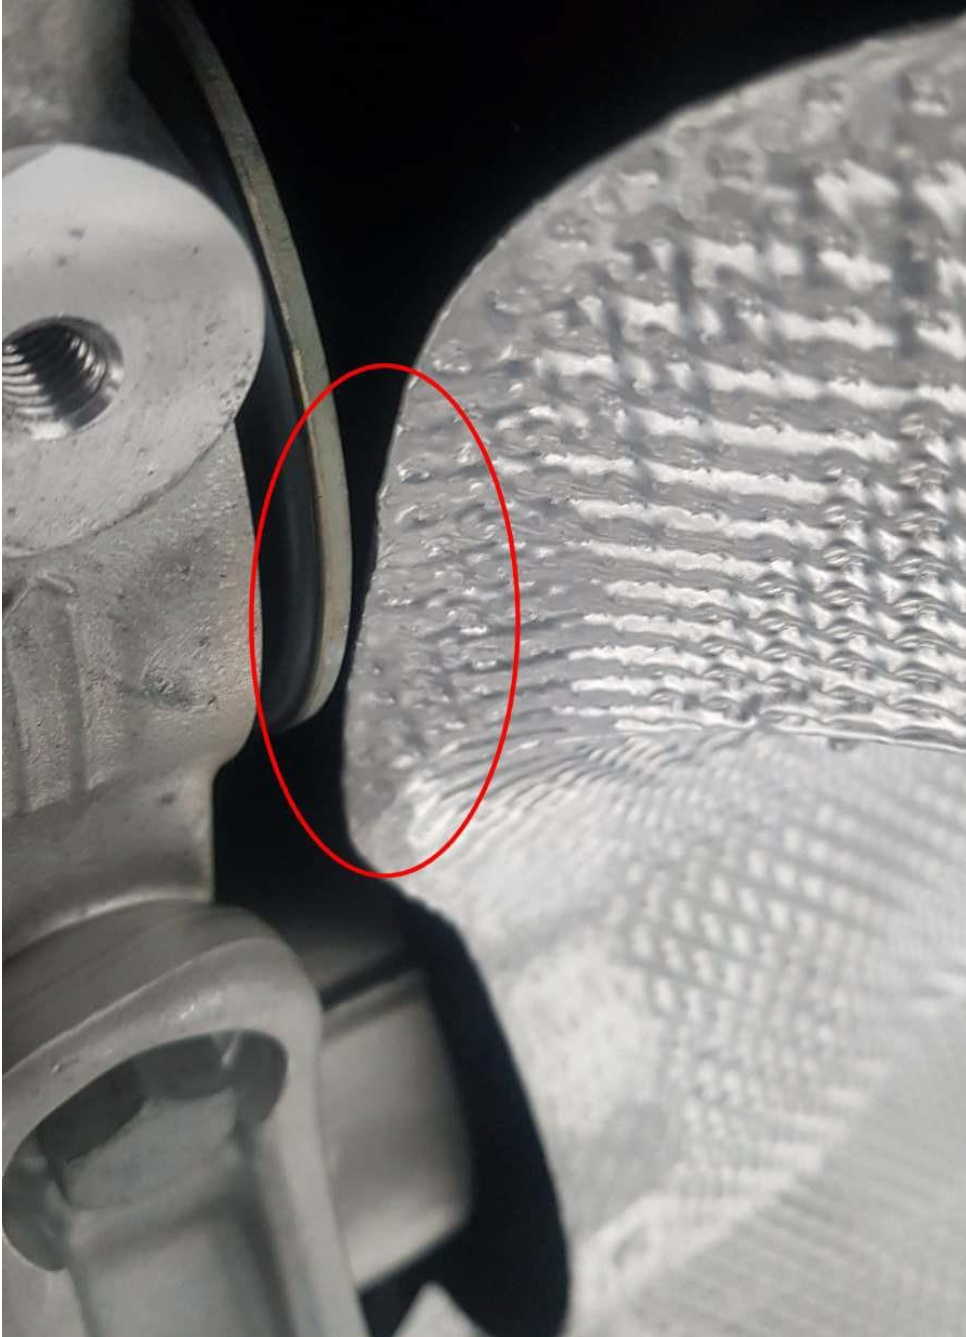
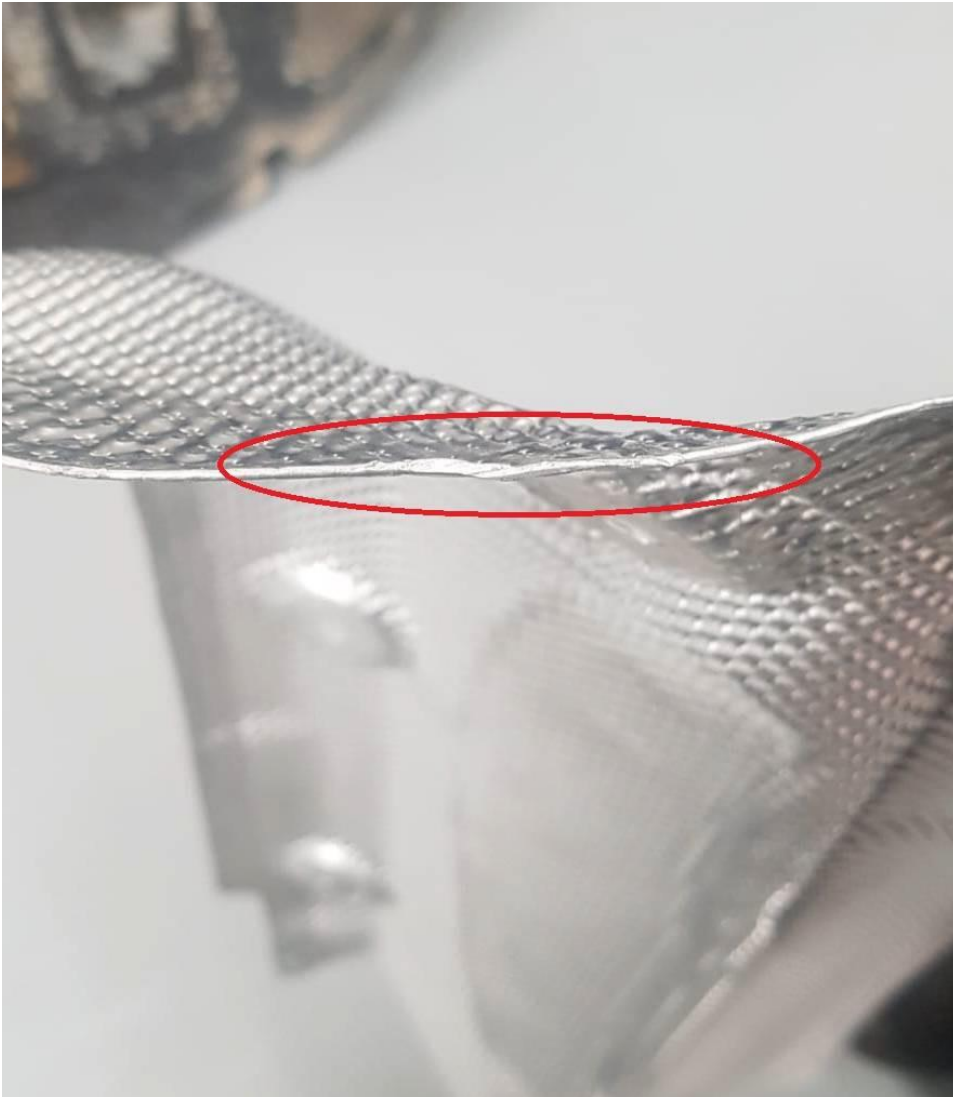
3) Referring to Figures 1 and 2

- Check to confirm the heat shields are not in contact or have witness marks showing evidence of contact with the rear differential and/or surrounding components

NOTE: In the event the issue shown regarding the heatshield is evident, the operative should rectify (relocate the heatshield) and retest

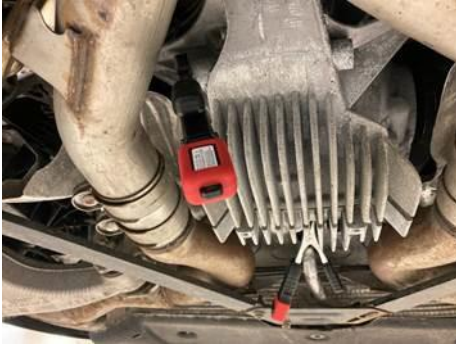
Figure 1

- Use WT 10437 (Chassis Ear Tool) to identify the source of problem by attaching the clamp and module assemblies to the areas of concern. For example, front and rear of the differential casing, as well as the upper control arms on the suspension (see Figures 1 to 3 for examples)
