Technical product information

Topic	Knocking noise from the front (Driving over an uneven road surface) - Front trailing arm bush found damaged/leaking
Market area	Russische Föderation (5RU),Australia E04 Bentley rest Asia and Australia (6E04),China 796 VW Import Comp. Ltd (Vico), Beijing (6796),Germany E02 Bentley rest Europe (6E02),Japan E03 Bentley Japan (6E03),Korea, (South) E08 Bentley South Korea (6E08),United Arab Emirates E06 Bentley Middle East and Africa (6E06),United Kingdom E01 Bentley UK (6E01),United States E05 Bentley USA and rest America (6E05)
Brand	Bentley
Transaction No.	2067403/2
Level	EH
Status	Released for publishing
Release date	04-Nov-2022

New Continental GT/GTC and New Flying Spur

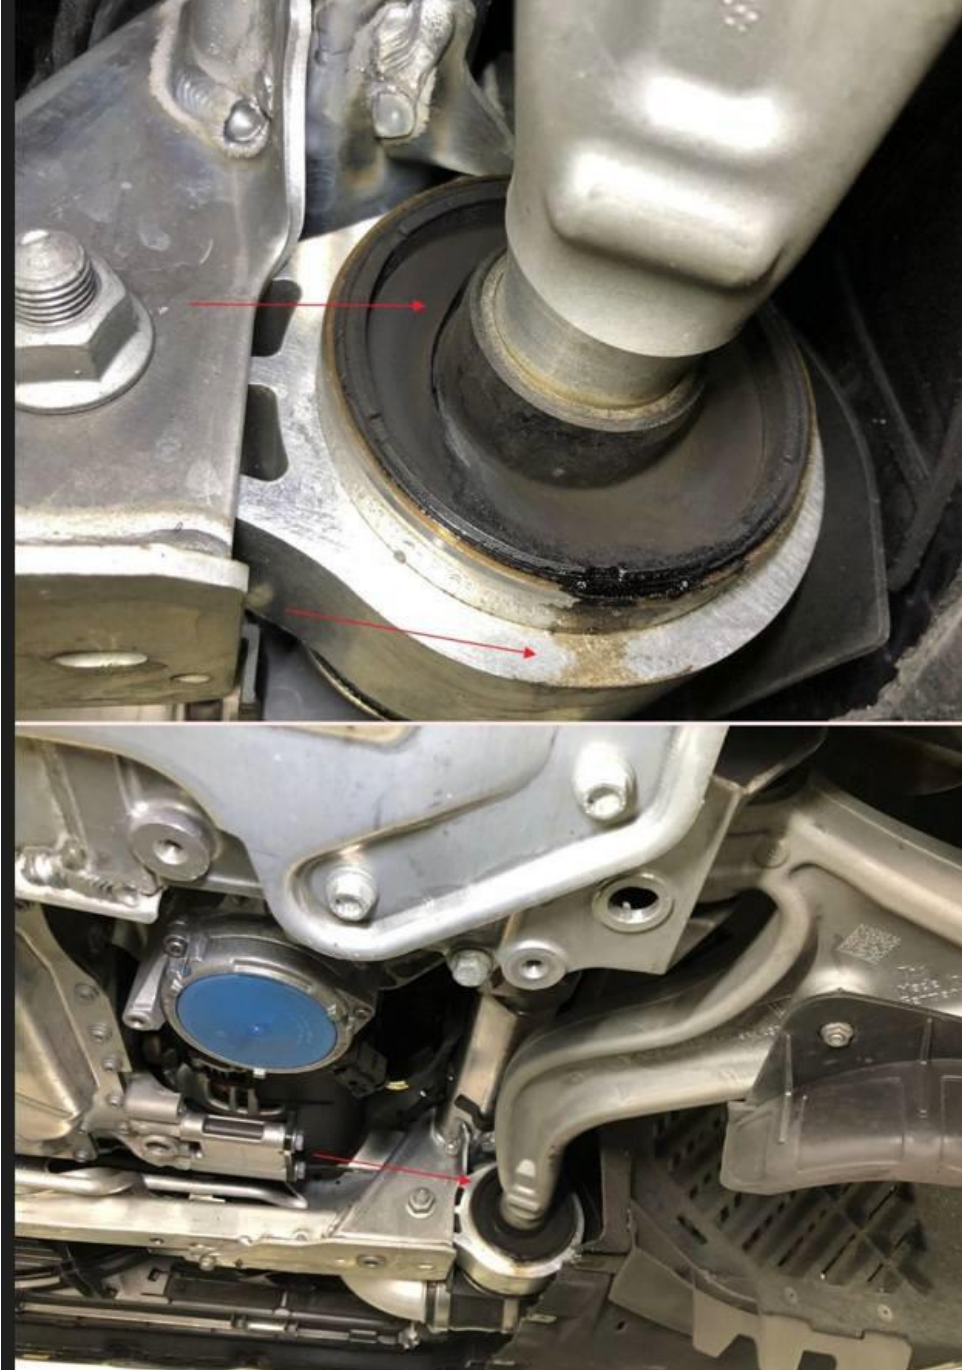
Figure 1

Front trailing arm bush found damaged/leaking as shown in Figures 1 and 2

2) Referring to Rep.Gr 40 - Replace the applicable front lower trailing arm NOTE: The front lower trailing arms should not be replaced in pairs (unless both are damaged/worn) only the damaged trailing arm should be replaced

3) Refer to Rep.Gr 44 - Check and adjust the suspension and steering geometry (Wheel alignment)
