Technical product information

Topic	New Continental GT and GTC - Rattle / Buzzing Noise - Head-Up display
Market area	Bentley: worldwide (2WBE)
Brand	Bentley
Transaction No.	2052431/8
Level	EH
Status	Released for publishing
Release date	07-Nov-2022

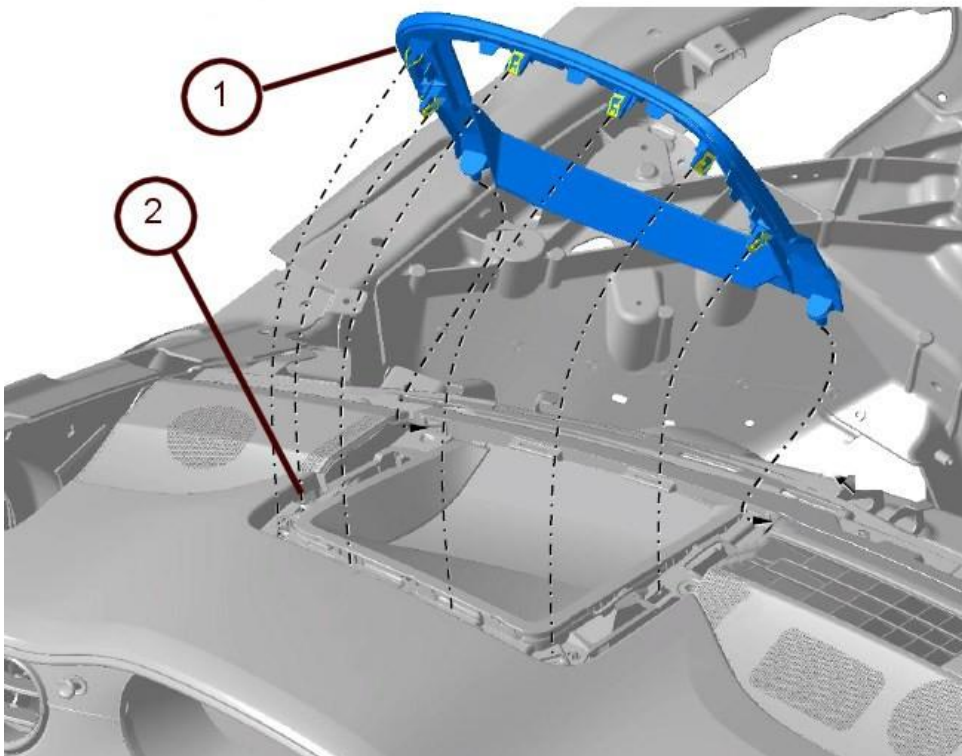
- Relative movement between Control Unit for Head-Up Display and associated Trim Ring – Figure 1
- Contact between the dashboard and dashboard upper trim panel.
- Head-up Display internal fault

1 – Trim Ring

2 – Control Unit for Head-Up Display

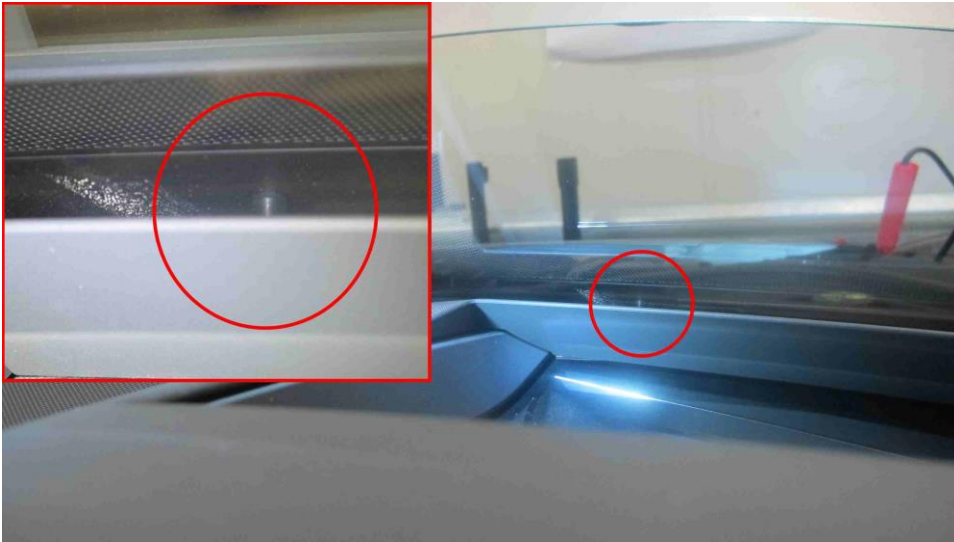
Figure 2

Bump stop introduced to the dashboard at the forward area of the HUD – Figure 2.
