Technical product information

Topic	Vehicle sitting low on one or more corners when static with no relevant DTCs stored
Market area	Russische Föderation (5RU),Australia E04 Bentley rest Asia and Australia (6E04),China 796 VW Import Comp. Ltd (Vico), Beijing (6796),Germany E02 Bentley rest Europe (6E02),Japan E03 Bentley Japan (6E03),Korea, (South) E08 Bentley South Korea (6E08),United Arab Emirates E06 Bentley Middle East and Africa (6E06),United Kingdom E01 Bentley UK (6E01),United States E05 Bentley USA and rest America (6E05)
Brand	Bentley
Transaction No.	2064582/4
Level	EH
Status	Released for publishing
Release date	04-Nov-2022

New Continental GT and New Continental GTC

New Flying Spur

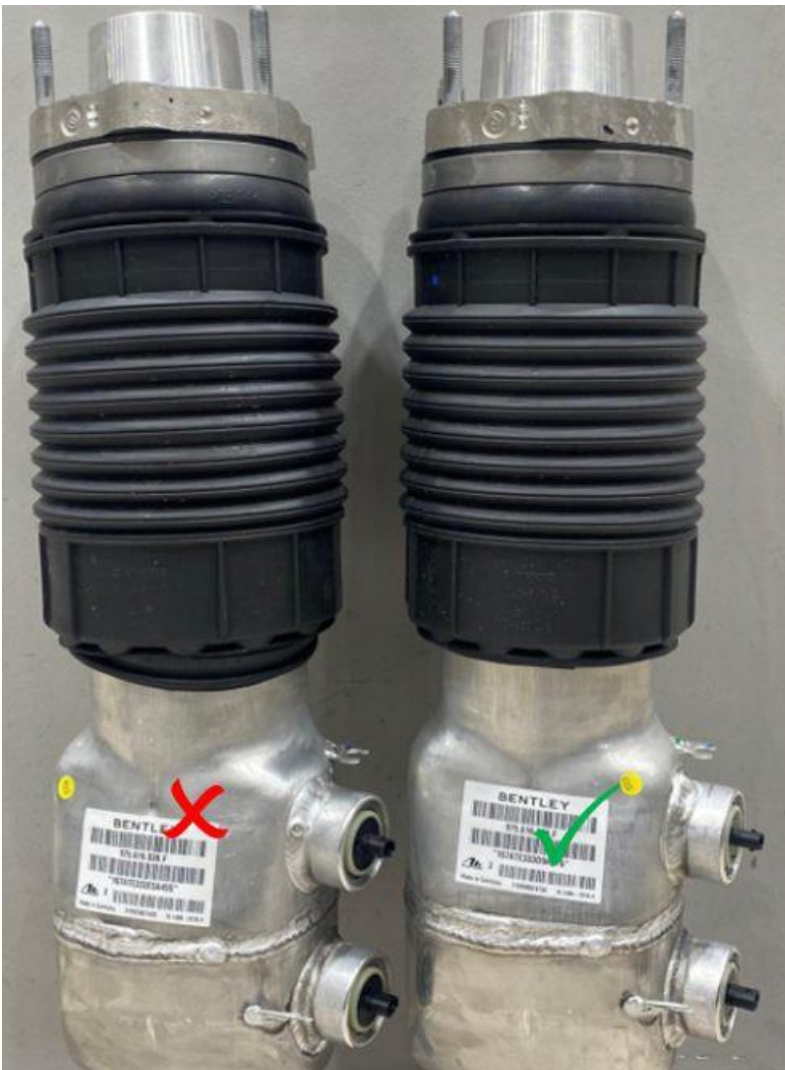
8) Referring to Figure 3 - Inspect the left and right hand front air springs checking for any signs of damage and/or distortion

NOTE: Figure 3 shows the left hand front air spring damper distorted

- In the event an issue is found with the left and/or right air spring damper - Refer to Rep.Gr 40 - Replace the left and right hand front air

spring dampers

Within the front air spring damper procedure there are single use items which must be replaced and not reused. Ensure that new replacements are available prior to starting this procedure - Refer to the ETKA parts catalogue

9) Referring to Rep.Gr 44 - Check and adjust the suspension and steering geometry
