# Technical Service Bulletin

## 91 MIB ASI: Apple CarPlay screen is blank

91 22 46 2065728/4 November 7, 2022. Supersedes Technical Service Bulletin Group 91 number 22-40 dated October 20, 2022, for reasons listed below.

Model(s)	Year	VIN Range	Vehicle-Specific Equipment
All Audi Models	2020 – 2024	Not Applicable	Apple CarPlay

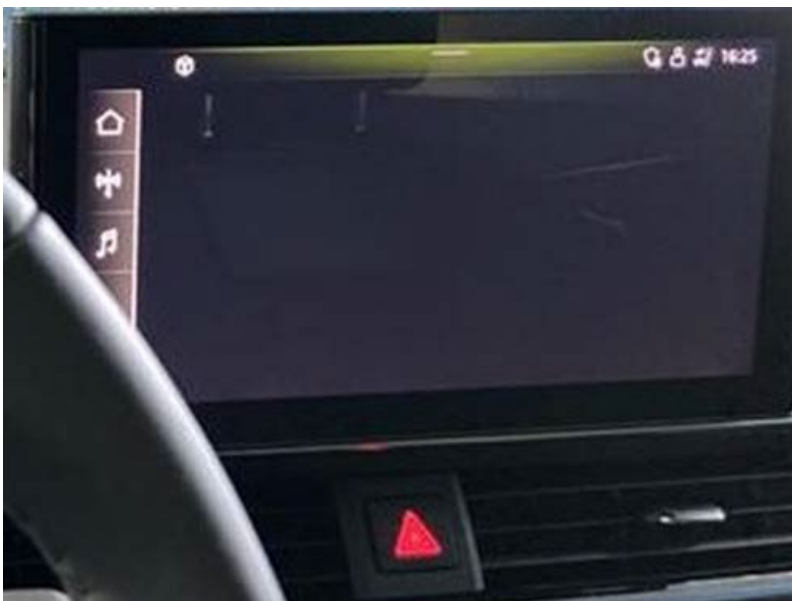
- Audio dropouts can be heard.
- The ASI display goes blank. The shortcut bar on the left side of the screen, as well as the top dropdown menu anchor, can still be seen on the screen (see *Figure 1*).

**Figure 1:** ASI display is blank when using wACP.

A non-standard behavior of the current Apple iOS versions (including all 14.x, 15.x, and 16.x versions) causes the phone to fail to send screen data to the vehicle. Additionally, a hardware issue in iPhone 8, iPhone X, and iPhone XR models can cause the display to blank out.

The problem is due to a hardware issue in the WiFi chipset of the listed phone models. As those phone models are already out of production, no repair will be available. It is advisable to use a wired connection to use Apple CarPlay for those models.

1. Do not perform any repairs. Any repairs for this concern may be denied.
2. **For customers with iPhone 8, iPhone X, and iPhone XR:**

Please inform the customer that this behavior is due to a bug in the phone's operating system (iOS). Apple is currently analyzing the root cause of this behavior and is working on a solution that will be distributed with a future iOS update.

In some cases, going to the home menu by clicking the home shortcut on the left of the screen and then reentering ASI resolves the concern. In other cases, the phone might need to be disconnected and then reconnected.
