Technical Service Bulletin

91 Poor hands-free call quality, speech dialogue system function impaired, DTCs B120313 - B120813

91 22 48 2067267/2 November 9, 2022. Supersedes Technical Service Bulletin Group 91 number 22-07 dated June 13, 2022 for reasons listed below.

Model(s)	Year	VIN Range	Vehicle-Specific Equipment
TT Roadster	2016 – 2023	All	Not Applicable
A5 Cabriolet, and S5 Cabriolet	2018 – 2023

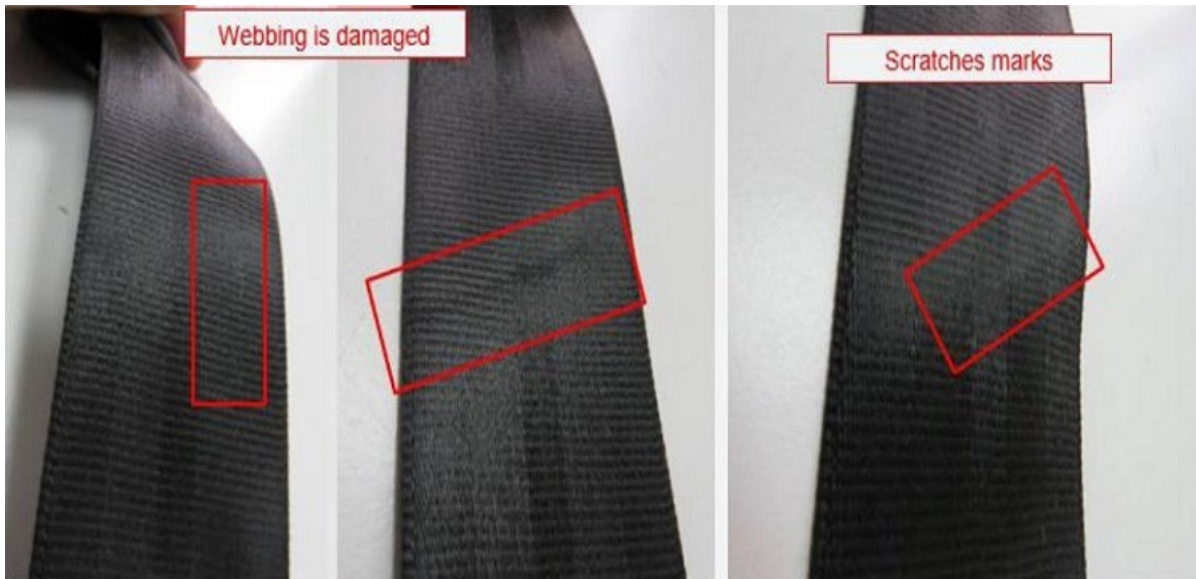
On the Cabriolet/Roadster models listed, there are three microphones for the hands-free calling and speech dialogue systems integrated into the front seat belts. The required wires are woven into the belt. Using the seat belt incorrectly can cause damage to these wires. This includes, for example:

- Trapping the seat belt in the door.
- Rear passengers pulling on the seat belt when exiting the vehicle.

1. Lines running down or across (A5/S5 Cabriolet, TT Roadster)

If there are visible lines running down or across the seat belt (Figure 1), it can be assumed that the seat belt was trapped in the front door.

Figure 1. Marks indicating that the seat belt was trapped in the front door

The seat belt must be replaced to restore proper function.

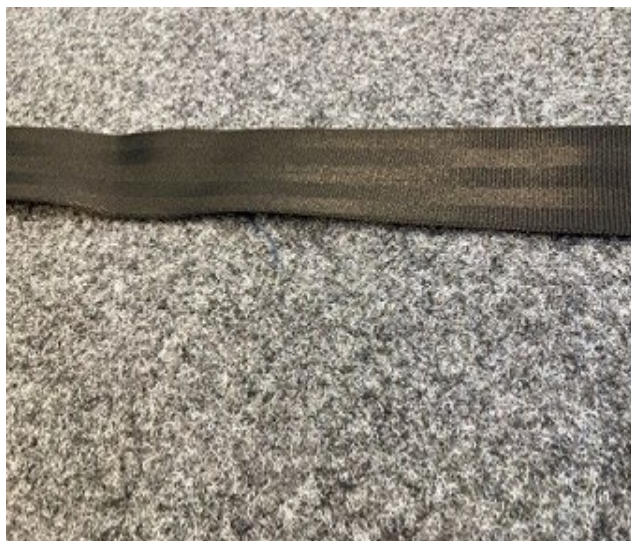
2. Waviness (A5/S5 Cabriolet only)

If the seat belt is wavy (Figure 2), it can be assumed that the seat belt was misused by a rear passenger by pulling on it while exiting the vehicle (Figure 3).

Figure 2. *Waviness indicates that the seat belt was pulled on when exiting the rear of the vehicle*

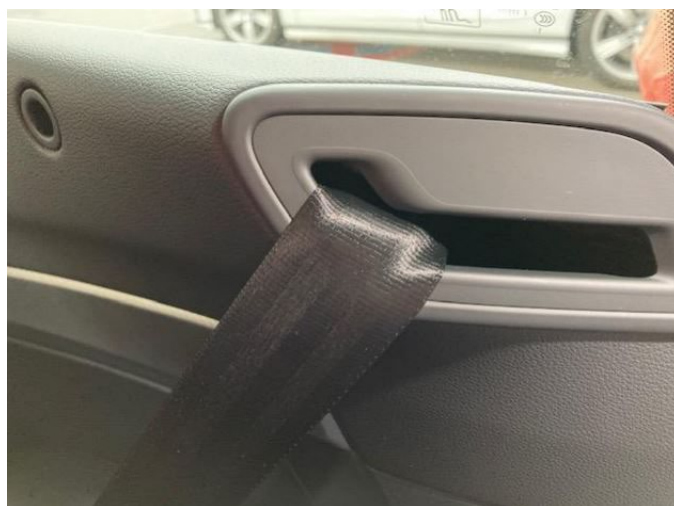
Figure 3. *Pulling on the seat belt when exiting the vehicle can damage the seat belt/microphones.*
