# Technical Service Bulletin

PSS 93 Electrical Malfunction Message Displayed on Start up, DTCs P060600 and P0A1B00 Stored in Electric drive 2  
93 22 84 2068370/1 November 7, 2022.

| Model(s) | Year | VIN Range | Vehicle Specific Equipment |
|---|---|---|---|
| Q4 e-tron quattro, and Q4 Sportback e-tron quattro | 2022 | All | Not Applicable |

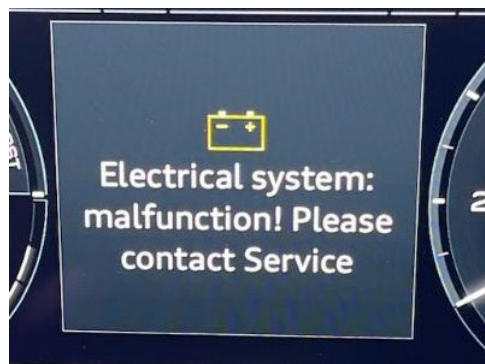
- Intermittently at start-up driver receives a malfunction message in the instrument cluster "Electrical system malfunction! Please contact Service" (Figure 1).
- After a key cycle the vehicle operates normally.

*Figure 1. A malfunction message is shown in the instrument cluster.*

The following DTCs are stored Electric drive 2 (DMC2), J944 (address word 00CE):

- DTC P060600: ECM/PCM Processor.
- DTC P0A1B00: Drive Motor "A" Control Module.

Software communication timing error on start-up.

- The warning is displayed on vehicle start-up.
- After an ignition cycle the vehicle operates normally.
- Clear the DTCs with the scan tool and confirm the vehicle drives normally on a test drive.

If the DTCs can be cleared and the vehicle drives normally the vehicle can be released to the customer.

Explain to the customer if the concern happens again they should turn the ignition off, wait a couple of seconds, and then turn the ignition back on. The vehicle will then operate normally.
