# Technical Service Bulletin

**94 "Electrical system fault" is displayed in the instrument cluster, DTC: P18F100, P0A1B00, U140500**  
94 22 60 2068617/1 November 18, 2022.

| Model(s) | Year | VIN Range | Vehicle-Specific Equipment |
|---|---|---|---|
| Q4 e-tron, and<br>Q4 Sportback e-tron | 2022 | All | Not Applicable |

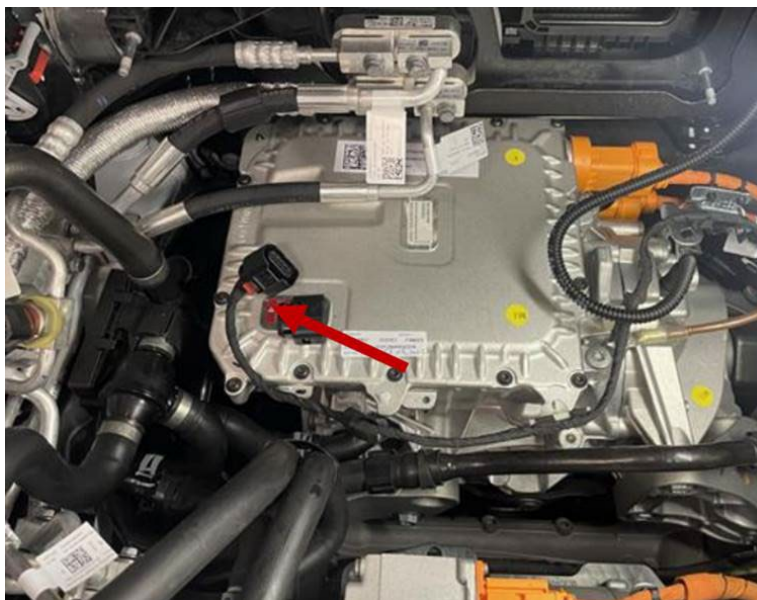
Pins may have become damaged during the end-of-line check during production.

Inspect connector T10 at power electronics 2 for electric drive JX4 for spread or damaged contacts:

**Figure 1:** 10 Pin connector.

If any damage is found to the pins or connector, replace the 10-pin connector and associated wires/pins.

**Note:** **DO NOT** de-pin the connector. Cut the connector off the harness leaving approximately 5cm of the harness attached to the connector. Retain the connector and harness section for analysis.

Replace the connector and repair the harness using **VAS 1978B**.
