Service Bulletin

Bulletin No.: 22-NA-225

Subject: Information on Red Fluid Leak from Center of Vehicle

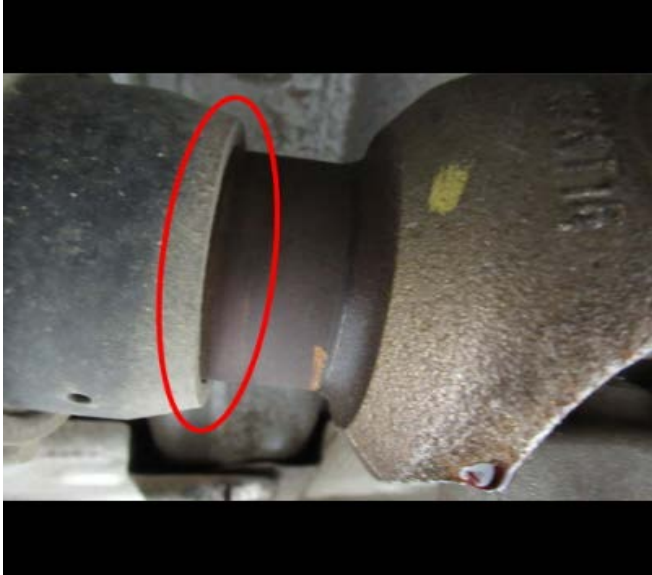
<p style="text-align: right;">6186773</p>
	<p>1. Visually observe the output seal and boot area for ATF leak.</p>

Involved Region or Country	North America
Additional Options (RPOs)	F48: CHASSIS DRIVE LINE-ALL WHEEL DRIVE (AWD)/FOUR WHEEL DRIVE(4WD), DRIVER SELECT
Condition	Some customers may comment that a red fluid is seen in the middle of the vehicle.
Information	<p>Verify the ATF leak is either from the T-case/transmission rear output seal leak or the prop shaft slip yoke welch plug leak:</p>

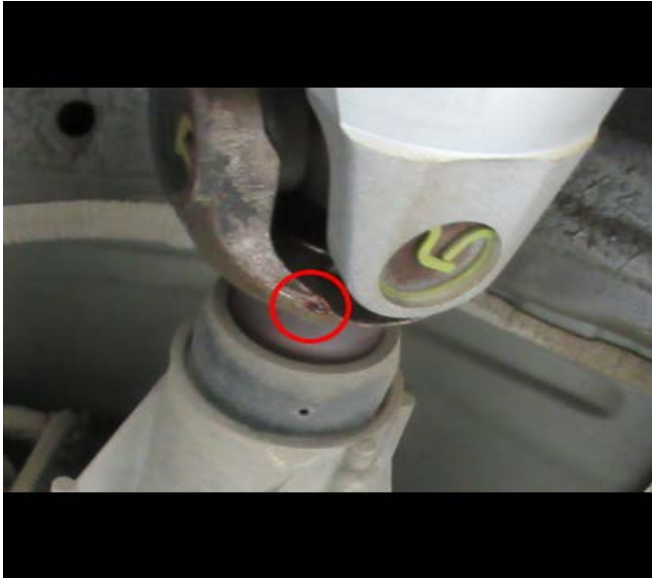
<p style="text-align: right;">6186771</p> <ol style="list-style-type: none"> 2. If the seal/boot area appear to be dry, inspect the welch plug area for ATF. <ul style="list-style-type: none"> – If the welch plug is the source of the leak. Go to step 4. – If the output seal is the source of the leak, replace the output seal. Refer to <i>Propeller Shaft Front Slip Yoke Replacement</i> in SI and no more work is required. 3. If both the seal/boot and the welch plug are wet with ATF, therefore unclear, dry the area with a soft rag and do a series of short drives (around the block) to initiate the leak. Go back to step 1. 4. If it has been determined that the welch plug is leaking, replace the propeller shaft front slip yoke. <i>Propeller Shaft Front Slip Yoke Replacement in SI.</i>
