Technical Service Bulletin

Topic	V8 Kovomo - Emission control warning illuminated within the DIP - Exhaust Gas Temperature Sensor DTC's evident
Market area	Russische Föderation (5RU),Australia E04 Bentley rest Asia and Australia (6E04),China 796 VW Import Comp. Ltd (Vico), Beijing (6796),Germany E02 Bentley rest Europe (6E02),Japan E03 Bentley Japan (6E03),Korea, (South) E08 Bentley South Korea (6E08),United Arab Emirates E06 Bentley Middle East and Africa (6E06),United Kingdom E01 Bentley UK (6E01),United States E05 Bentley USA and rest America (6E05)
Brand	Bentley
Transaction No.	2065698/2
Level	EH
Status	Released for publishing
Release date	Nov 22, 2022

V8 Kovomo - New Continental GT/GTC - New Flying Spur

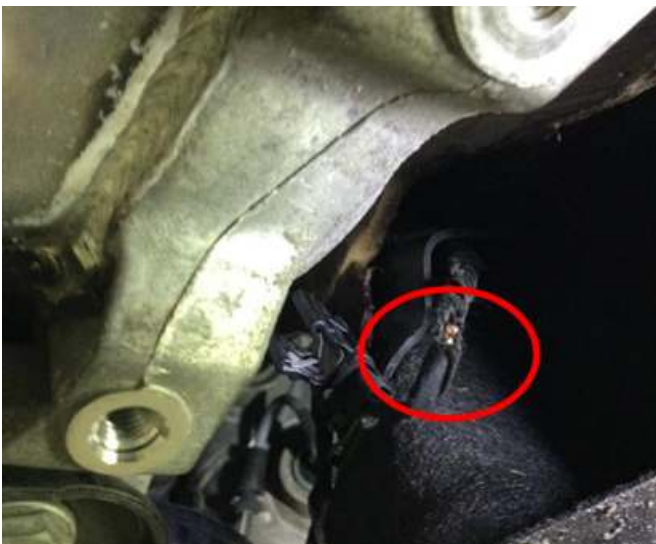
After further investigation the wiring harness leading to the Exhaust gas temperature sensor (Bank 1 and/or Bank 2) runs close to the sub-frame may rub/contact the edge of the bracket inside of the wheel arch cover/liner

See the examples shown in Figure 1 (Chaffed/damaged wiring Bank 1)

- 1) Check Bank 1 and Bank 2 Exhaust Gas Temperature sensor wiring harnesses for damage/chaffing
- 2) Referring to Rep.Gr 97 - Repair the applicable damaged wire(s)
- 3) Once repaired - Reposition and secure the Exhaust Gas Temperature sensor wiring harness, ensuring the harness cannot contact any surrounding components which could result in chaffing/damage

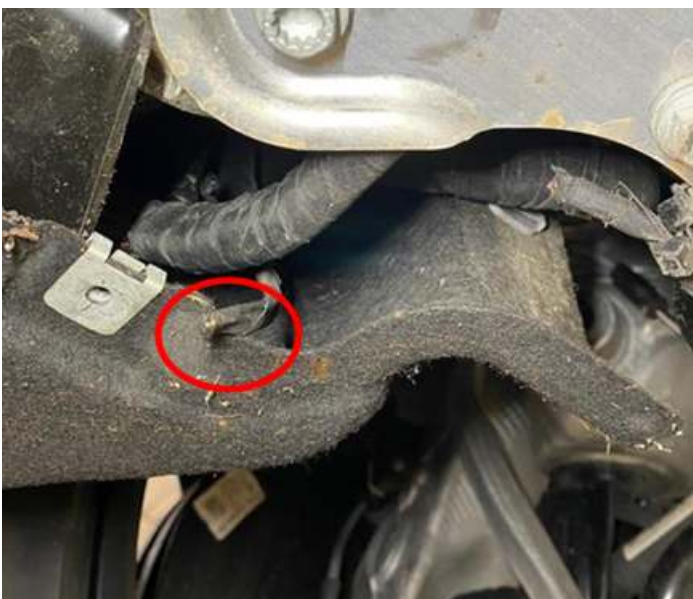
Figure 2 (Broken/damaged wiring Bank 2)
