## Technical product information

<b>Topic</b>	Convertible hood cannot close - Header trim flap eyelet broken
<b>Market area</b>	Bentley: worldwide (2WBE)
<b>Brand</b>	Bentley
<b>Transaction No.</b>	2060120/6
<b>Level</b>	EH
<b>Status</b>	Released for publishing
<b>Release date</b>	07-Nov-2022

### New Continental GTC

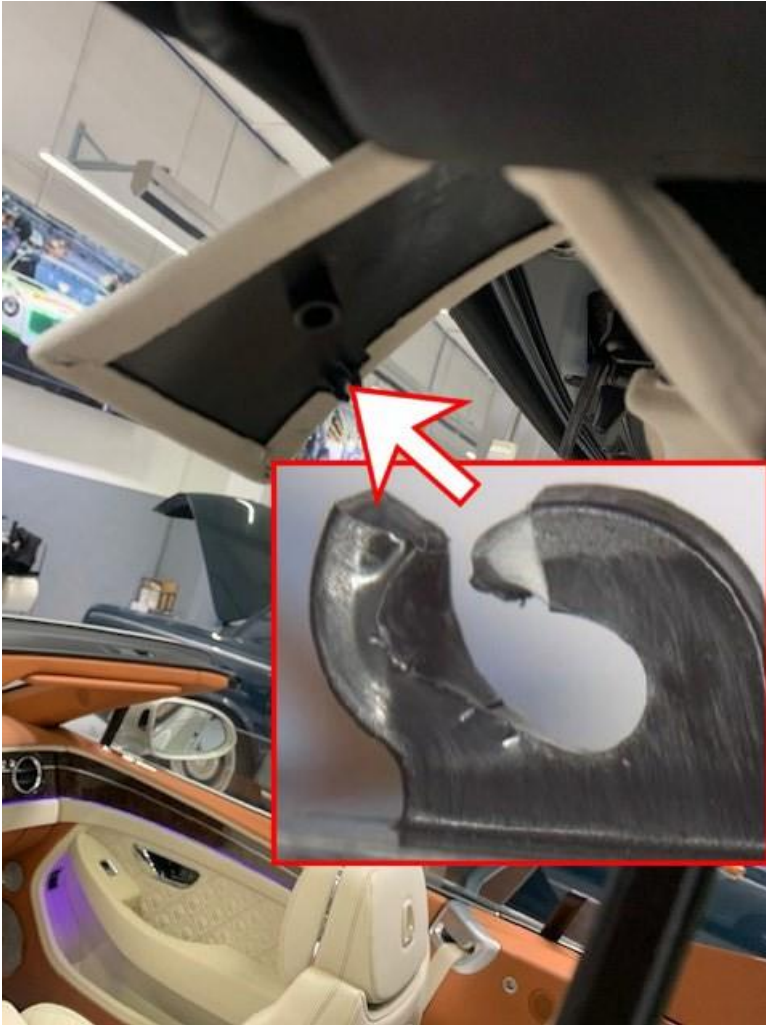
Figure 1

Convertible hood cannot close/latch due to a broken eyelet. The eyelet is part of the trim flap assembly (Figure 1)

1) Replace the right and left hand trim flaps - Rep.Gr 61

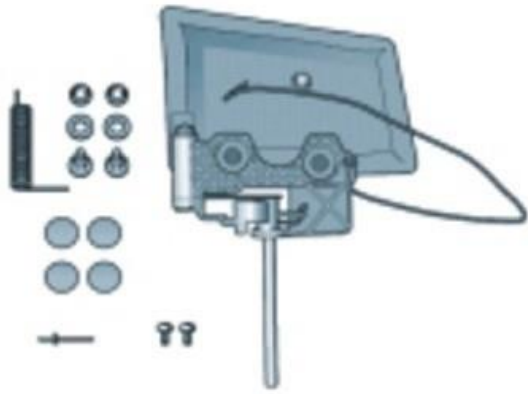
Figure 2

A kit of parts to replace the right and left hand trim flaps is now available (Figure 2)

NOTE: The trim flaps should be replaced in pairs
