Technical product information

Topic	New Continental GT - Ski hatch difficult to latch/unlatch
Market area	Bentley: worldwide (2WBE)
Brand	Bentley
Transaction No.	2052208/6
Level	EH
Status	Released for publishing
Release date	07-Nov-2022

New Continental GT

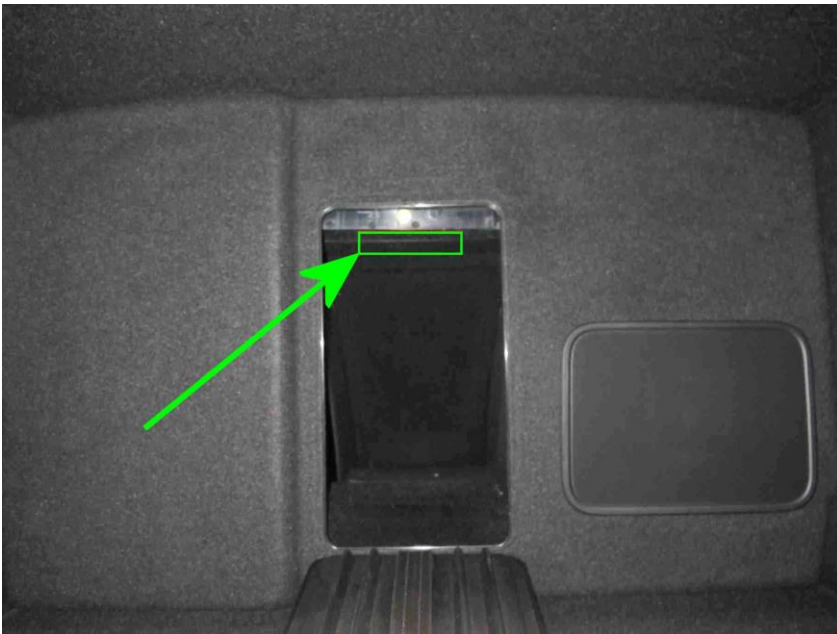
Figure 1

Due to tight tolerances the ski hatch mechanism fouls the upper ski hatch trim when closed/locked.

- Refer to Figure 1, looking into the boot locate the ski hatch lock aperture which is in the area shown
