Rotary Joint/Slip Ring Hardware Inspection

Units Affected: Certain AA, AN, AN-OC, AM, and A Class aerial devices built from January 2021 to February 2022. Verify your unit is affected by reviewing the attached list or accessing Altec Connect.

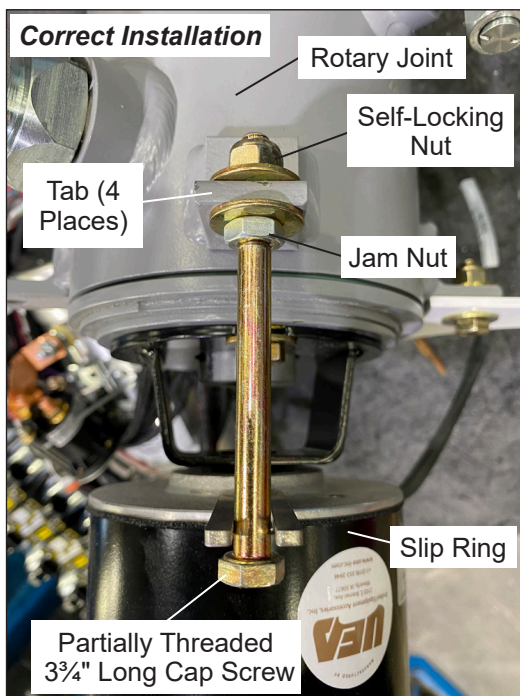
Figure 2 — Partially Threaded 3¾" Long Cap Screw, Correct Nut Types

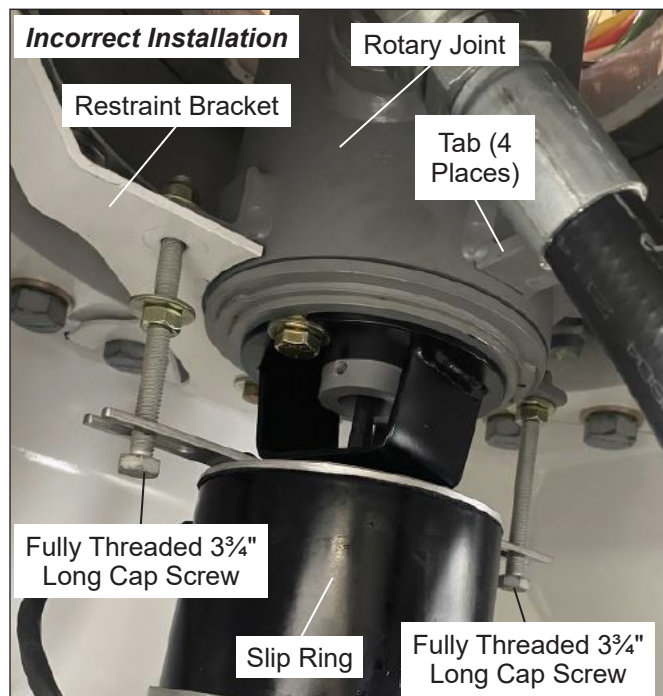
Background: Altec has learned that the threaded hardware between the rotary joint and slip ring could have been installed incorrectly on the affected units. This can cause the rotary joint restraint bracket to disengage from contact with the rotation bearing cap screw heads, allowing the outer housing of the rotary joint to turn in the pedestal and cause damage to the attached hoses.

Figure 3 — Fully Threaded 3¾" Long Cap Screw(s)

- If the fastener installation is incorrect, repair is required. Perform steps a through d below.
 - a. Order and schedule to install the Rotary Joint/Slip Ring Hardware Kit, part number 991476870, or schedule the installation of the kit by Altec.

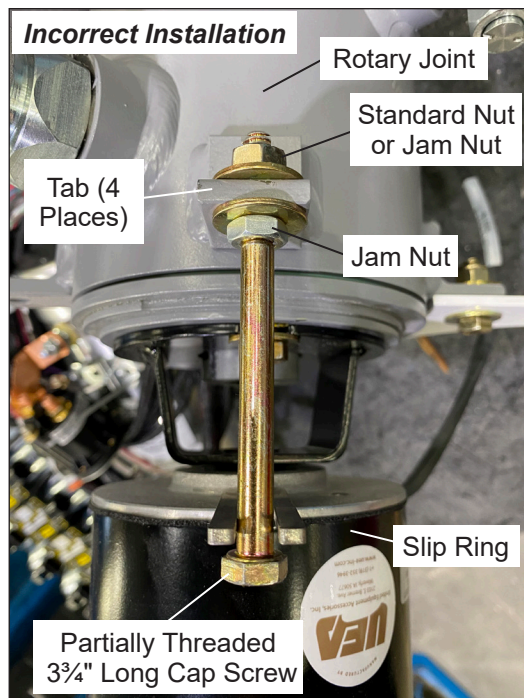
Figure 4 — Partially Threaded 3/4" Long Cap Screw, Incorrect Top Nut Type

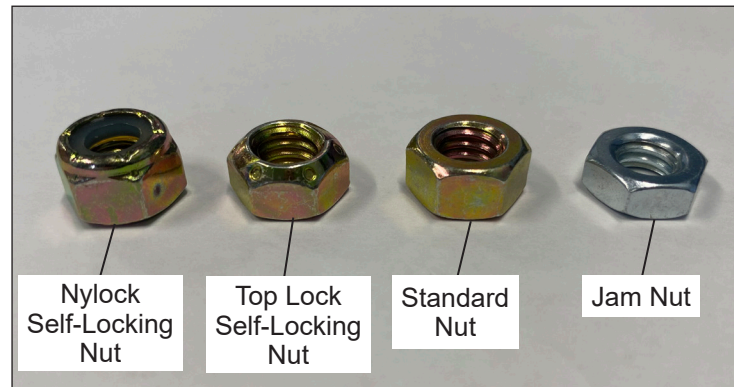
Figure 5 — Types of Nuts
