TECHNICAL SERVICE BULLETIN

Classification: AT22-016	Reference: ITB22-039	Date: November 15, 2022
-----------------------------	-------------------------	----------------------------

VIBRATION DURING LIGHT OR MODERATE THROTTLE INPUT

APPLIED VEHICLES: 2017-2019 QX80 (Z62)
APPLIED DATES: Built on or before August 6, 2018
APPLIED TRANSMISSIONS: 7 Speed Automatic

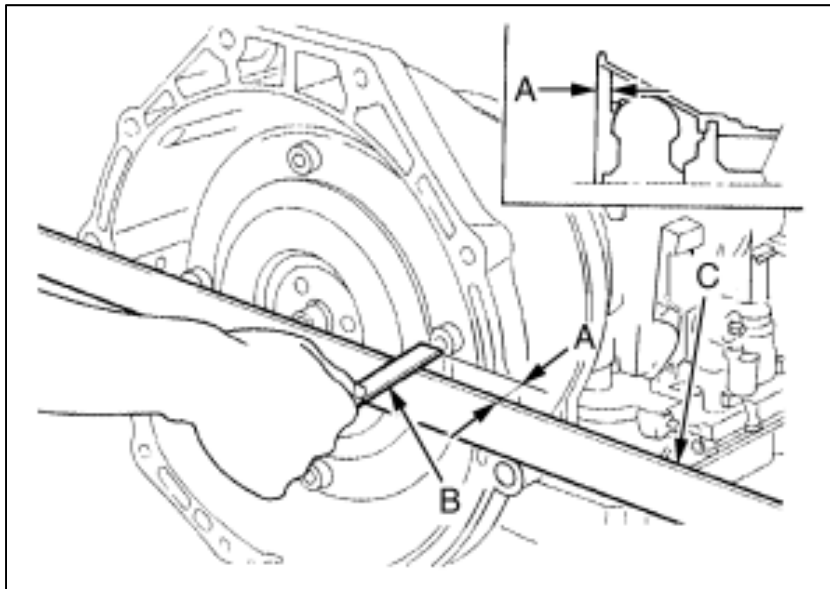
Figure 1

- Be sure to install a new input shaft O-ring when replacing the Torque Converter.
- After installing the Torque Converter into the transmission assembly, check dimension (A) before installing the transmission assembly in the vehicle.
 - (A): Dimension between the end of the converter housing and the Torque Converter 24.0 mm (**0.94 in.**).
