Service Bulletin

Bulletin No.: 22-NA-216

Subject: Information on Concern of an Engine Thermostat Tick Noise and/or Running Hot

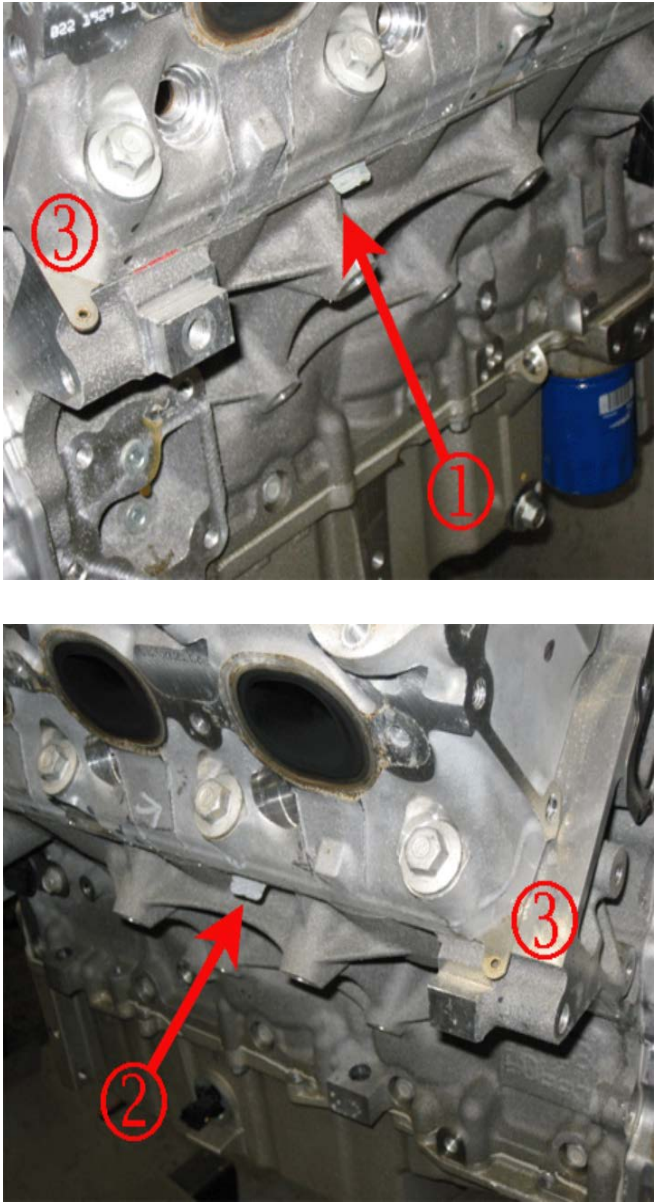
<p>3960230</p> <p>3960232</p> <ul style="list-style-type: none"> - #1 is Bank 1 tab near cylinder 3 - #2 is Bank 2 tab near cylinder 4 - #3 is the front of the engine <p>If the head gasket locating tabs are found to be closer to cylinders 5 or 6, this indicates the head gaskets were installed incorrectly, restricting the engine coolant flow. Replace the head gasket for this concern. Note: GEN5+ engines (L82, L84, L87 all model years).</p>
