GLOBAL SAFETY FIELD INVESTIGATIONS
DCS6355
URGENT - DISTRIBUTE IMMEDIATELY

Date: December 6, 2022
Subject: N222387720 - Service Update
Outer Body Panel Split
Models: 2023 Cadillac XT6
To: All General Motors Dealers

Service Update

N222387720 Outer Body Panel Split

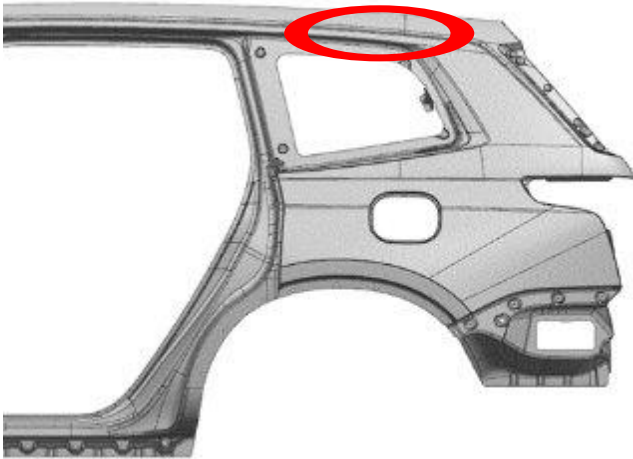
6203012

TIP: Use a flashlight to illuminate the area of inspection, the crack is in a recessed area of the sheet metal.

- Carefully inspect the area above the left quarter panel window for a cracking condition. This condition will be directly above the glass to body seal.

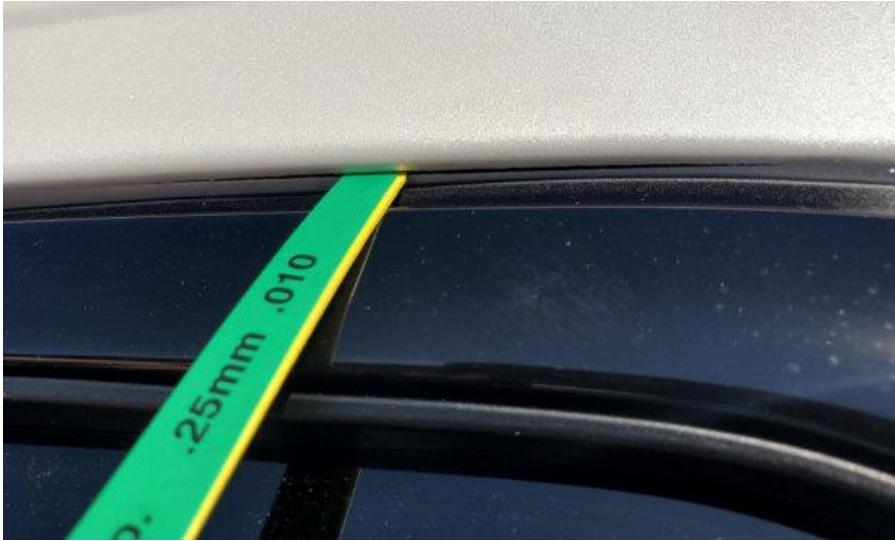
6203023

- If no cracking condition is found, no further action is required.
 - If a cracking condition is found, proceed to step # 2.
2. Remove the left quarter panel glass. Refer to *Quarter Window Replacement* in SI.
 3. Remove the left front, rear and 3rd. row roof rail airbag from the work area, it is not necessary to remove the complete assembly. Refer to *Front, Rear, and 3rd Row Roof Rail Airbag Replacement* in SI.
 4. Remove the left rear body structure stop lamp. Refer to *Rear Body Structure Stop Lamp Replacement* in SI.
 5. Move any wiring or flammable insulation from the inside of the repair area.
 6. Disconnect the negative battery cable. Refer to *Battery Negative Cable Disconnection and Connection* in SI.
